**New York State Department of Environmental Conservation  
Waste Tire Stockpile Assessment Summary Sheet - Site 7-07**

## **H O Tires Extension Town of Brookfield**

**Region 7, Madison County**

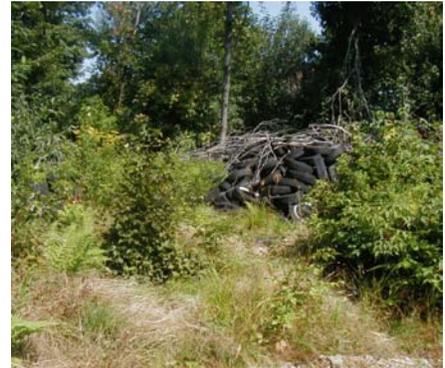
**Tires are located at the end of a dirt driveway. Most tires are located in two piles with additional tires scattered throughout the woods.**

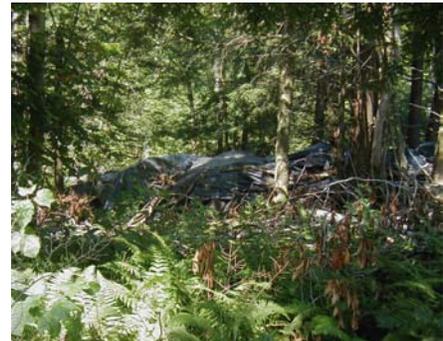
**Tires are old and weathered. Tires are overgrown with vegetation and located in wooded area. One pile of tires is covered with a plastic tarp**

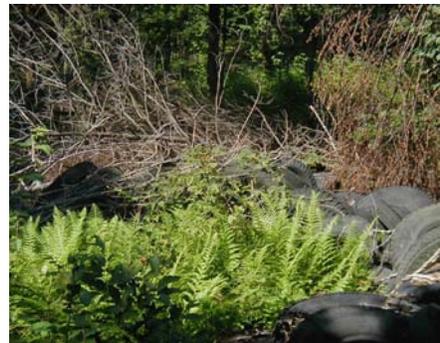
**Difficult access to most of tires.  
Tires are located on a wooded hillside with one old logging trail present**

**Two trailer homes are located on the same parcel of land as the tires.  
No municipal water source available.  
A protected stream is located 500 feet down gradient of site.**
