**New York State Department of Environmental Conservation
Waste Tire Stockpile Assessment Summary Sheet - Site 7-10**

Carl Bice (Krais Road) Junkyard Town of Pulaski

Region 7, Oswego County

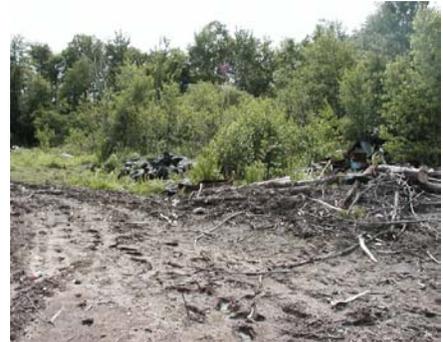
Tire piles are distinct but mixed with C&D waste. Limited access and piled in wooded areas.

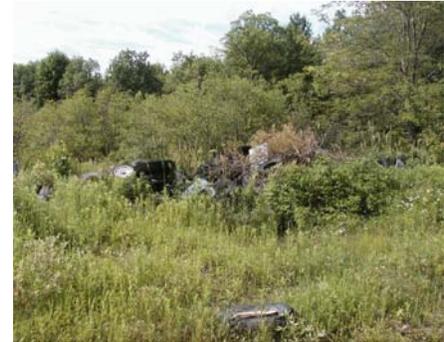
**Number of tires: 7,500 estimated
(approximately half hidden in overgrown areas and mixed in with C&D waste.)**

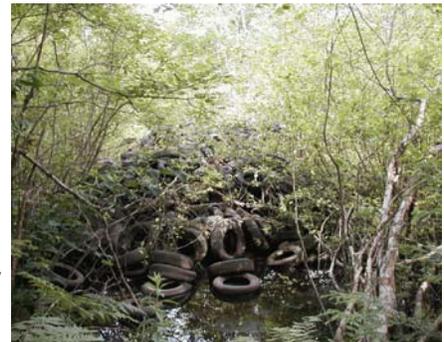
Mostly passenger tires in distinct piles. Majority of tires clean and mixed in with C&D waste. Mixture of rimmed and unrimmed tires.

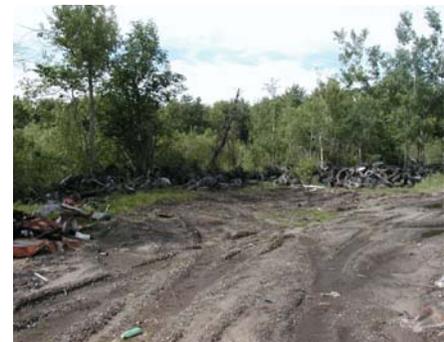
Access road off Krais Road, which is a dead end. Access road is very muddy; limited access due to feeder streams leading to wetland and stream. Some piles blocked by junk and trees growing in piles.

Limited fire access, damage to wetland and trout stream from runoff. Estimate may be low due to unknown quantity buried and intermixed with C&D material. The site is within a freshwater wetland and adjacent to a protected trout stream.
