**New York State Department of Environmental Conservation
Waste Tire Stockpile Assessment Summary Sheet - Site 9-02**

**Clarence Auto
Town of Newstead**

Region 9, Erie County

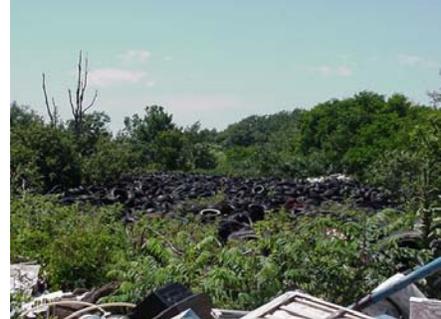
All one pile behind a dirt berm. The tires are accessible by narrow road to one side of berm. Site is somewhat of a swampy area and a firm access road may have to be built for site access. Trailers and cars next to pile. One of the trailers may be occupied.

Site dimensions were measured and an estimate was made, of approximately 650,000 waste tires.

Could not tell accurately, appeared to be old, clean, none with rims
