New York State Department of Environmental Conservation
Waste Tire Stockpile Assessment Summary Sheet - Site 9-11

**Kusior Auto Parts
Town of Brant**

Region 9, Erie County

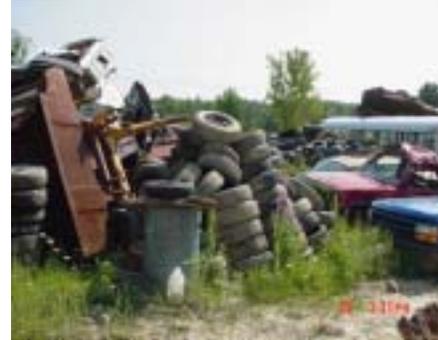
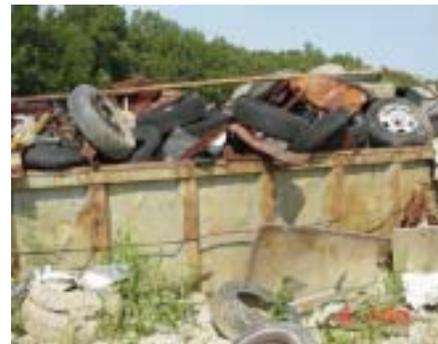
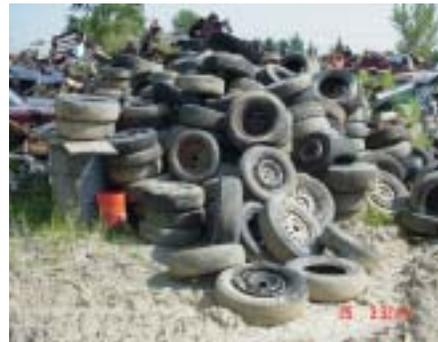
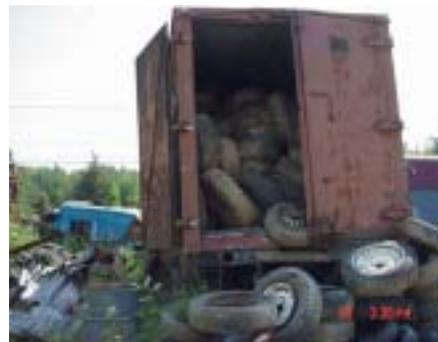
This site is an operating junkyard in a rural residential setting. There is vegetation around the site and many tires are mixed with scrap. There was a fire in one of the piles.

Some of the tires are mixed with other scrap. Many of the tires are in trailers or rolloffs around the site. Many have rims and are dirty.

Concerns: Vectors and fire
