Record of Decision
Depew Village Landfill Site
Operable Unit No. 01
Village of Depew, Erie County, New York
Site Number 915105

DECLARATION STATEMENT - RECORD OF DECISION

Village of Depew Landfill Inactive Hazardous Waste Disposal Site Operable Unit No. 01 Village of Depew, Erie County, New York Site No. 915105

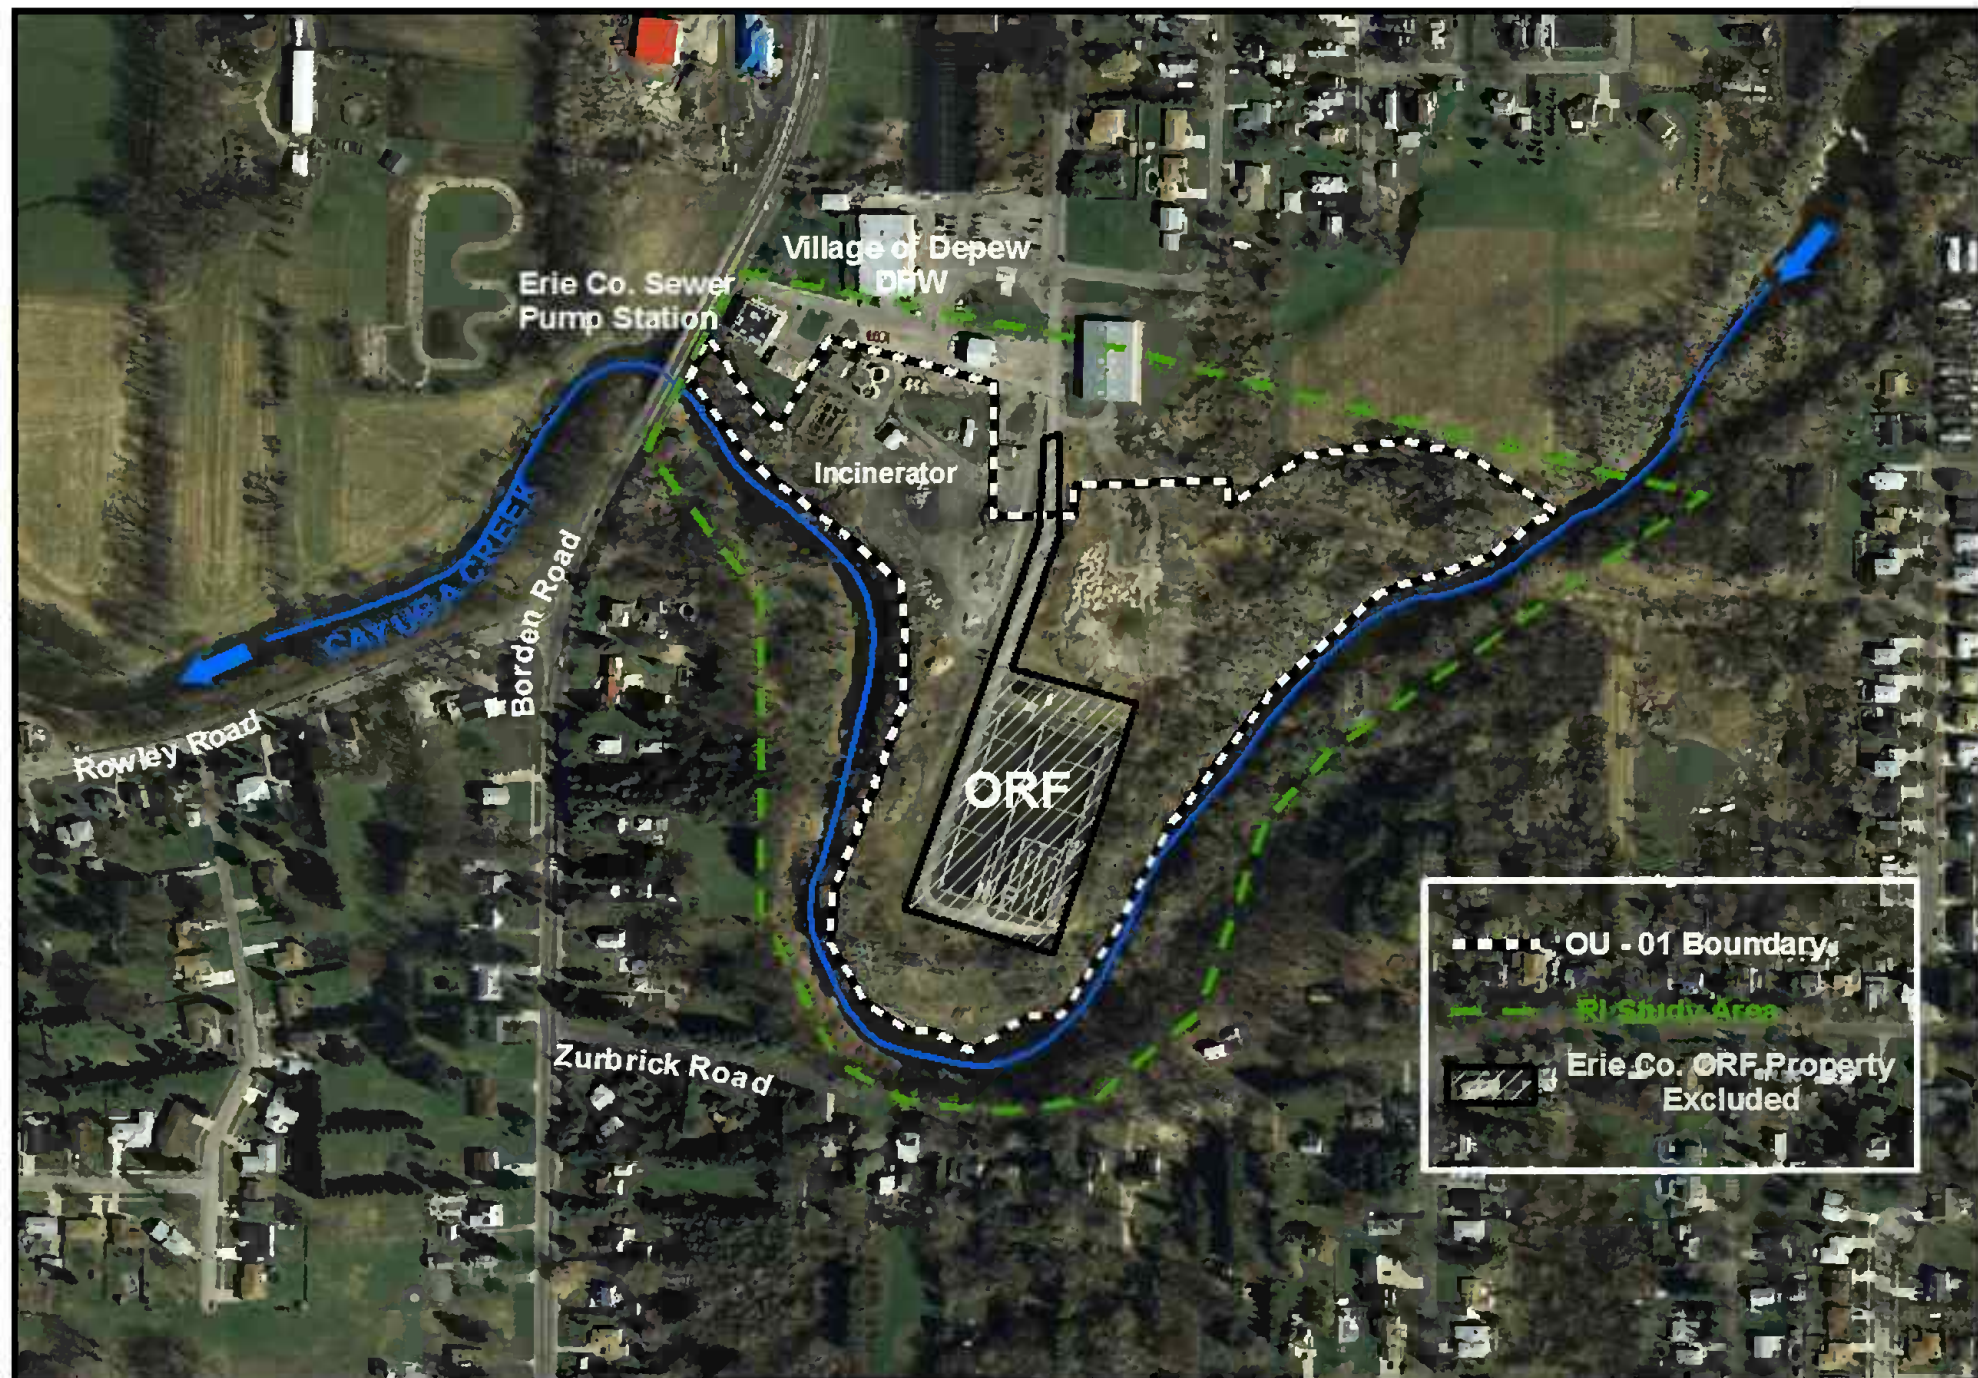
FIGURE 2

DEPEW VILLAGE LANDFILL
OPERABLE UNIT - 01 BOUNDARY

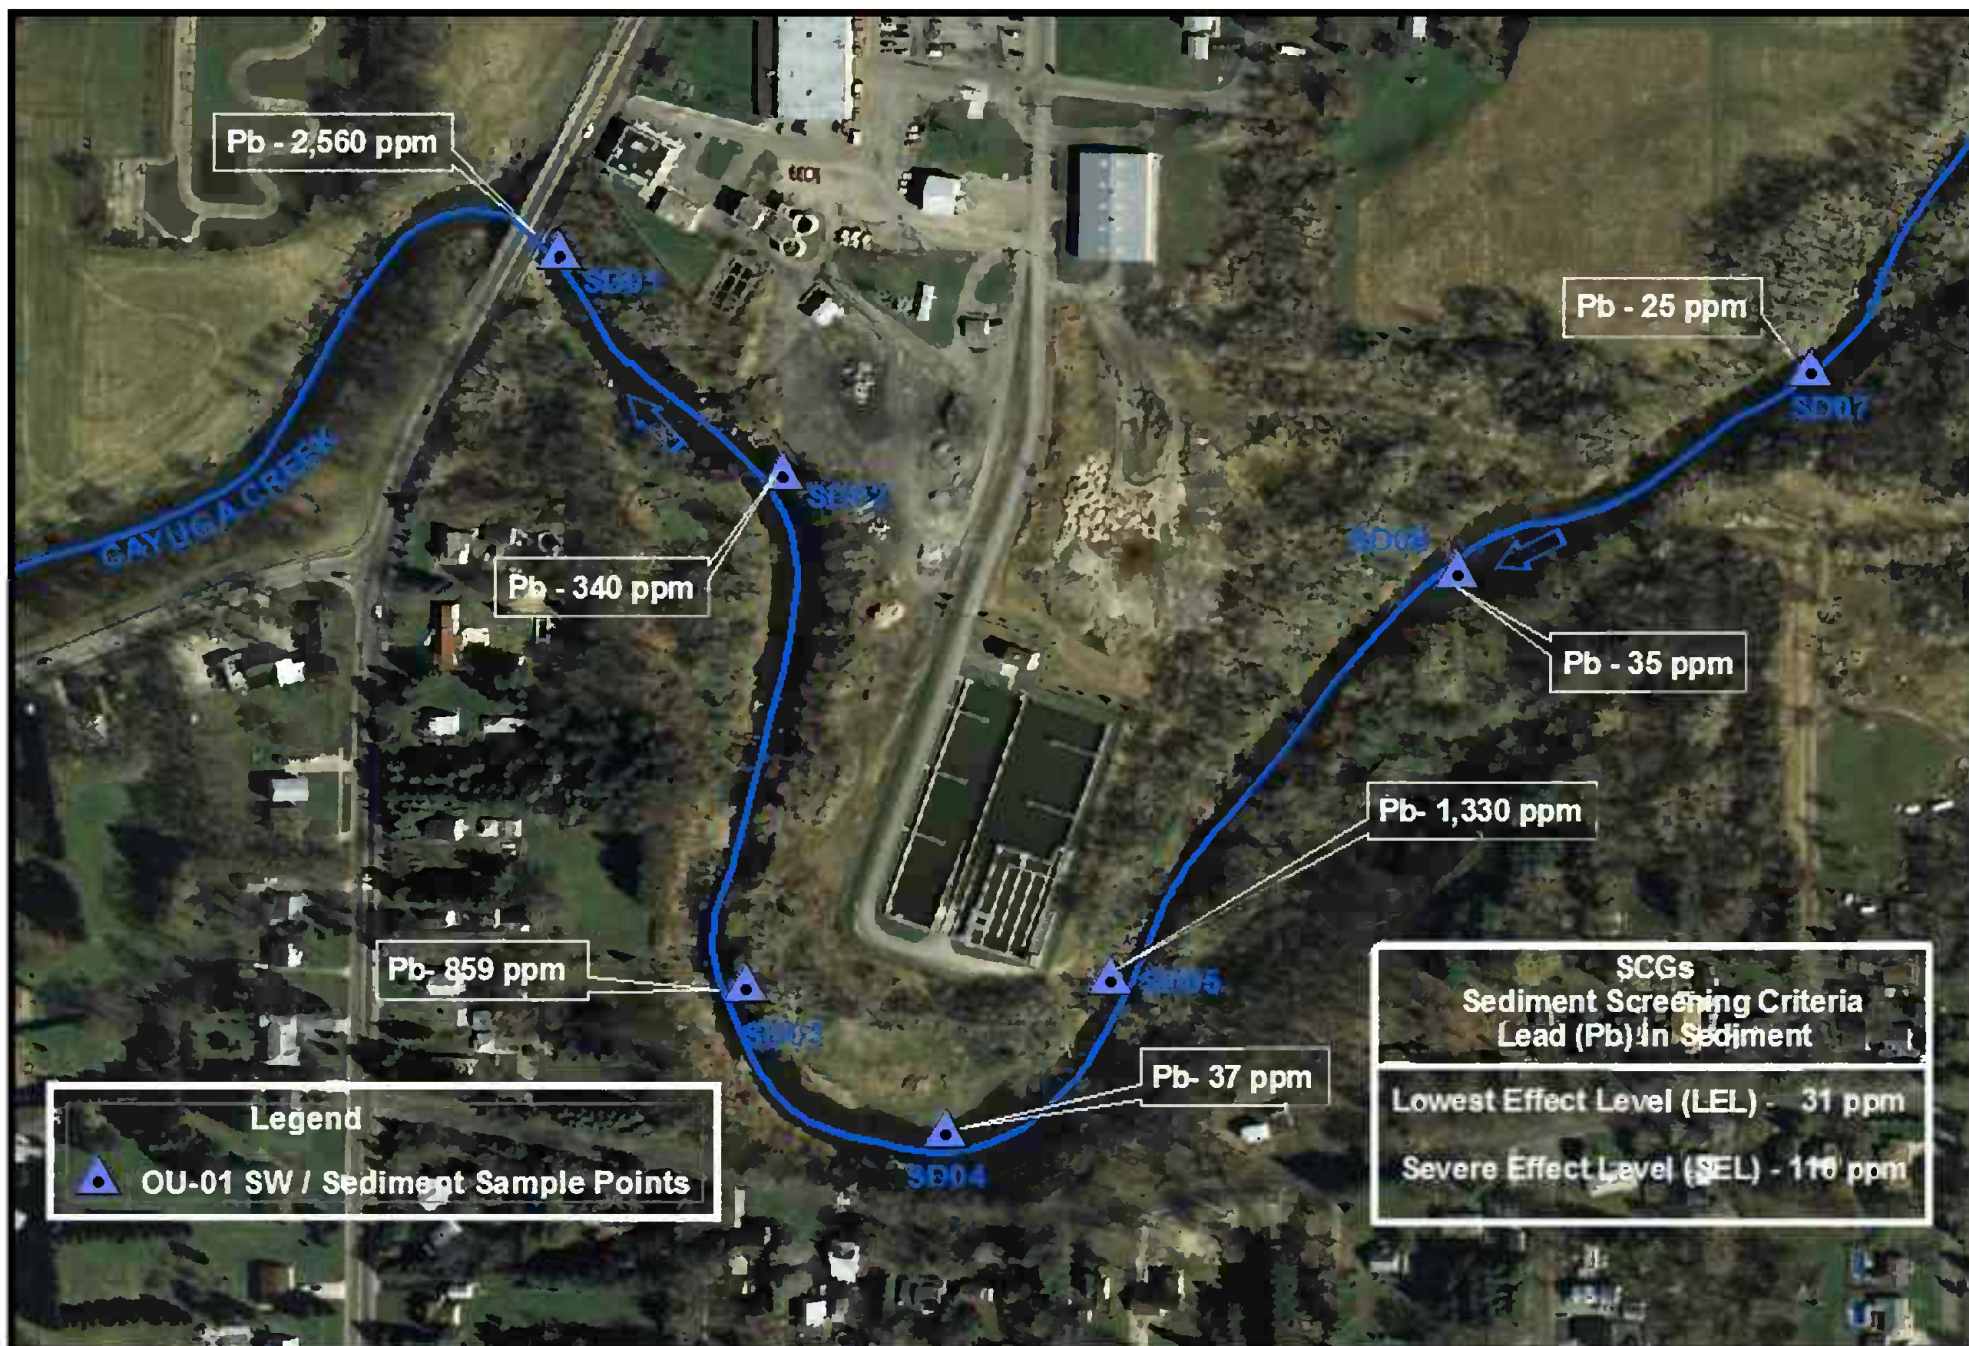
FIGURE 4

NATURE AND EXTENT OF CONTAMINATION
LEAD (Pb) IN SEDIMENTS - FEB 2006

RESPONSE 19: The 40,000 ppm concentration of lead was found at one location in the stream at a point adjacent to the site along the northwest side where sediment deposition occurs. Lead concentrations in the creek sediments downstream of the Borden Road bridge range from 7.0 to 474 ppm. Further investigation of the downstream sediments is on-going as part of OU-02 of the site. The source of the lead contamination in the sediments appears to be the erosion of the exposed contaminated fill materials along the creek banks and not erosion of the floodplain. Thus, complete removal of the exposed fill materials along the creek bank, coupled with bank stabilization and restoration as proposed, is the critical measure needed to control the source of the lead to the creek.

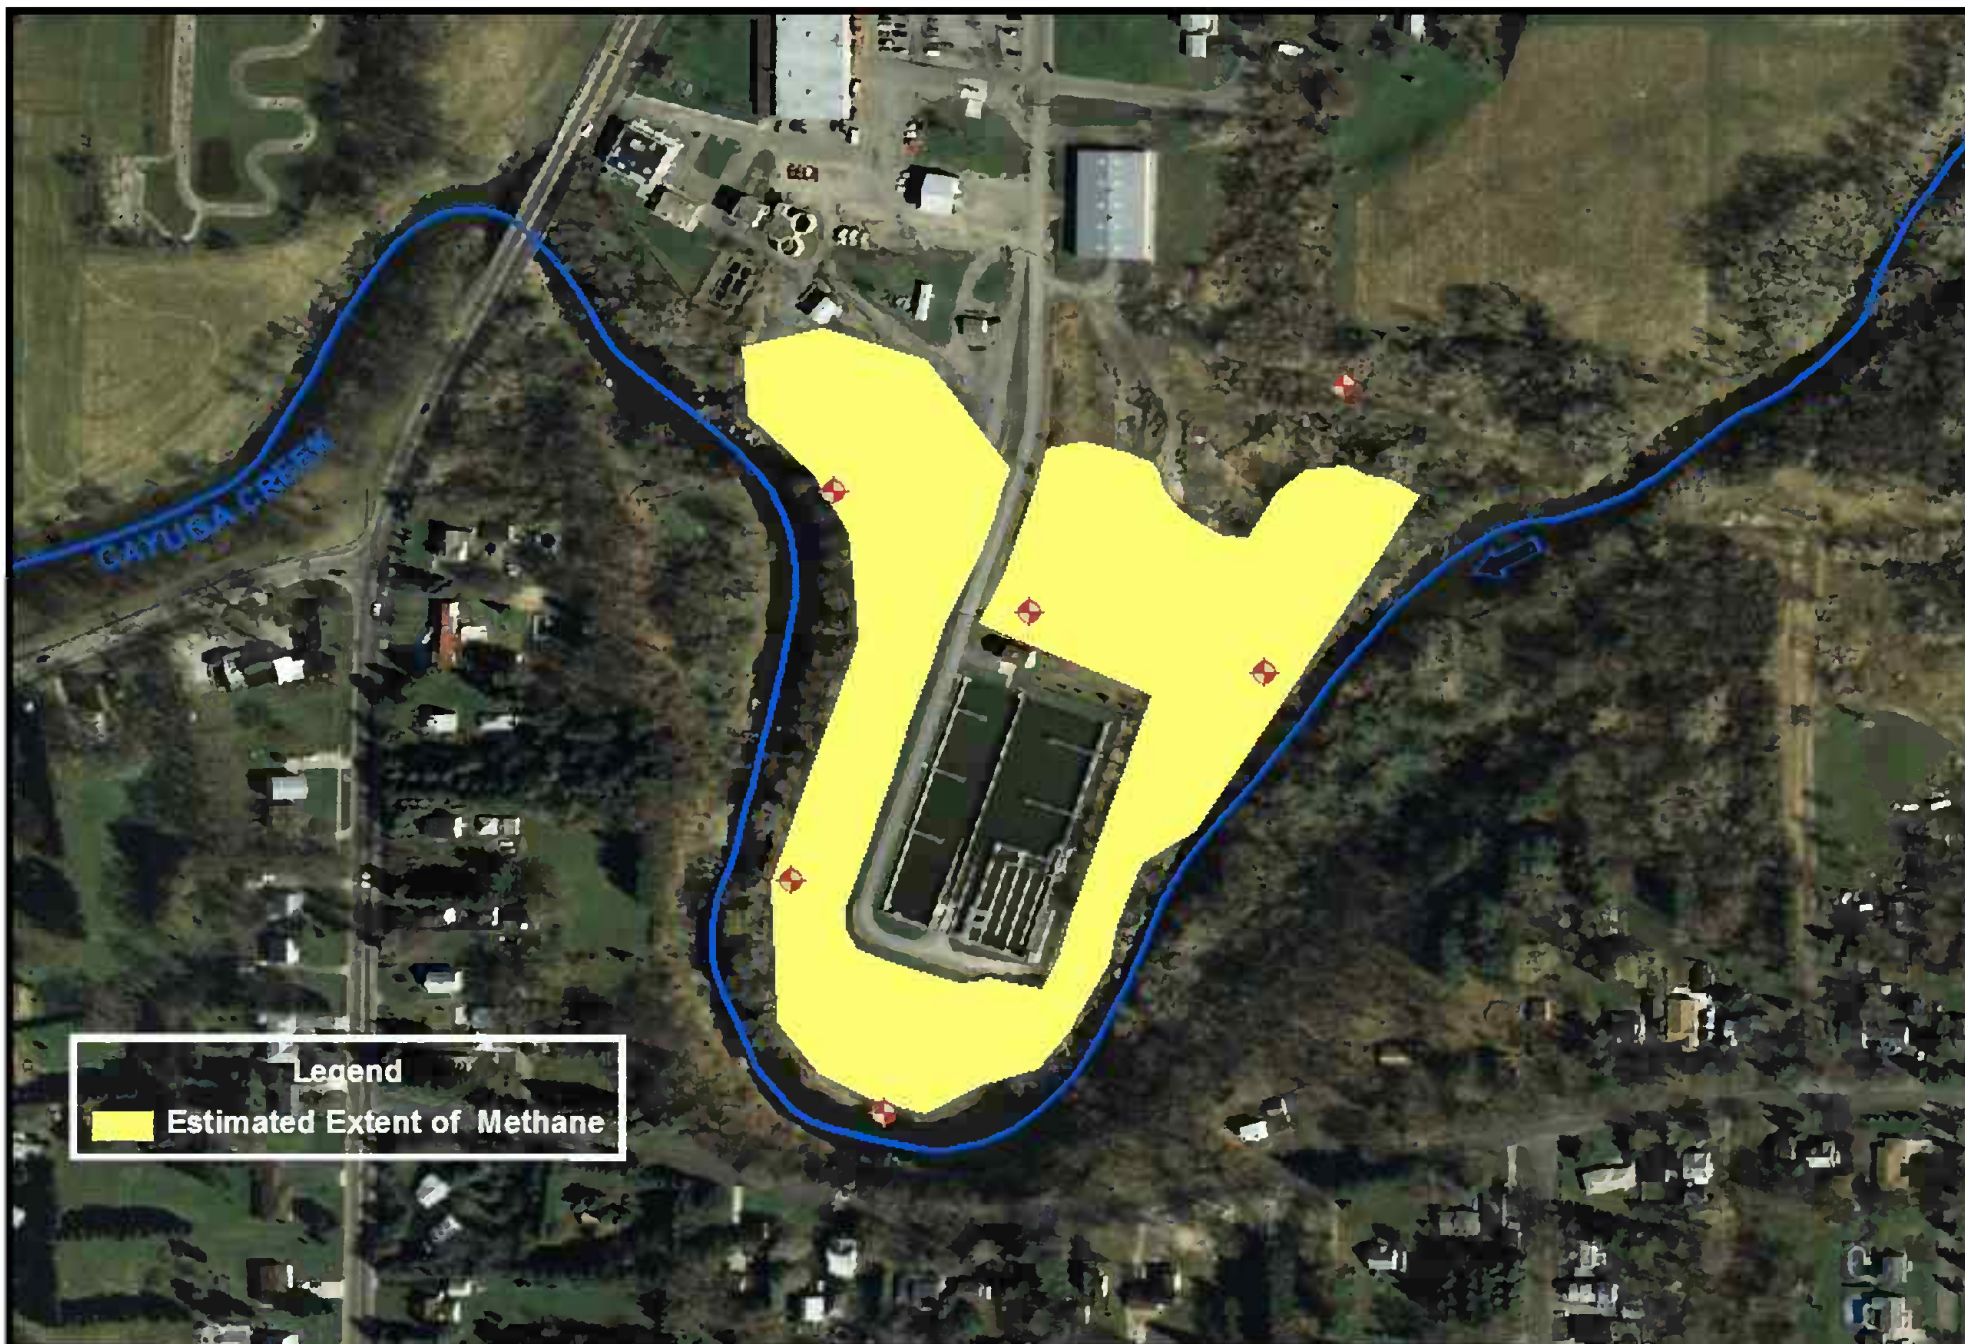
FIGURE 5

NATURE AND EXTENT OF CONTAMINATION
EXTENT OF LFG IN SOIL VAPOR - FEB 2006

Landfill gas as methane (CH₄) was present in all of the groundwater samples collected from the monitoring wells, with the exception of the up-gradient well (MW-05), located in the northeast section of the site. It was also detected in the open holes of several of the soil borings. Thus, it can be assumed that it is dispersed throughout the fill material layer and presents a health and safety hazard if allowed to accumulate in site buildings, structures and utilities. The highest concentration

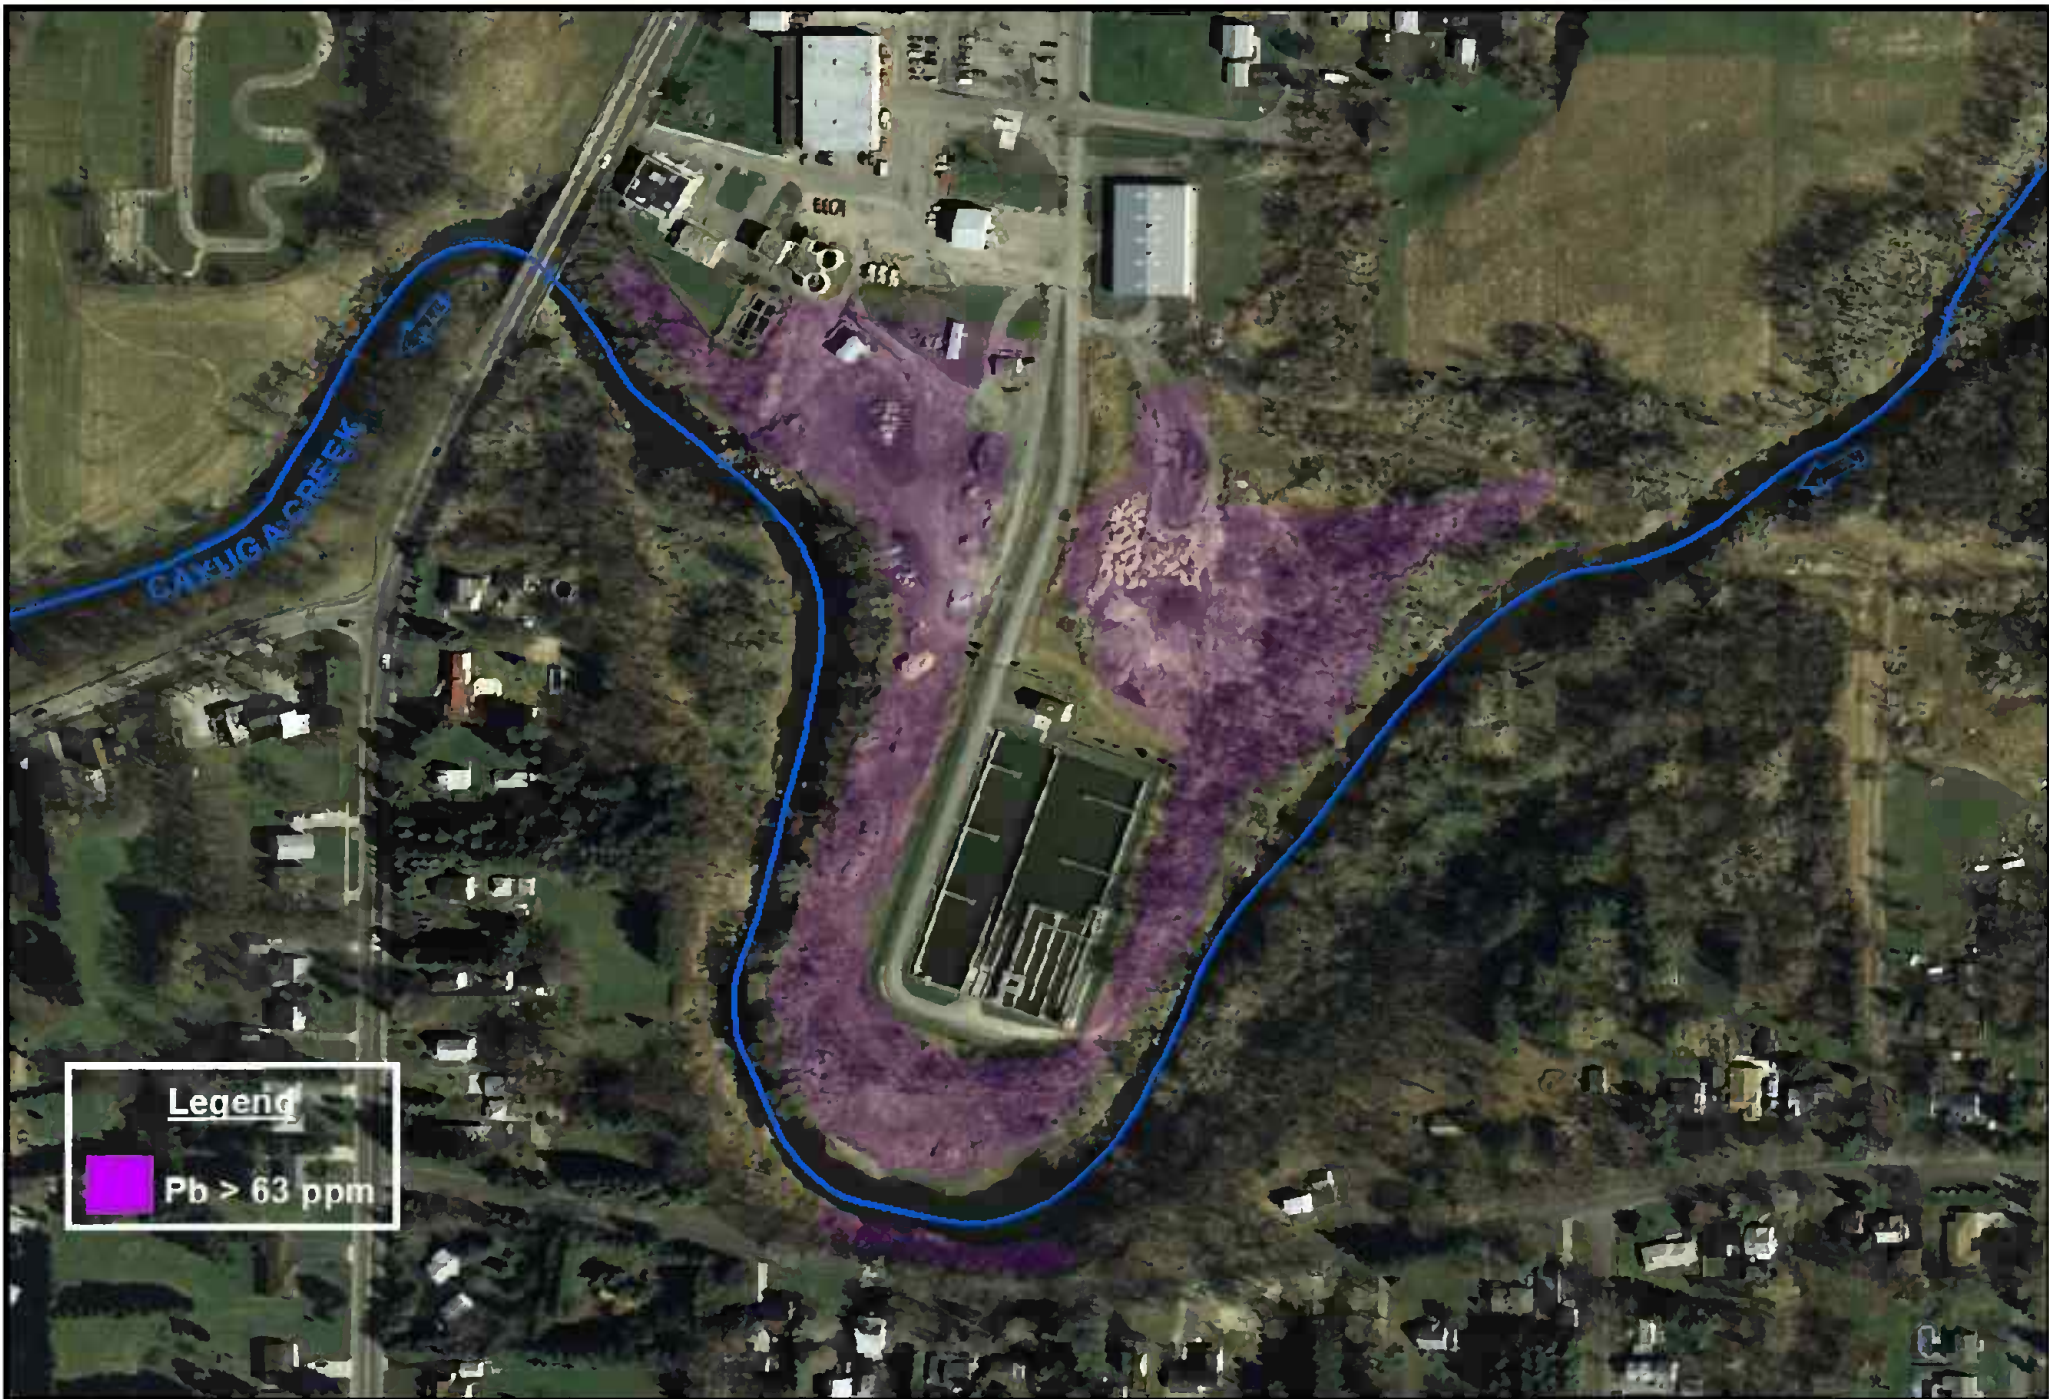
FIGURE 6

ALTERNATIVE 3
AREA OF EXCAVATION

Alternative 3: Contaminated Soil Removal to Pre-disposal Conditions, Off-site Disposal, Bank Stabilization and Continued Monitoring

Excavation of the fill material would result in a reduction of the waste mass available for anaerobic degradation and subsequent generation of landfill gas (methane), thus reducing and/or eliminating this health and safety hazard.

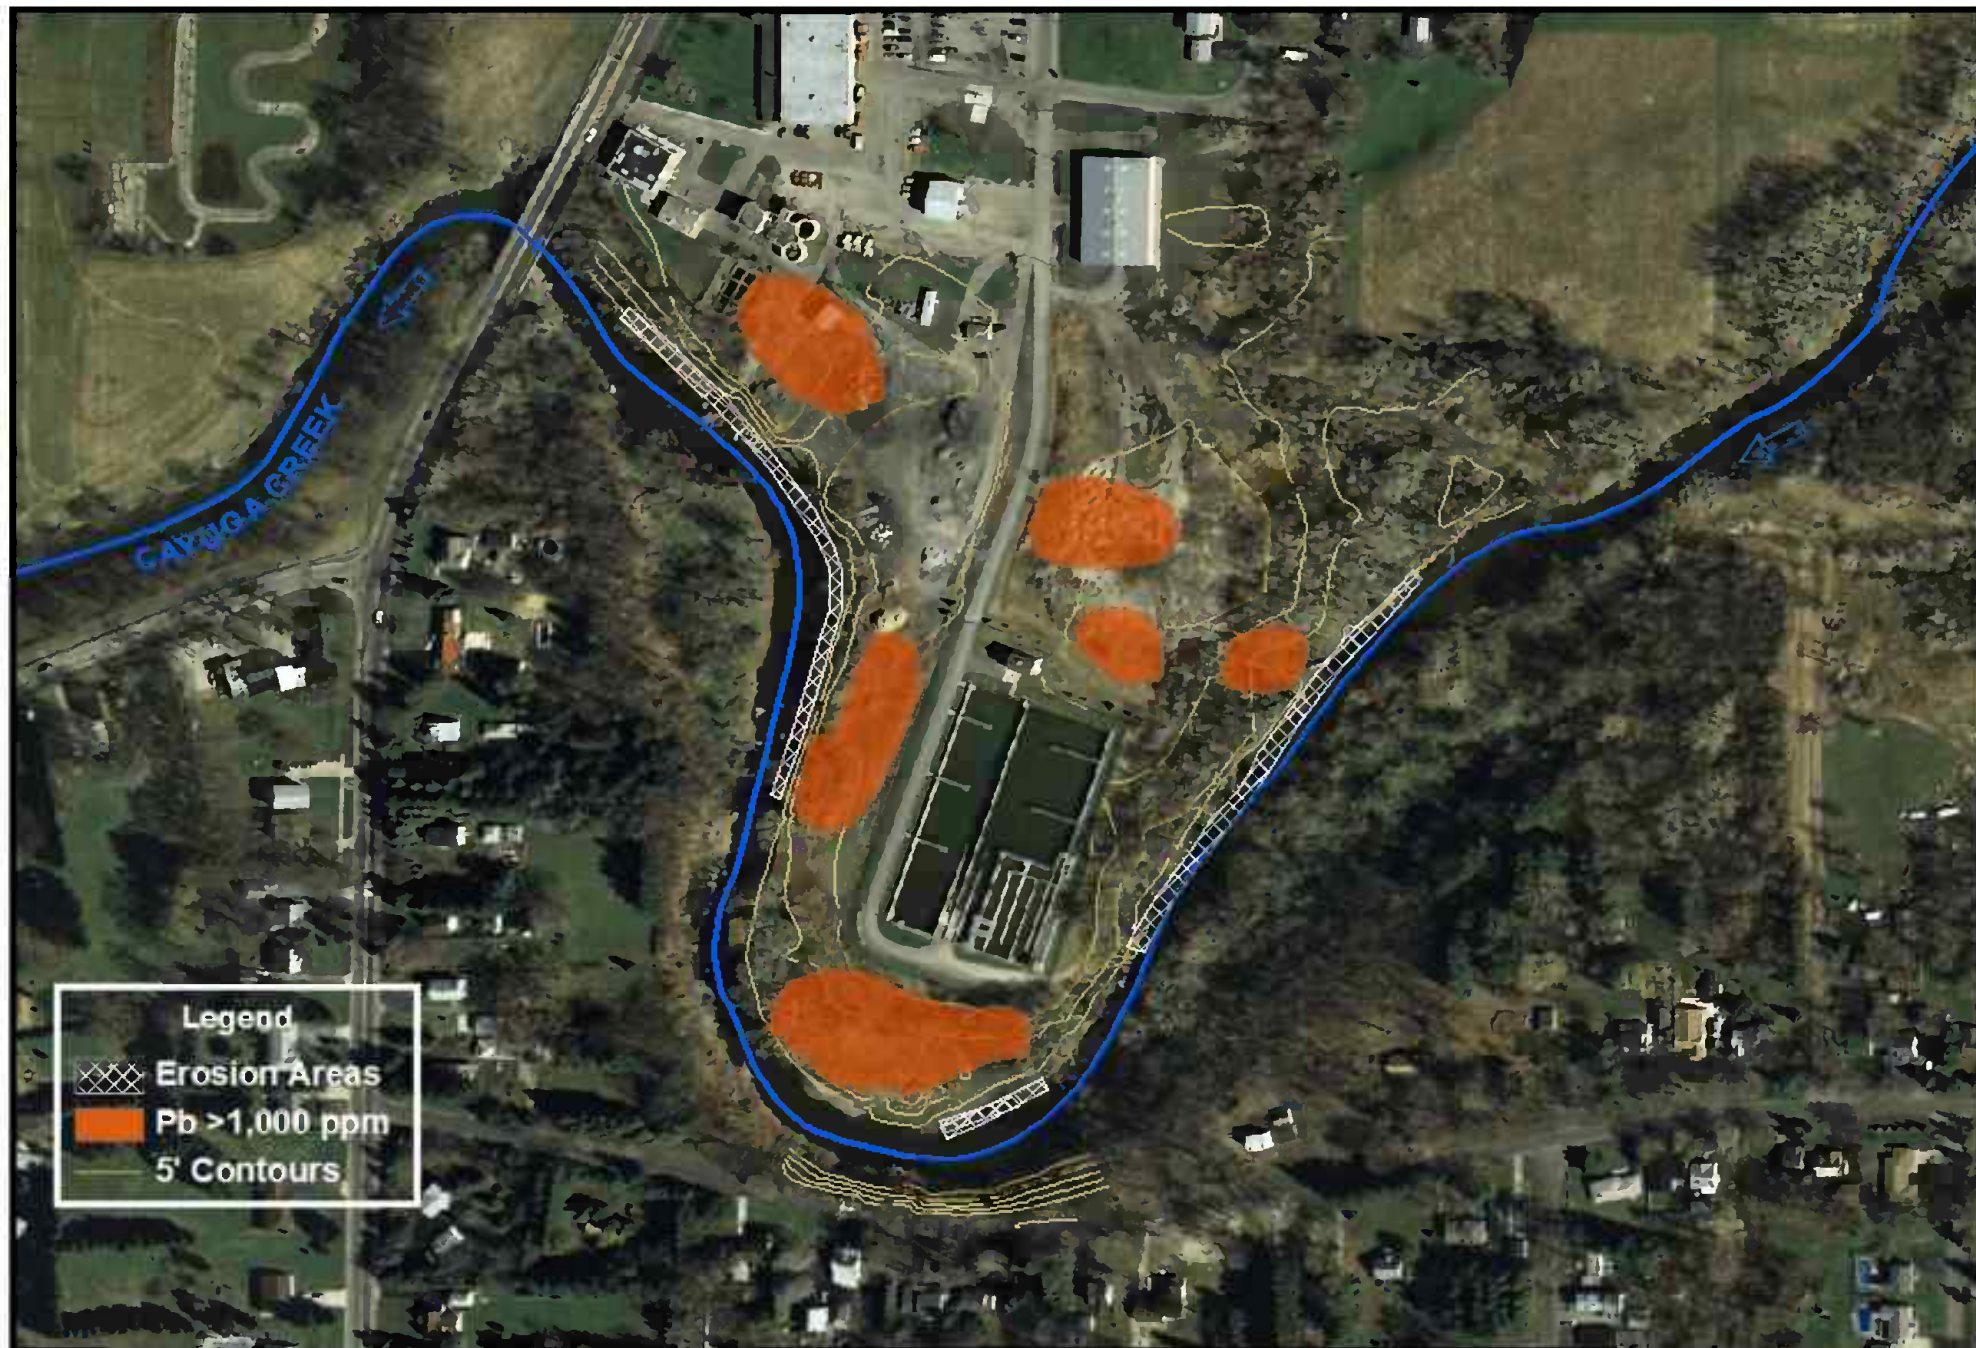
FIGURE 7

ALTERNATIVE 4
AREAS OF EXCAVATION - EROSION CONTROL

Under this alternative, all contaminated soils above the Protection of Ecological Resources SCO of 63 ppm located on the stream bank between the bankfull flow elevation and the stream bed would be removed. The bankfull flow elevation is equivalent to the point of transition between the stream channel and the flood plain (top of bank) as determined by regionalized hydraulic-geometry equations and actual stream flow data and conditions. Remediation of the contamination to the bankfull flow elevation, would result in the removal of approximately 14,000 yd³ of contaminated soils and fill material from this zone. The extent of stream bank to be remediated is approximately 2,100 linear feet around the peninsula extending inland up to approximately 25 feet from the stream bed and with an average depth of 7 feet. Excavated soils would be moved to the upland part of the site, spread and placed under the proposed soil cover. All excavated material would be replaced with clean fill. Stream bank stabilization and restoration measures would be performed in the remediated area to provide natural erosion protection and to provide for the re-establishment of the riparian habitat. Bank stabilization and restoration would be designed to protect the stream bank without reducing floodwater conveyance consistent with 6 NYCRR Part 608.

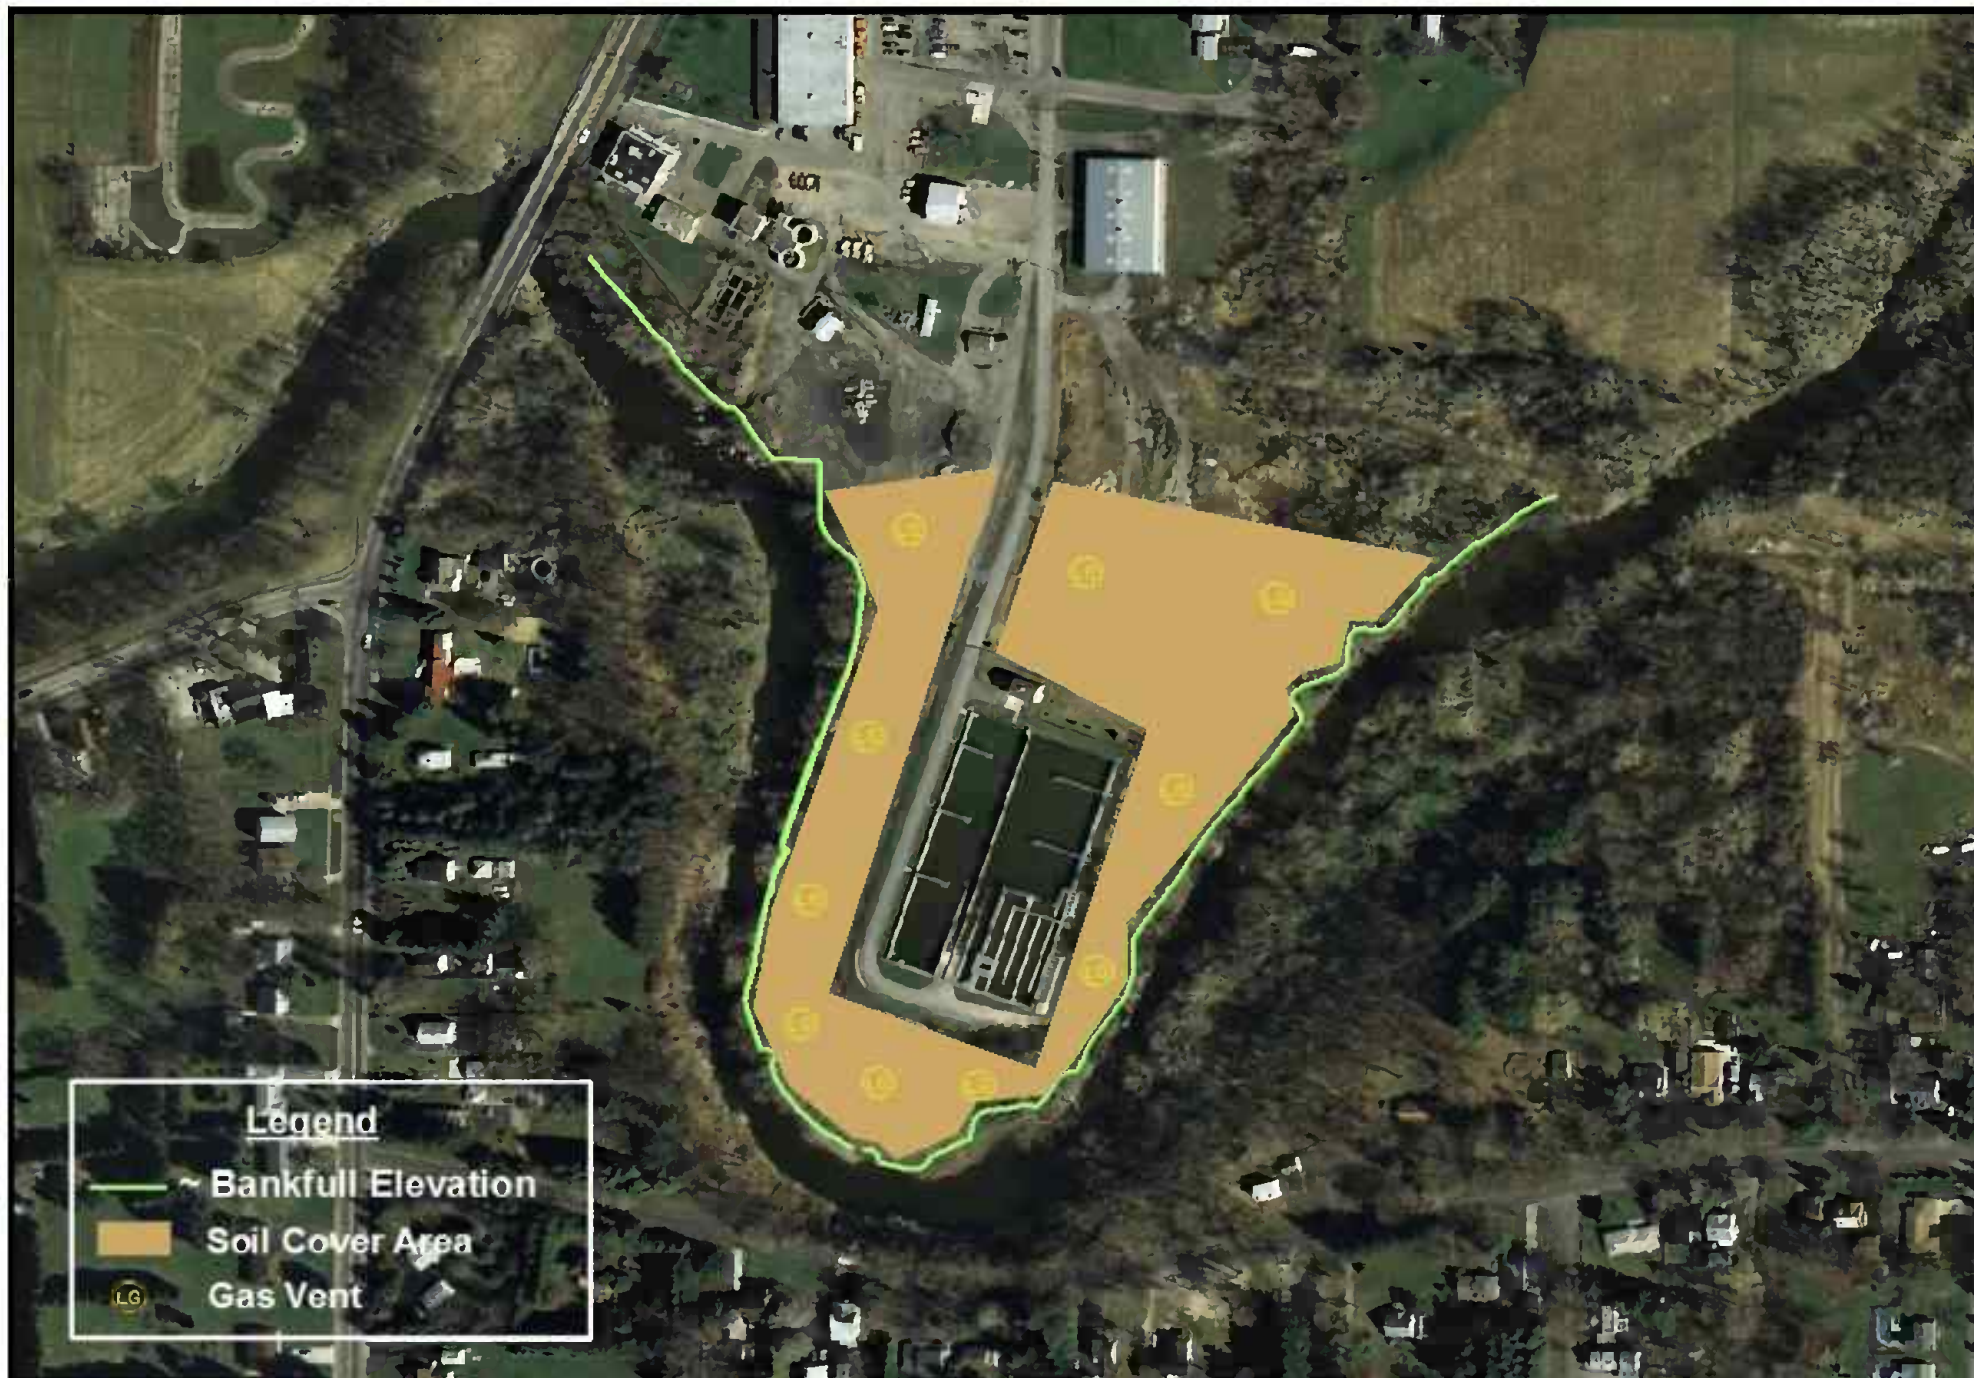
ALTERNATIVE 5
CREEK BANK SOIL REMOVAL, BANK STABILIZATION,
SOIL COVER, PASSIVE GAS CONTROL,
INSTITUTIONAL CONTROLS AND MONITORING

stabilized including erosion controls, in accordance with 6 NYCRR Part 608. In addition, a one foot thick soil cover as depicted in Figure 8, will be constructed over vegetated areas on-site above the bankfull flow elevation. The excavated material from along the stream bank will be integrated under the cover system. The top six inches of soil will be of sufficient quality to support vegetation. Clean soil will constitute soil that meets the Division of Environmental Remediation's criteria for backfill or local site background. Non-vegetated areas (buildings, roadways, parking lots, etc.), will be covered by a paving system or concrete at least 6 inches thick.
