Hillcrest Industries Update: 8/22/12

What is Hillcrest Industries? The Hillcrest Industries facility located on Favor Street in Attica collects boiler slag material (hardened residue collected from off-site coal boilers) and processes it into abrasive blast media (sandblasting materials). The facility also processes glass fragments (cullet) into reflective road striping beads and abrasive blast media.

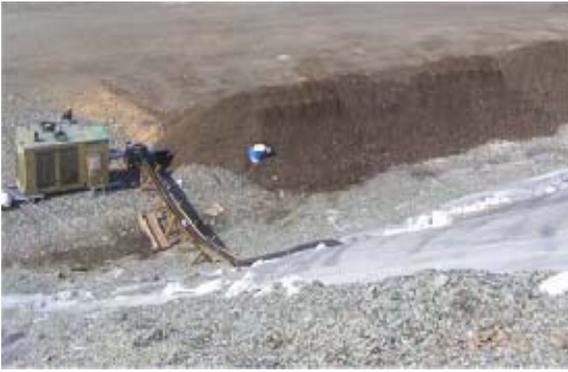
The deodorization system used to treat the gases extracted from the large pile of glass. The blue and white object in the compost pile is a 55-gallon plastic drum used to collect and pump out liquids.

In an attempt to control odors, Hillcrest has installed perforated pipe in the large glass cullet pile located in the southwest portion of the site. The pipe is connected to a blower that pulls odorous gas out of the glass cullet pile. The gas is then piped into a pile of compost that contains bacteria that reduces the odors before the gas is discharged to the air. In addition, Hillcrest has covered most of the large glass cullet pile on the site with plastic sheeting, which should significantly reduce the amount of untreated gas leaving the glass cullet pile. This gas collection system will be continuously evaluated and modified as needed to attain improved odor control. Hillcrest is also preparing to inject nitrogen into the pile to further assist in odor control.

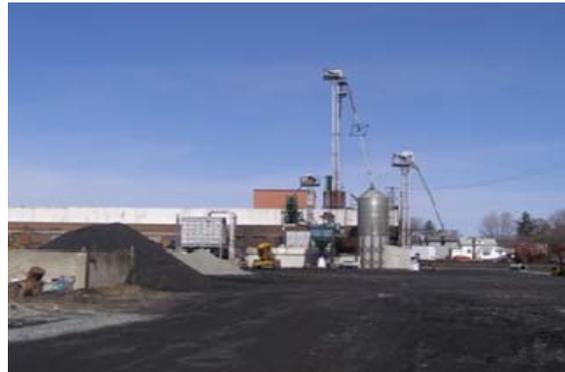
Air pollution control equipment, material conveying and storage equipment for the crushing and screening of slag and colored glass.

To reduce particulate emissions (dust) Hillcrest has repaired leaking process equipment, sealed off broken bag filters, ordered replacement filters and applied a dust suppressant to the facility's roadways.
