Hillcrest Industries Update: 9/4/12

Results from Residential Sampling – Dust

Results from Residential Sampling – Air

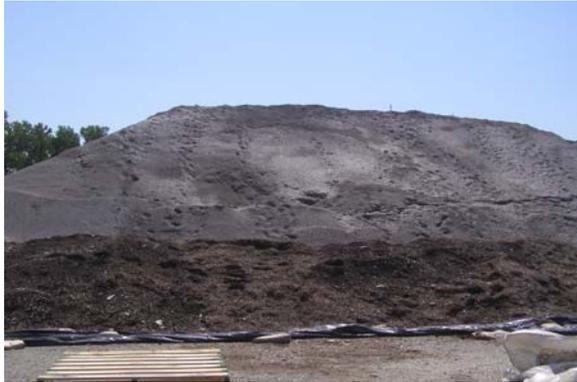
North side of glass pile with two applications of Posi-Shell (shot-crete like material)

Application of Posi-Shell, the shot-crete like material, was completed Friday, August 31st. Injection of nitrogen and carbon dioxide resumed after the Posi-Shell was applied.

Also, nitrogen gas was injected into glass pile at nine locations to reduce the temperature. The temperature of the pile at each injection point is being monitored to evaluate the effectiveness of the method for controlling odors. The Hillcrest facility has applied a spray cover to the glass pile to further reduce odors. Additionally, Hillcrest is in the process of removing the piles of plastic and paper from the property.

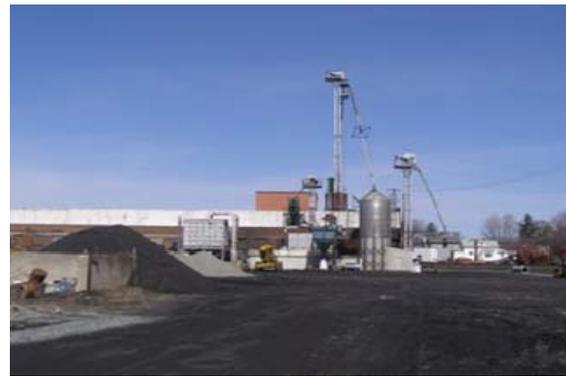
Air pollution control equipment, material conveying and storage equipment for the crushing and screening of slag and colored glass.

To reduce particulate emissions (dust) Hillcrest has repaired leaking process equipment, sealed off broken bag filters, ordered replacement filters and applied a dust suppressant to the facility's roadways.

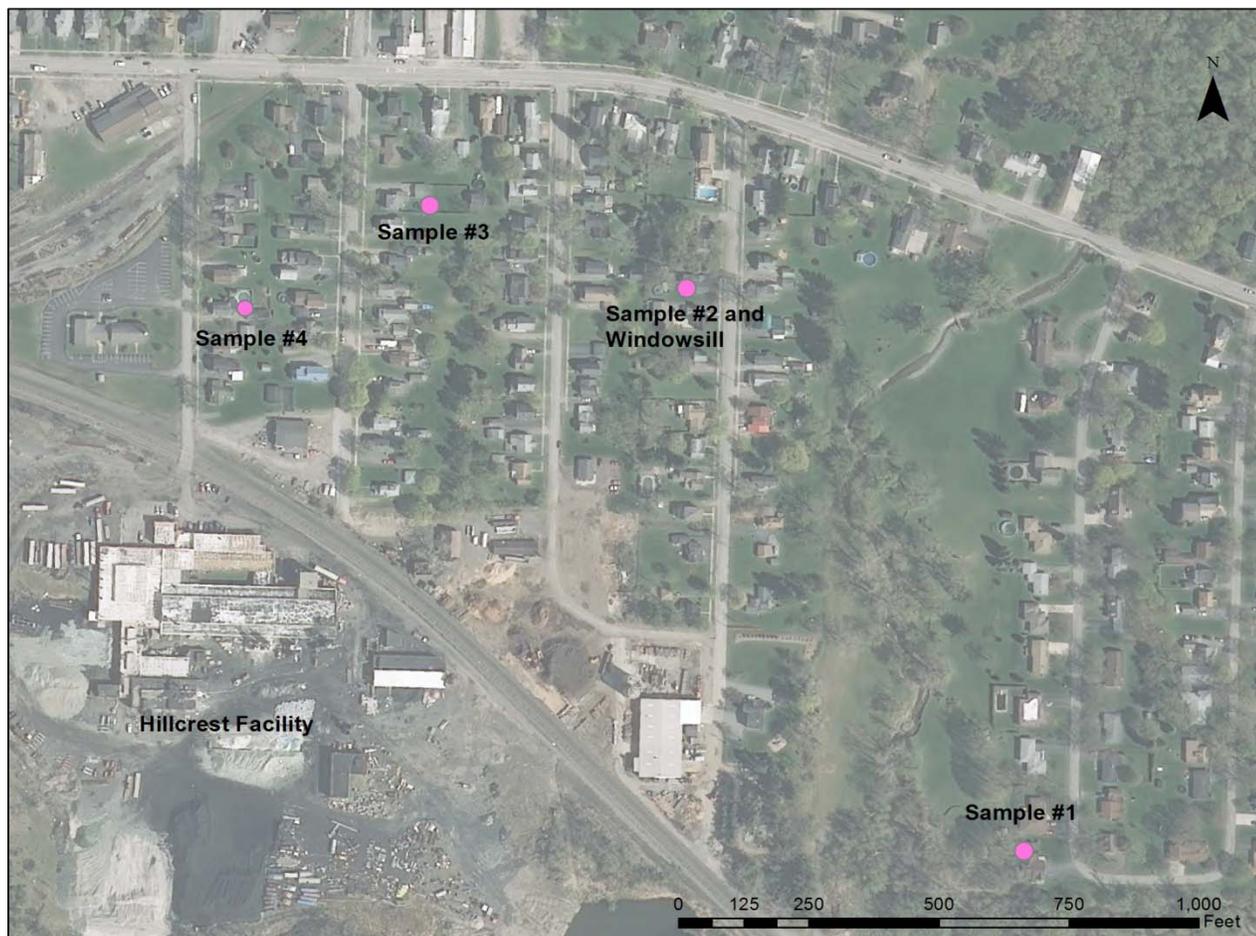
Dust Sampling Locations

DEC collected five dust samples from four residential properties in response to resident's concerns about health risks from exposure to dust releases from the facility. Dust samples were collected July 10-17, 2012. See **Dust Sampling Locations** on page 3 for an aerial map of the sampling locations. Eleven samples were collected on site of the facility at specific release points and from raw material and finished product. Matching the types of particles found on the residential properties with the types found onsite of the facility could provide DEC staff with an understanding of which release points need to be better controlled. The samples were submitted to DEC's Microscopy Lab for analysis. The lab determined the composition of the residential dust samples and the size of the particles to evaluate whether the dust could be from operations at the Hillcrest facility.

The microscopy lab found particles in all five of the residential dust samples with similar characteristics as the particles of glass fragments from the facility. The samples collected from the facility contained particles which ranged in size from fine particulate matter (particles 2.5 microns or less in size) to much larger sizes, well above 100 microns with most particles very large in size. By comparison, the width of human hair is 40 to 120 microns, where a micron is one millionth of a meter. Similarly the particles in the residential dust samples which were distinguished as either glass fragments, glass beads or slag fragments were also mostly very large in size, generally 10 microns and larger, but also contained smaller particles in the 2.5 to 10 micron range. The particles found in the residential samples attributable to facility releases appear to be from crushed clear glass that feeds the bead furnace and fines from the glass bead furnace cyclone. In addition to the glass spheres and fractured glass, some slag product was identified. Results of the analysis are available upon request.

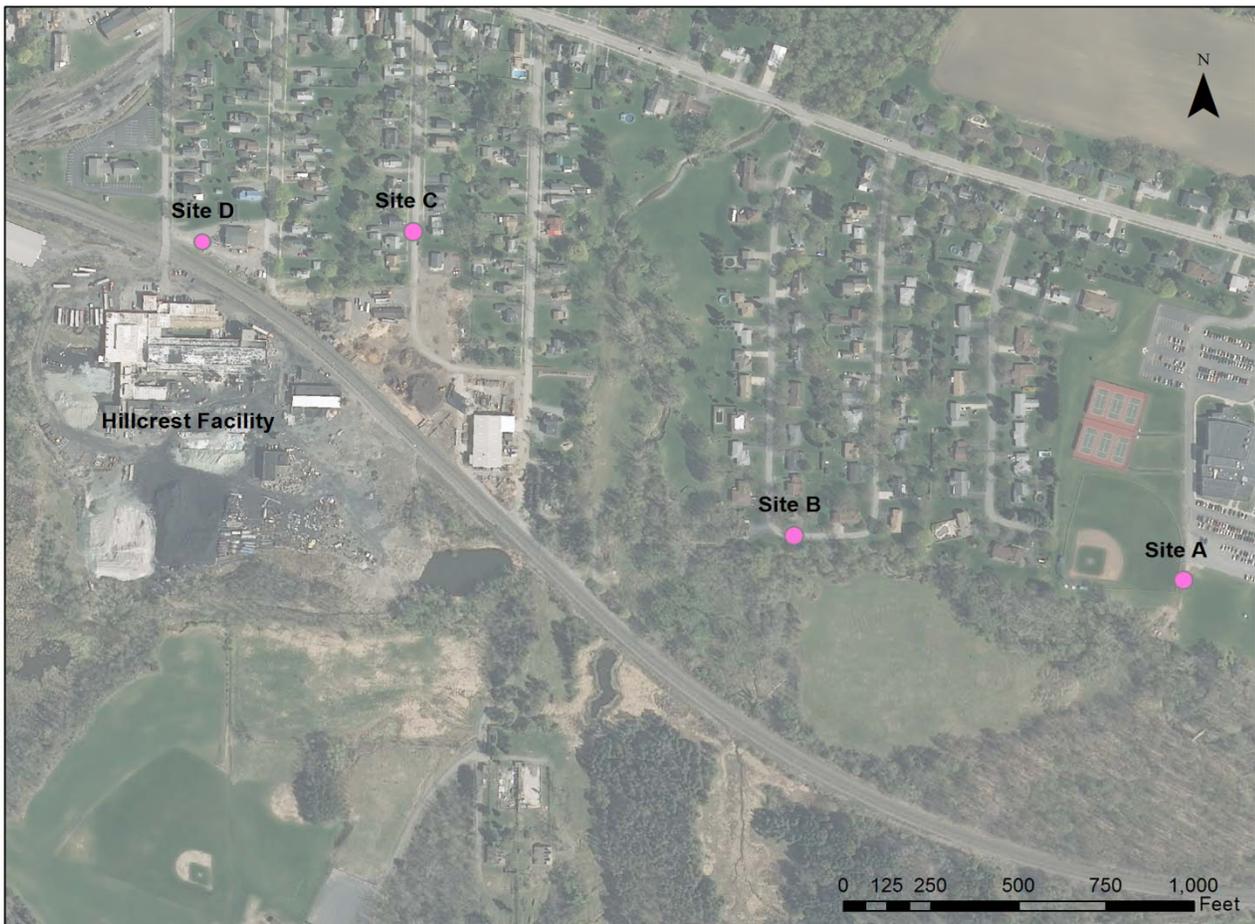
Air Sampling Locations

DEC collected four one-hour ambient air samples on August 8, 2012 between 12:00 p.m. and 3:00 p.m. in response to community concerns about odors and exposure to volatile air contaminants from the Hillcrest facility. See **Air Sampling Locations** on page 4 for an aerial map of the sampling locations. Three samples were collected in the odor plume in the neighborhood downwind from the Hillcrest facility, one of which was at the facility property line. A fourth sample was collected at the Attica High School between the gas well and baseball diamond, approximately 20 yards south of the parking lot. DEC's laboratory analyzed all air samples and provided the results for 41 volatile organic compounds (VOCs). These results were compared to DEC's Short-term Guideline Concentrations (SGCs) since the sample collection was a short period of time. SGC's were developed by the DEC to ensure that short-term exposures do not cause any significant health effects.
