Sampling Report

**Water Street Properties,
City of Lockport,
Niagara County, New York**

March 2003

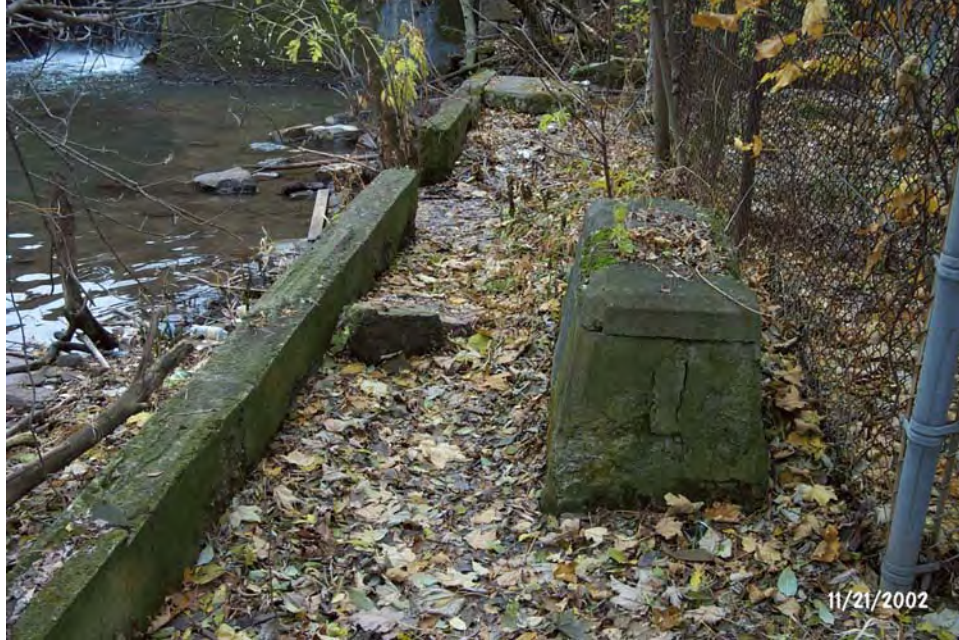
Figure 2-1. Photograph of the fenced containment structure that may have housed transformers and/or capacitors containing PCB oil. The Clinton Street dam is in the background, while Eighteenmile Creek is to the left. Photograph taken by Paul Dicky on November 21, 2002.

On November 7, 2002 during an inspection of Eighteenmile Creek to identify potential sampling locations, NYSDEC and NCHD personnel discovered a fenced containment structure downstream of the Clinton Street dam. This structure may have housed transformers and/or capacitors, which historically contained PCB oil. As a result, this area was identified as a potential source of PCBs to Eighteenmile Creek.

On November 7, 2002 during an inspection of Eighteenmile Creek to identify potential sampling locations, NYSDEC and NCHD personnel discovered a fenced containment structure downstream of the Clinton Street dam that may have housed transformers and/or capacitors (Figure 2-1). Historically, such equipment contained PCB oil. As a result, this area was identified as a potential source of PCBs to Eighteenmile Creek. To evaluate this potential, two soil samples and three sediment samples were collected from this area on November 26, 2002.

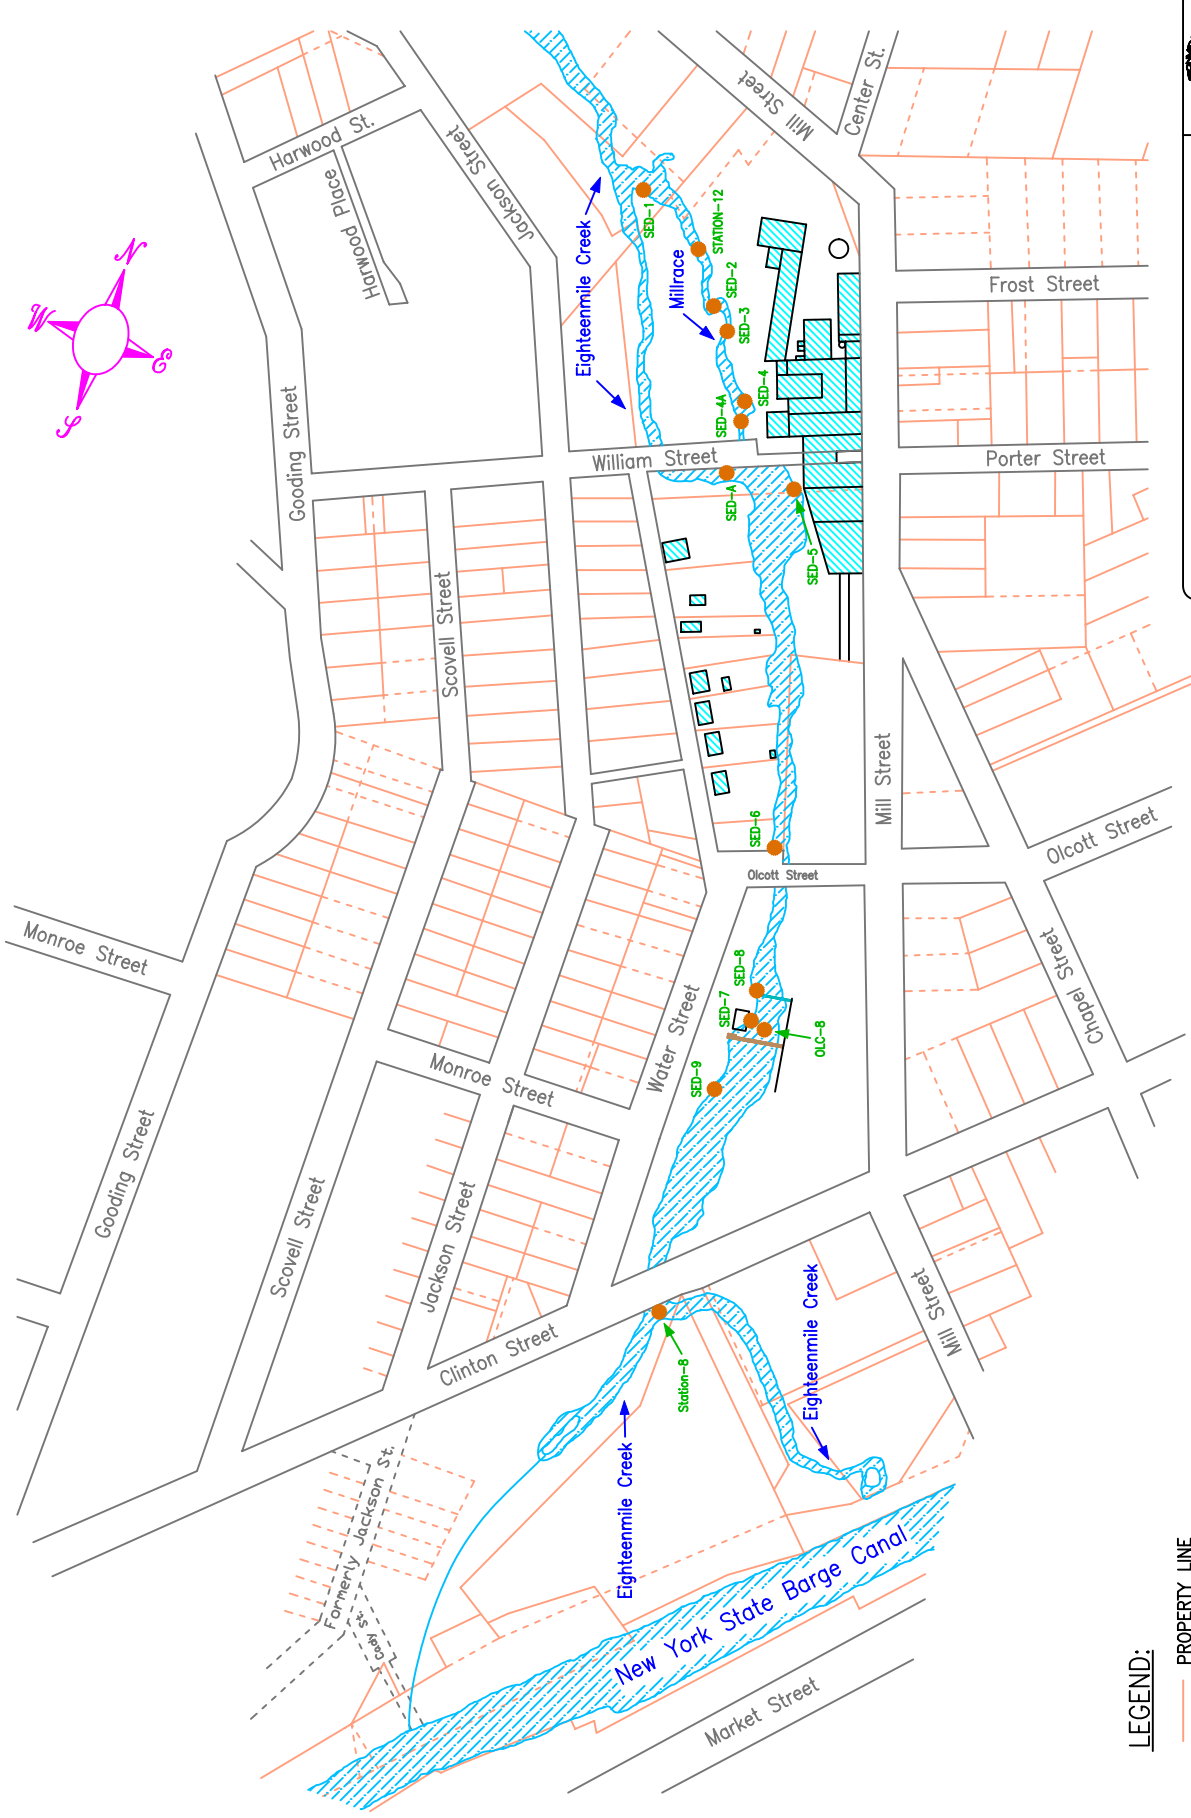
- PROPERTY LINE
- - - ORIGINAL LOT LINE
- SEDIMENT SAMPLE LOCATION

Four sediment samples (SED-6 through SED-9) were collected from the locations shown on Figure 3-1, which also shows the locations of historical sediment samples collected from Eighteenmile Creek. Five waste samples and eighteen surface soil samples (SS-1 through SS-22, and SS-24) were collected from the locations shown on Figure 3-2. All sampling was completed by NYSDEC staff utilizing Department owned equipment. Sample analysis was completed by Severn Trent Laboratories, Inc. in Amherst, New York, a NYSDEC contract laboratory. All twenty-seven samples collected during the three sampling events were analyzed for lead, with fifteen of the samples also analyzed for PCBs. Four waste samples and one surface soil sample were also analyzed for lead using the Toxicity Characteristic Leaching Procedure (TCLP) to determine if these samples were characteristic hazardous waste. Information concerning sample collection and analysis is given in Table 3-1.

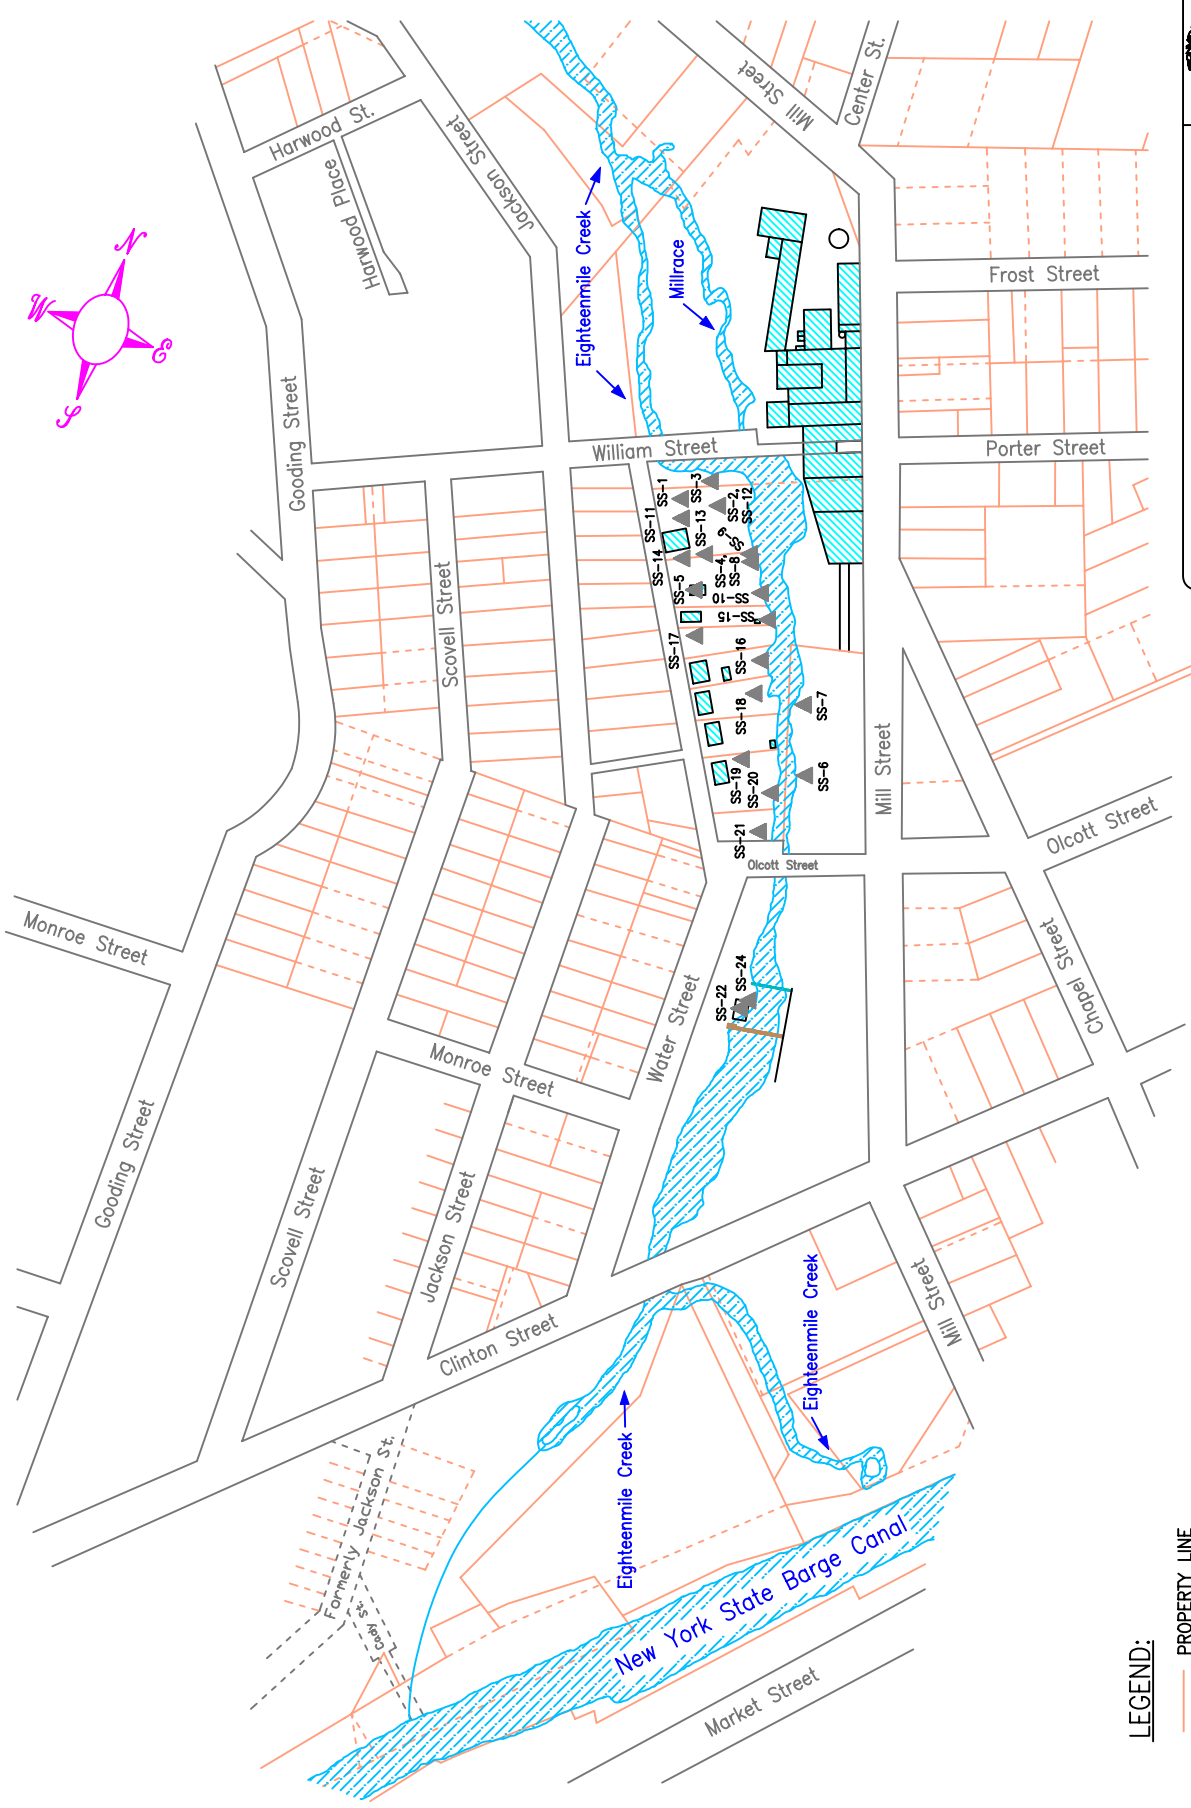
SURFACE SOIL & WASTE SAMPLE LOCATION MAP	
DIVISION OF ENVIRONMENTAL REMEDIATION	
DATE: 01/15/03	DRAWING: DEC Sampling.dwg
SITE NAME: FORMER FLINTKOTE PLANT SITE

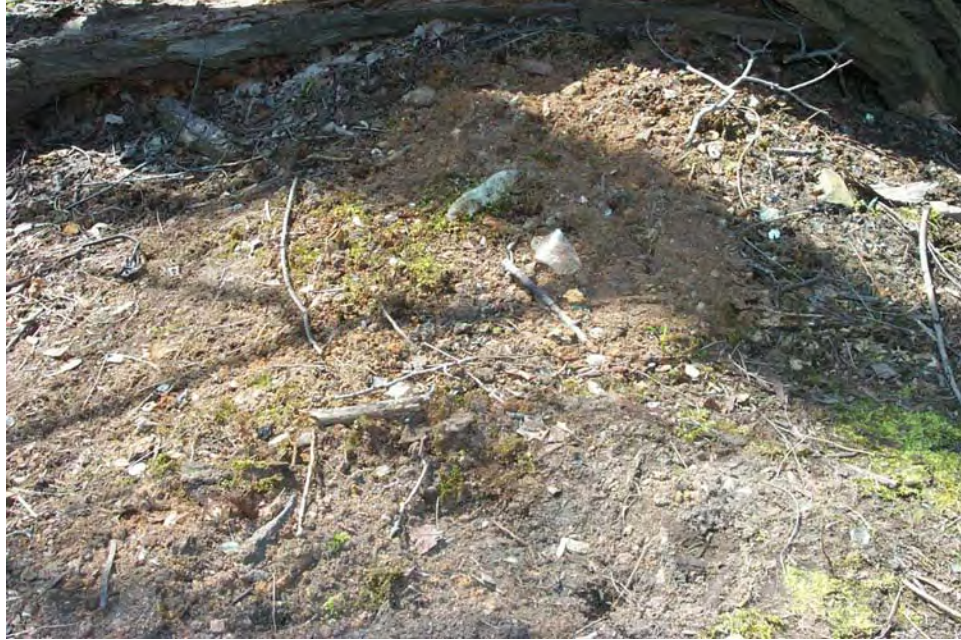
Figure 5-1. Photograph of ash from a small ridge along Eighteenmile Creek. This area was the location of sample SS-3. Photograph taken by Paul Dicky on April 16, 2002.

Prior to collecting any samples, a walk through of the property was conducted to identify sample locations. During this reconnaissance, ash fill (Figure 5-1) was observed at the surface of a small ridge along Eighteenmile Creek on a small strip of wooded property (Figure 5-2). Tax records indicate that this property is part of the former Flintkote property that is now owned by Niagara County. Extensive ash fill was also observed in the bank of Eighteenmile Creek (Figure 5-3).

Analytical results from an ash sample collected from the small ridge adjacent to the 143 Water Street property revealed the presence of lead at a concentration (4,250 mg/kg) that exceeded the Department's TAGM 4046 soil cleanup objective. This sample also exceeded the TCLP Regulatory Limit for lead, indicating that this ash is a characteristic hazardous waste (D008). This ash is similar in appearance to the ash observed on the island of the Former Flintkote Plant Site, which is also a characteristic hazardous waste for lead (D008). While surface water/solids runoff from this ridge to the 143 Water Street property may explain the relatively high concentrations of lead in surface soil samples SS-1 (shallow swale), SS-2 (garden), SS-11 (dog trail) and SS-12 (garden), this ash does not explain the high concentrations of lead detected at other Water Street properties. Also, the possible presence of ash fill in the garden at 143 Water Street, as suggested by the buttons, coal and glass that were observed, could explain the high concentration of lead in samples SS-2 and SS-12.

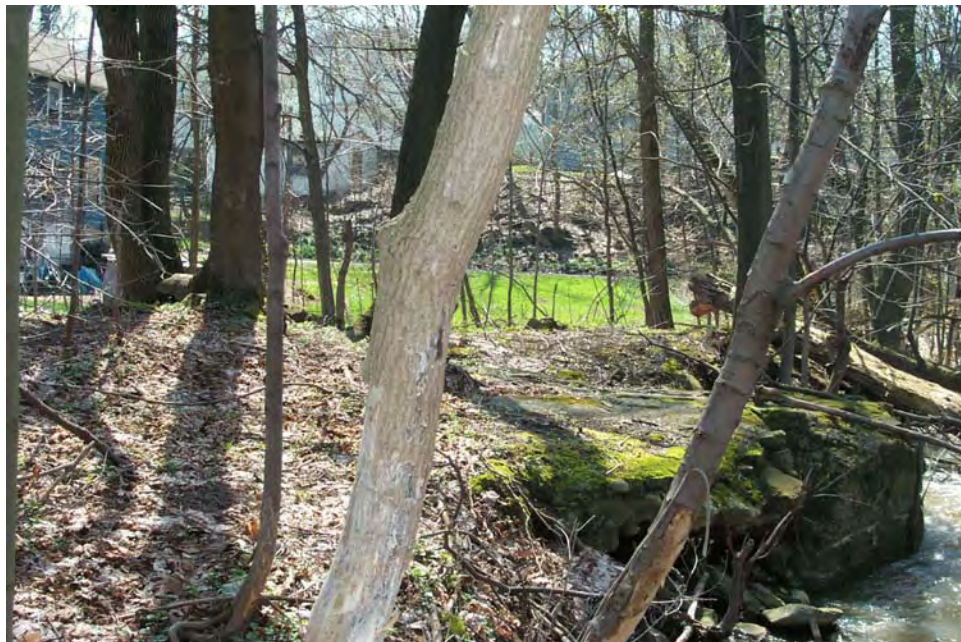
Figure 5-2. Photograph of the small ridge of ash fill along Eighteenmile Creek. The grassy area in the background is the side yard of the property at 143 Water Street. Photograph taken by Paul Dicky on April 16, 2002.

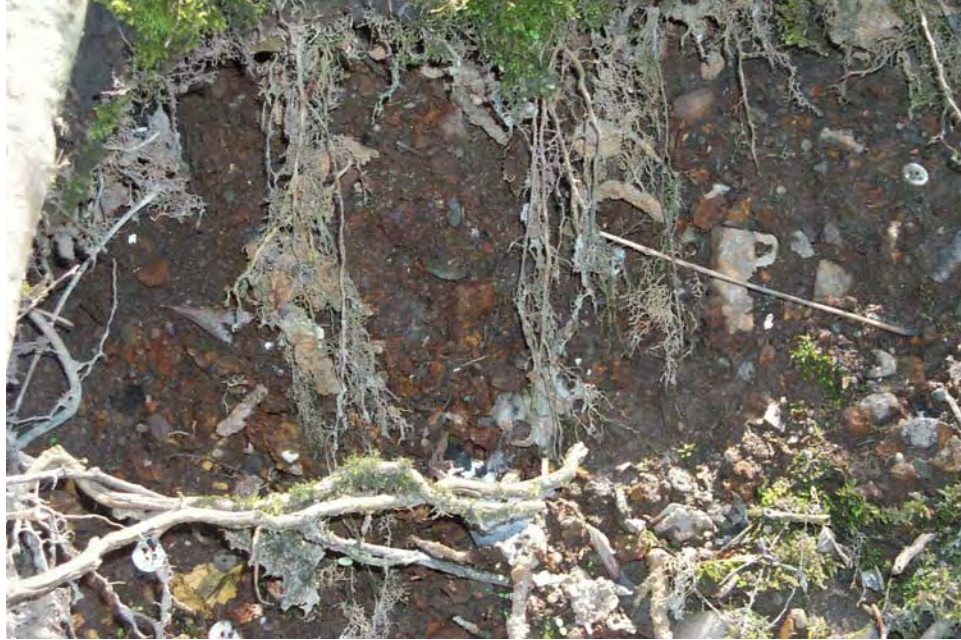
Figure 5-3. Photograph of ash fill in the creek bank along Eighteenmile Creek. Observe the buttons, which are characteristic of the ash fill on the island of the former Flintkote property. Photograph taken by Paul Dicky on April 16, 2002.

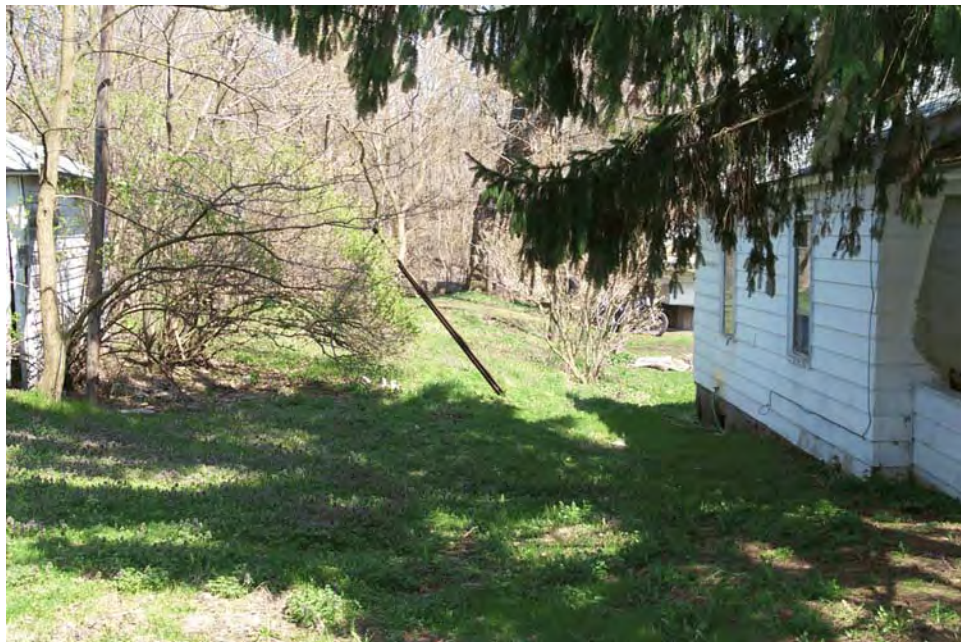
Figure 5-4. Photograph of the property line between 131 and 127 Water Street. The elevation difference (about 3 feet) delineates the extent of ash-cinder fill at the 143 and 131 Water Street properties. Photograph taken by Paul Dicky on April 16, 2002.

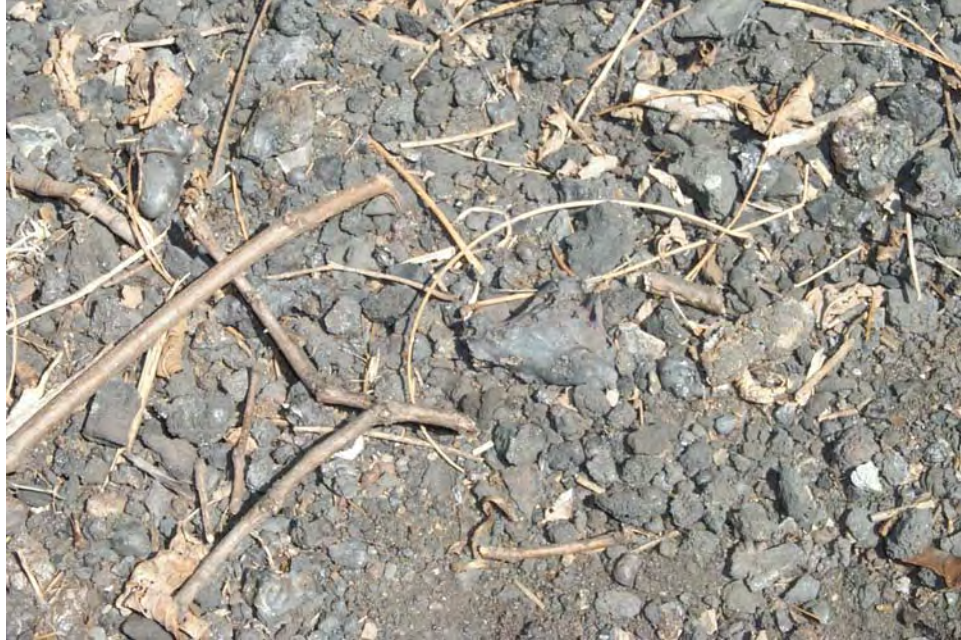
Figure 5-5. Photograph of the floor inside the garage at 131 Water Street. This ash-cinder fill is found throughout the mound shown in Figure 5-4. Photograph taken by Paul Dicky on April 16, 2002.

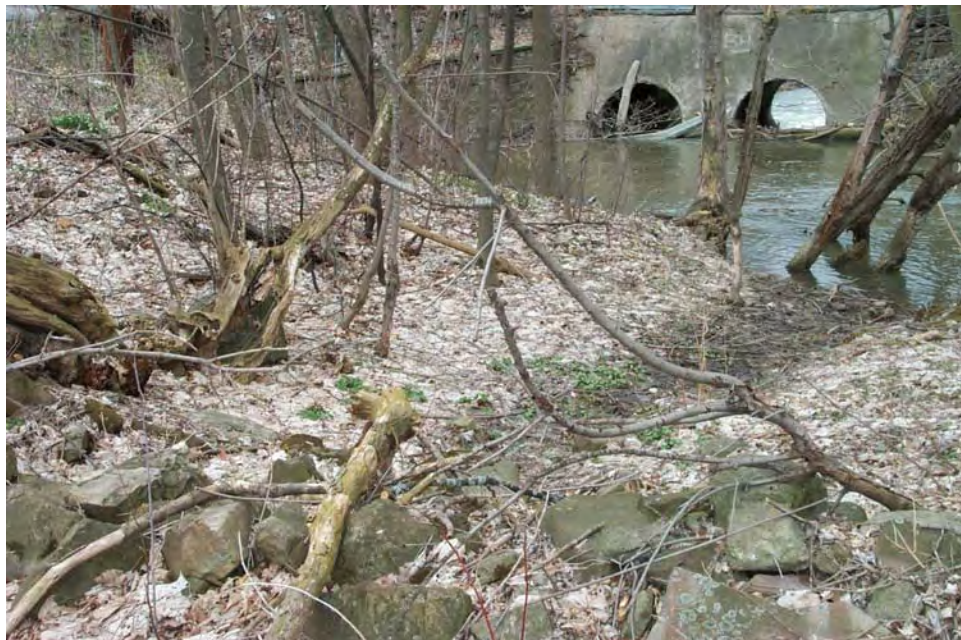
Figure 5-6. Photograph of the natural drainage swale from the side yard of 143 Water Street to Eighteenmile Creek. The cross-culverts beneath William Street can be observed in the background. Note the debris partially blocking these culverts. Photograph taken by Paul Dicky on April 16, 2002.

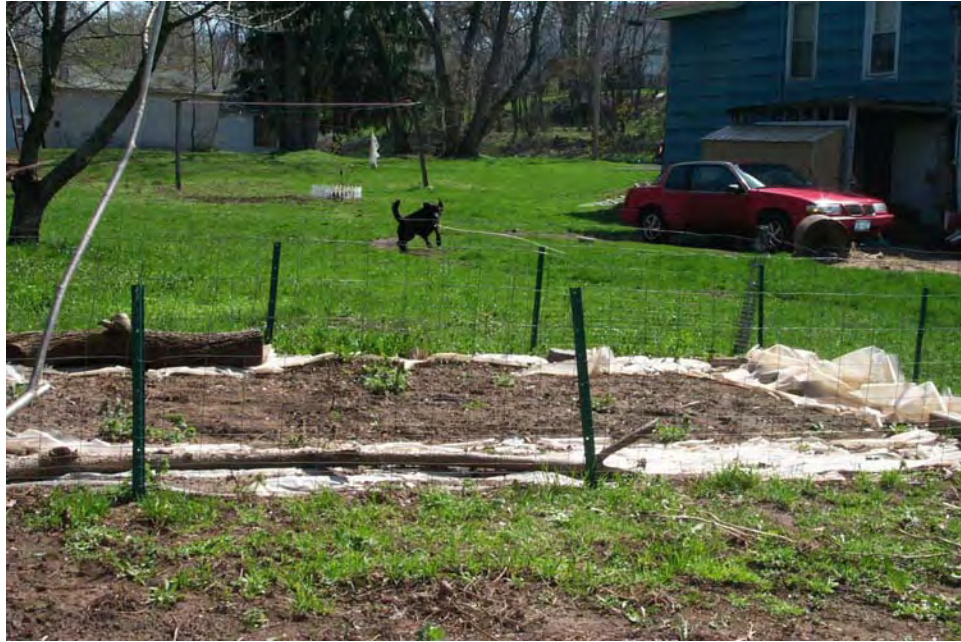
Figure 5-7. Photograph of the small garden at 143 Water Street. Samples SS-2 and SS-12 were collected from the center of this garden. Photograph taken by Paul Dicky on April 16, 2002.

A small vegetable garden in the backyard was also inspected; buttons, coal and glass were observed. When asked, the property owners informed us that the garden was rototilled in place. The portion of the yard that floods during high water events was also identified.

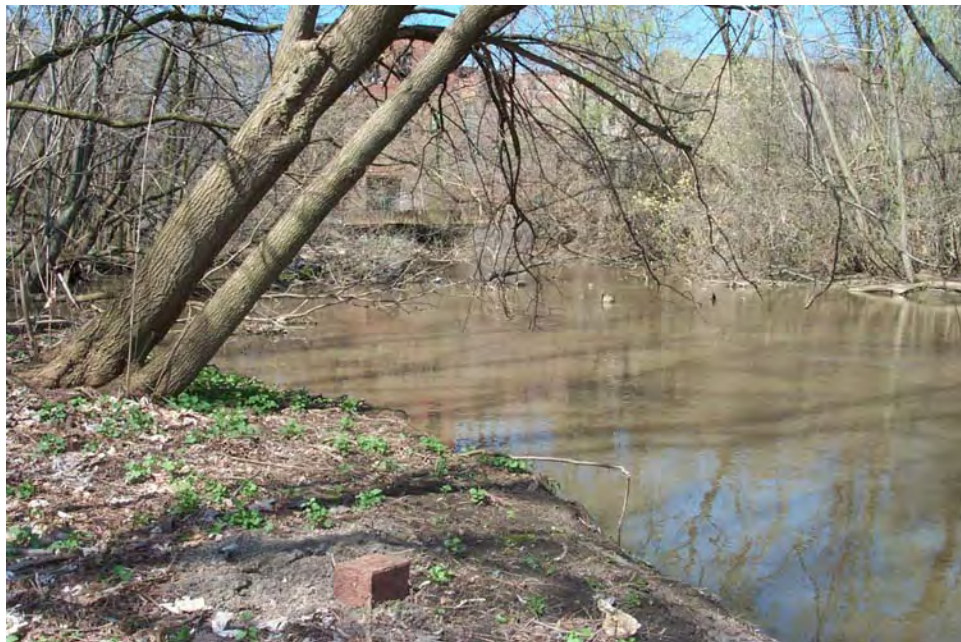
Figure 5-8. Photograph of sample location SS-4 and SS-8 (at the brick) along Eighteenmile Creek. The former Flintkote buildings can be observed in the background. Photograph taken by Paul Dicky on April 16, 2002.

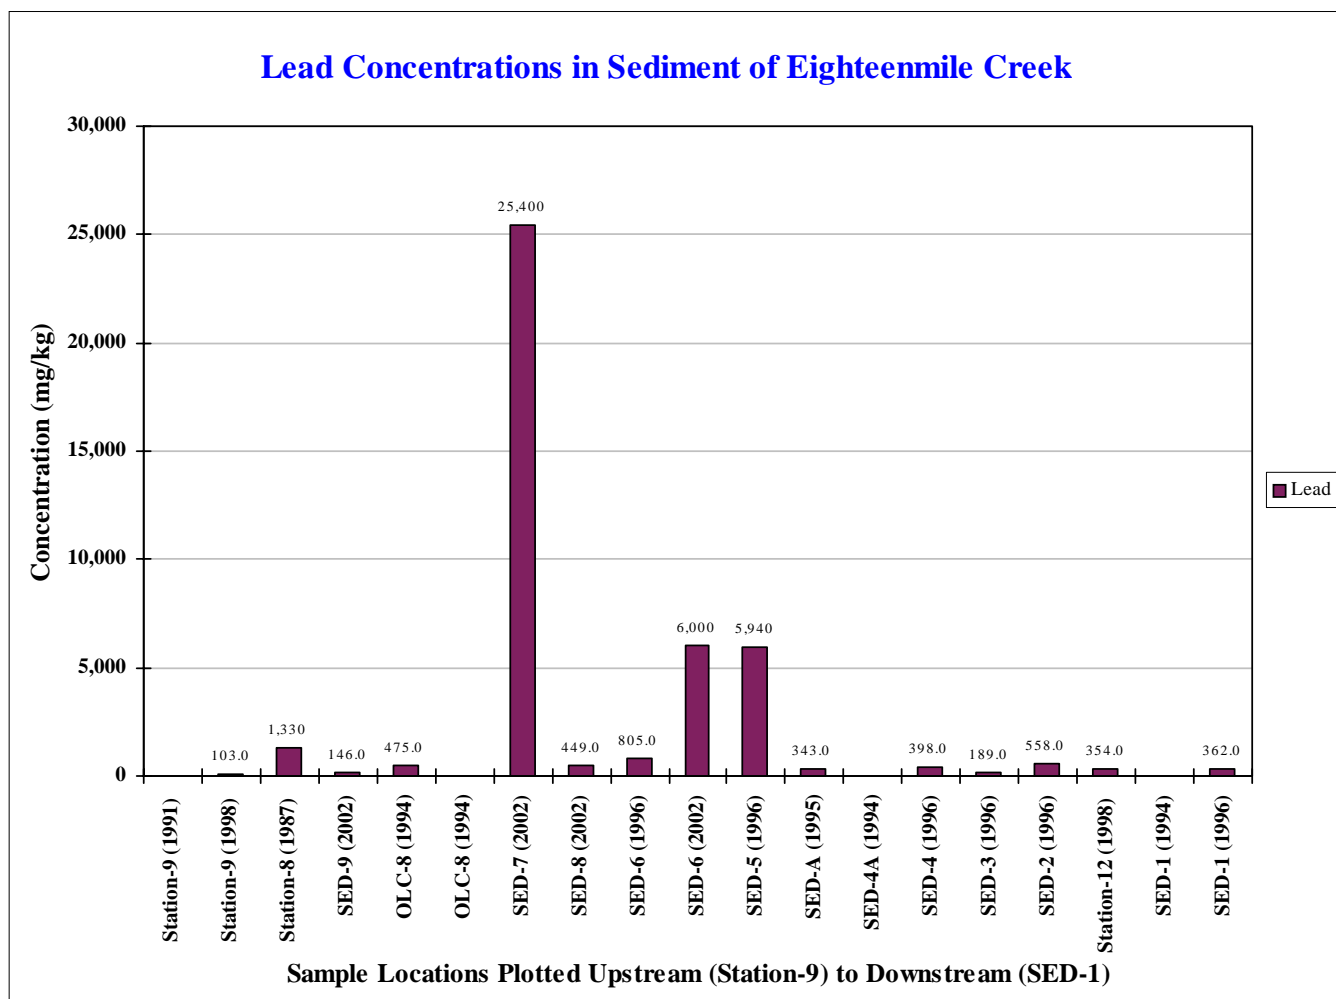
Figure 6-1. Lead concentrations in sediment of Eighteenmile Creek from Remick Parkway (Station-9) to the Former Flintkote Plant Site (SED-5 to SED-1).

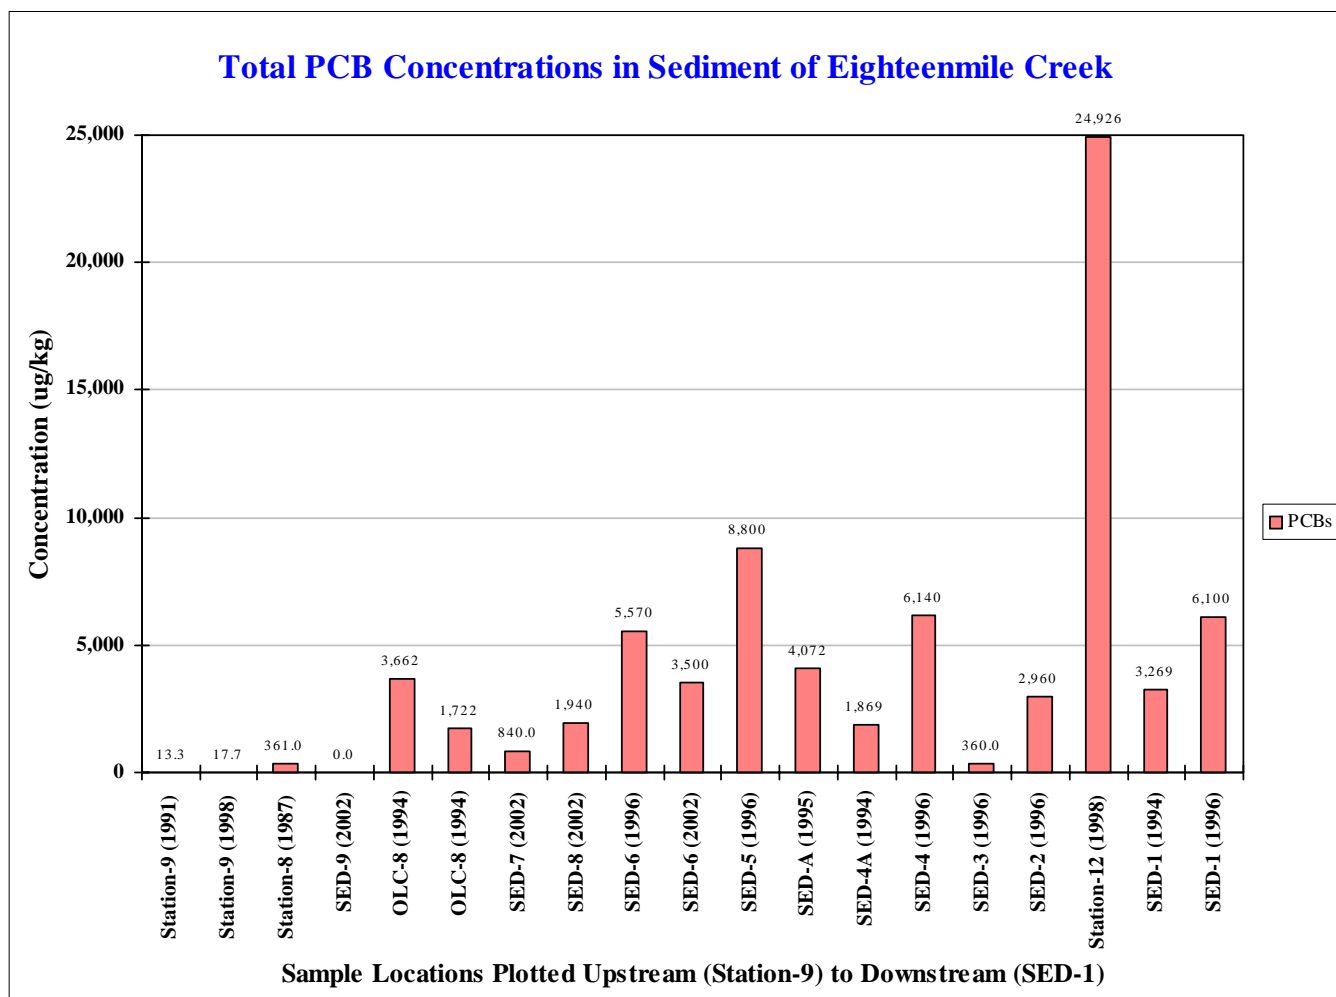
Figure 6-2. PCB concentrations in sediment of Eighteenmile Creek from Remick Parkway (Station-9) to the Former Flintkote Plant Site (SED-5 to SED-1).

Upstream of the Clinton Street dam, PCB concentrations were relatively low, ranging from 13.3 to 361 Fg/kg. Immediately downstream of the dam, PCB concentrations increase substantially (840 to 3,662 Fg/kg), and remain elevated throughout the portion of Eighteenmile Creek evaluated in this study. These data suggest a source of PCBs near the Clinton Street dam. This source, however, does not appear to be the former transformer area or the extensive ash fill that was observed south of the Former Flintkote Plant Site. At this time the source remains unknown.

The available analytical data suggest a source of PCBs near the Clinton Street dam; immediately downstream of the dam PCB concentrations increase substantially (840 to 3,662 mg/kg) and remain elevated throughout the portion of Eighteenmile Creek evaluated in this study. This source, however, does not appear to be the former transformer area or the extensive ash fill that was observed south of the Former Flintkote Plant Site. At this time the source remains unknown.
