Figure 2.
Geddes Brook/Ninemile Creek and Vicinity

Figure 4. Geddes Brook/Ninemile Creek Reaches and Former Channel Locations

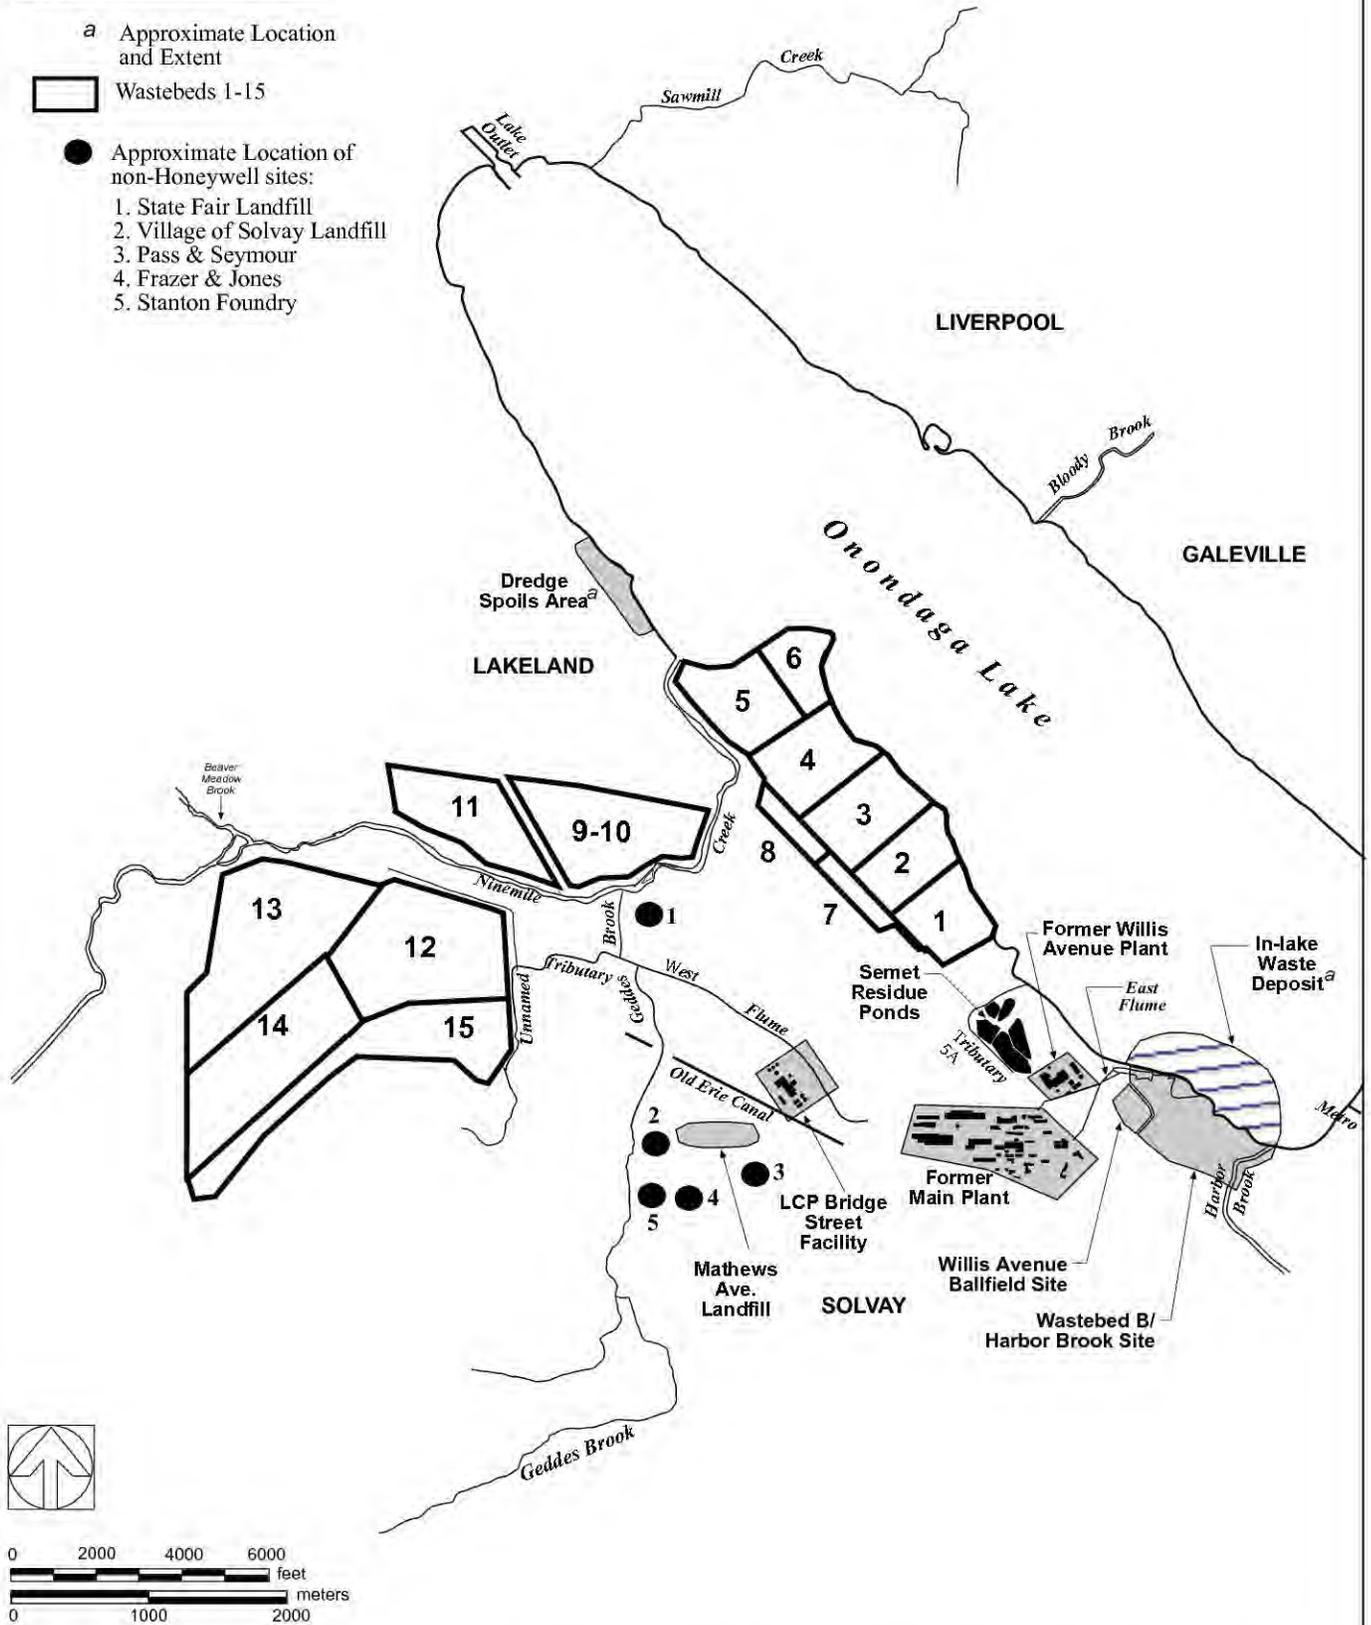
Figure 5. Location of Honeywell and Other Referenced Sites Near Geddes Brook/Ninemile Creek

Approximate Location of non-Honeywell sites:
 1. State Fair Landfill
 2. Village of Solvay Landfill
 3. Pass & Seymour
 4. Frazer & Jones
 5. Stanton Foundry

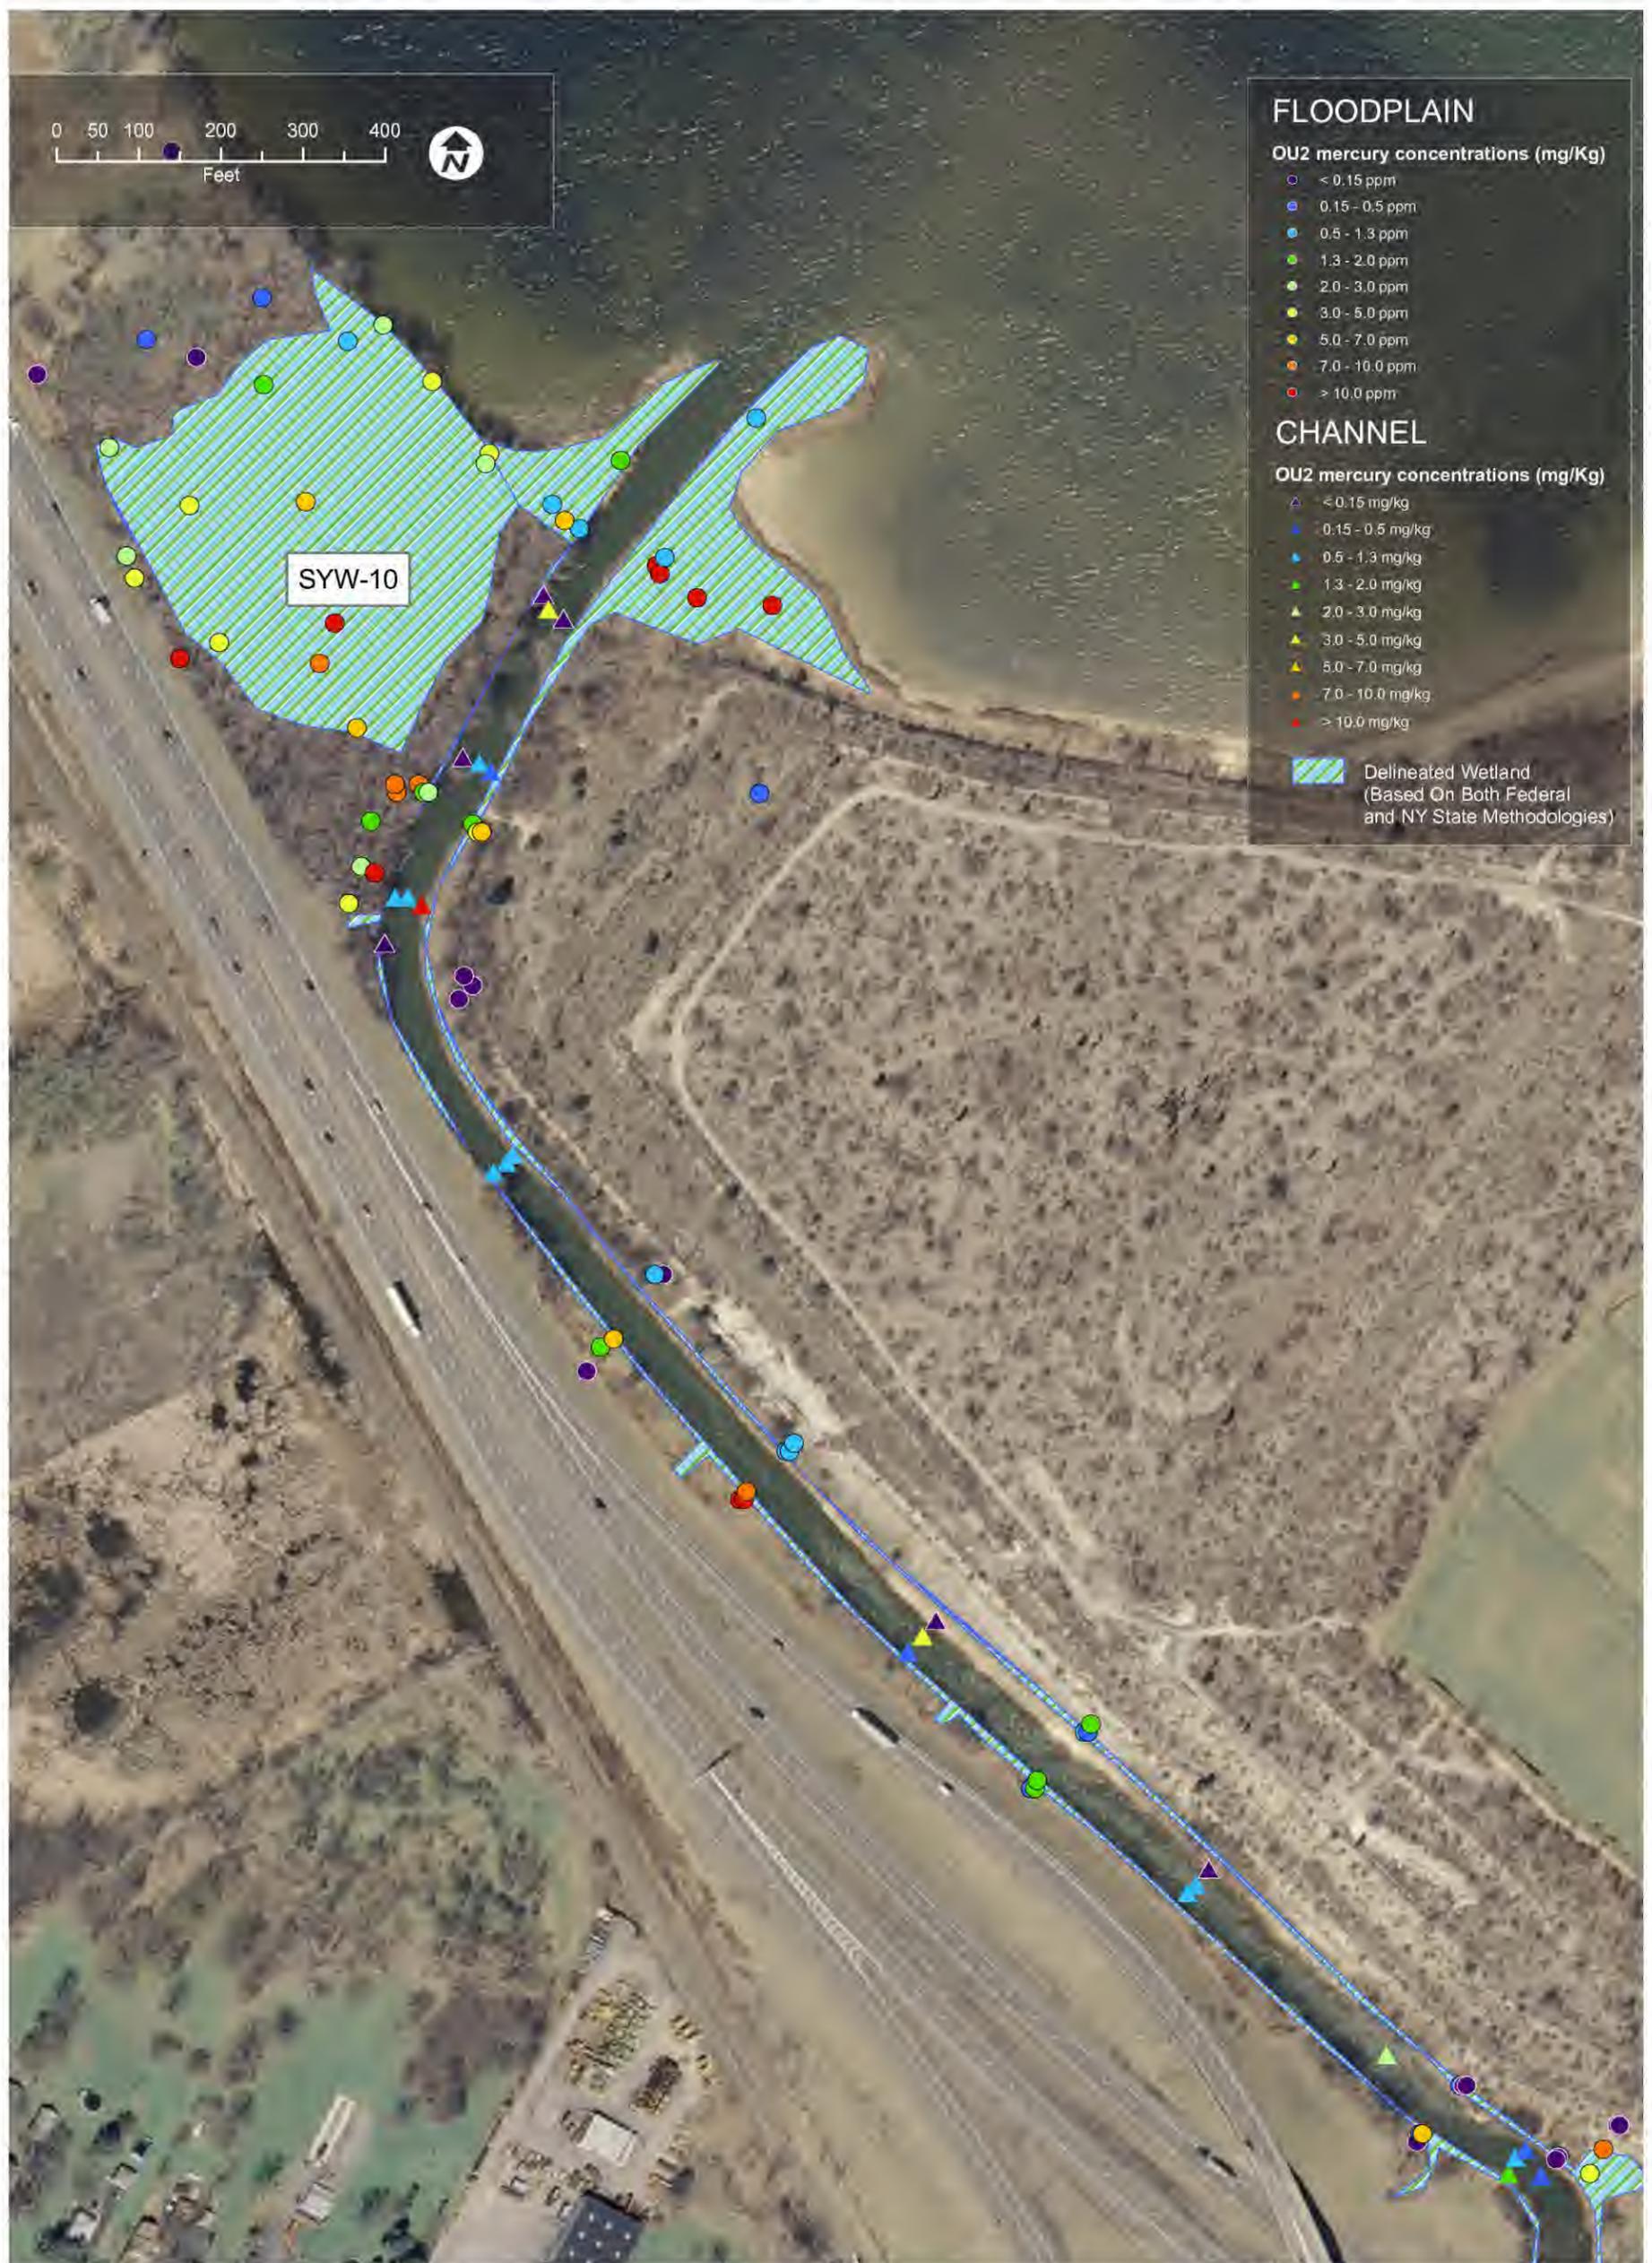
Figure 6a

Source: Modified from OU2 Supplemental FS (Parsons, 2009) Mercury Concentrations in Channel and Floodplain Samples in Reach AB (0 to 1 ft)

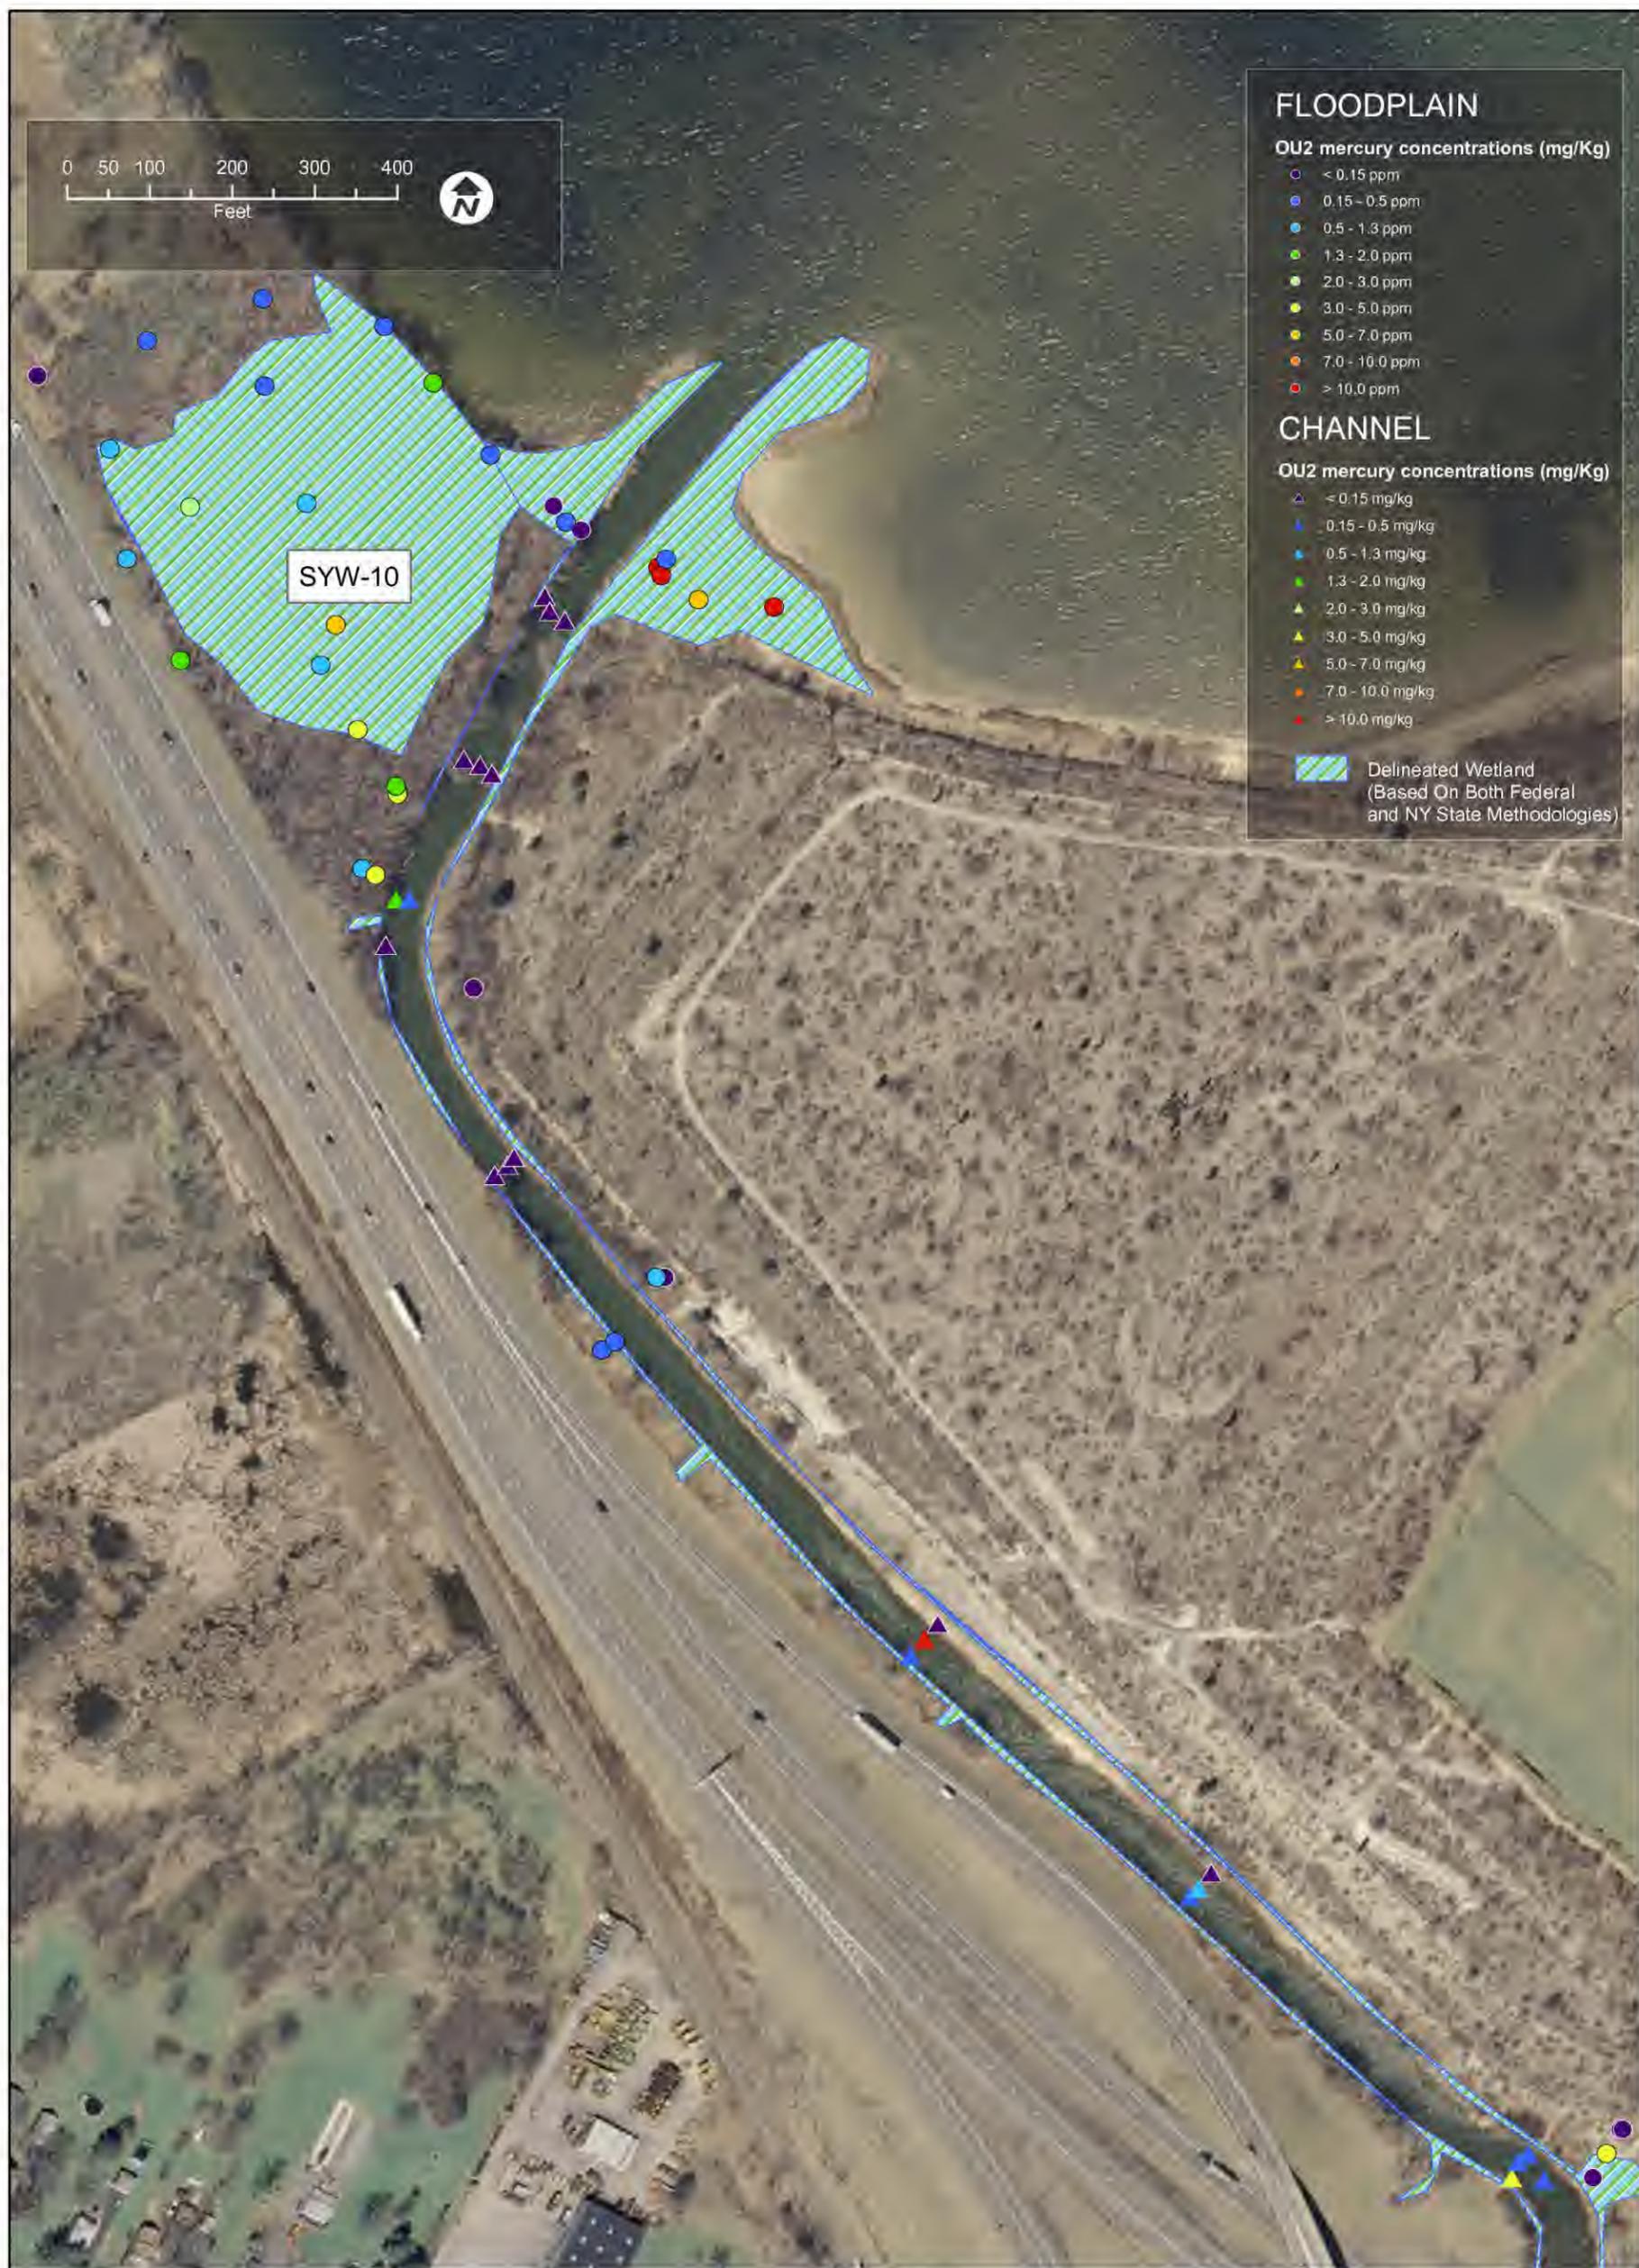
Figure 6b

Source: Modified from OU2 Supplemental FS (Parsons, 2009) Mercury Concentrations in Channel and Floodplain Samples in Reach AB (1 to 2 ft)

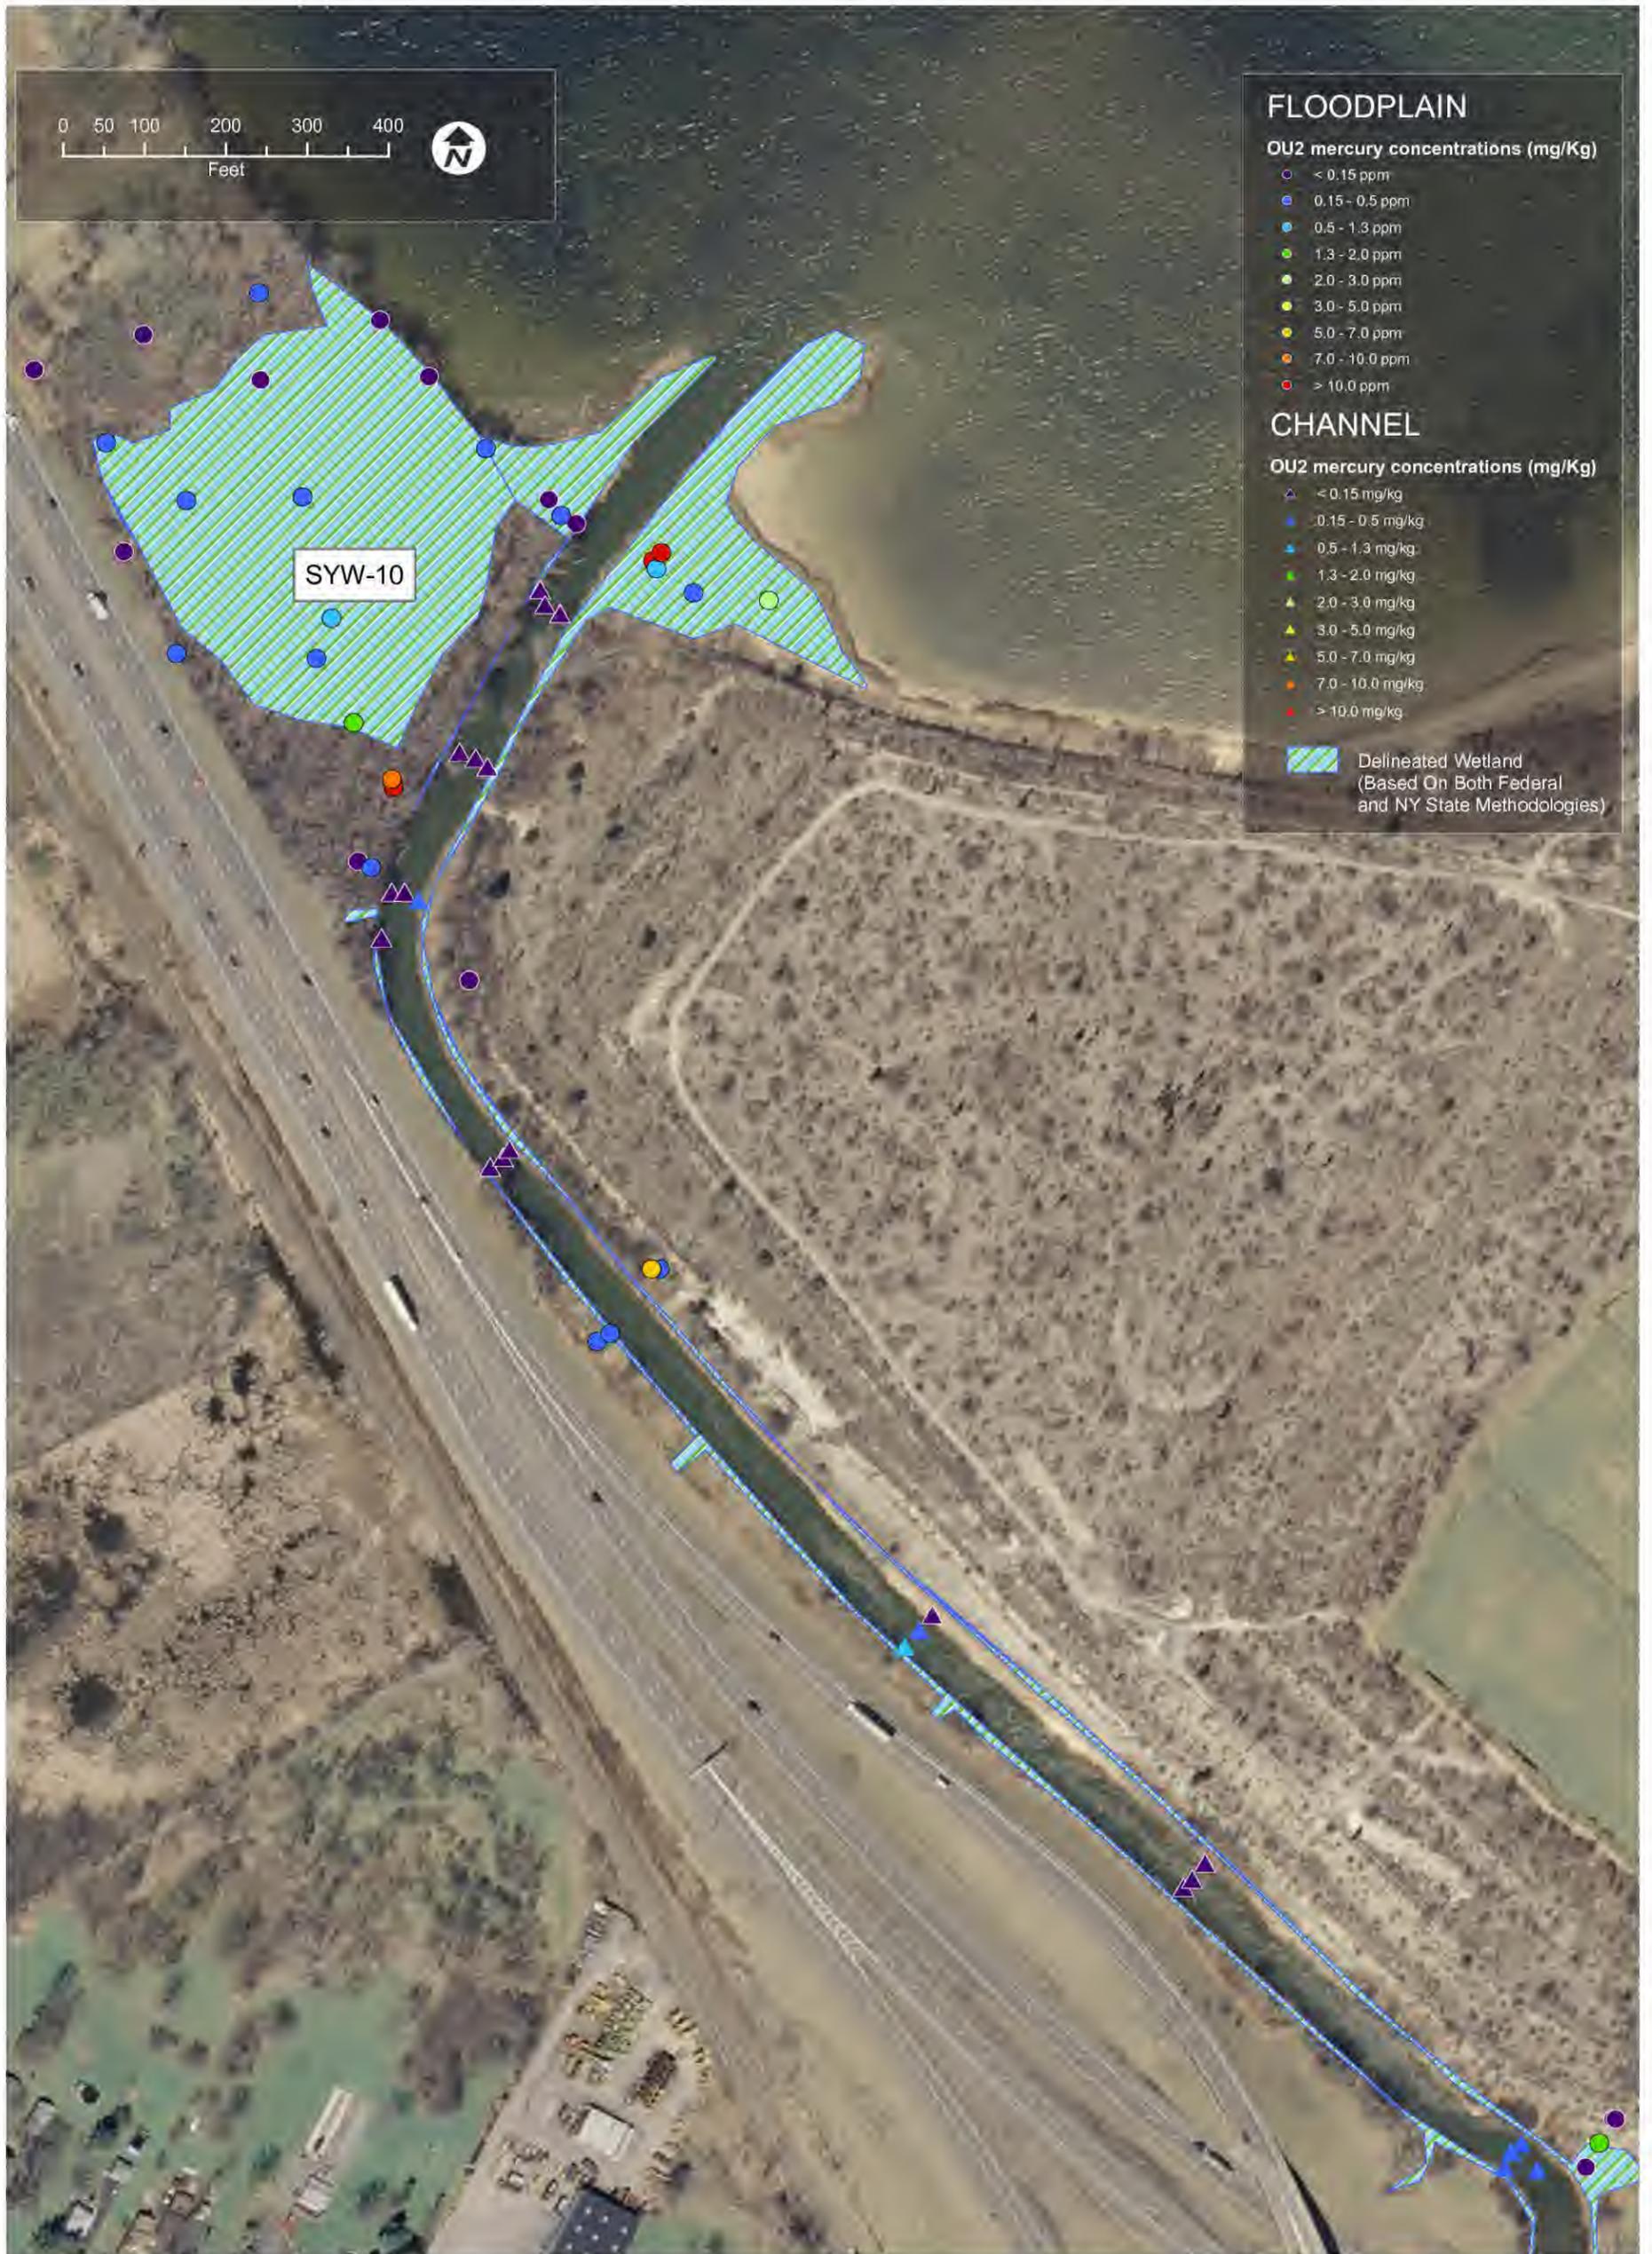
Figure 6c

Source: Modified from OU2 Supplemental FS (Parsons, 2009) Mercury Concentrations in Channel and Floodplain Samples in Reach AB (2 to 3 ft)

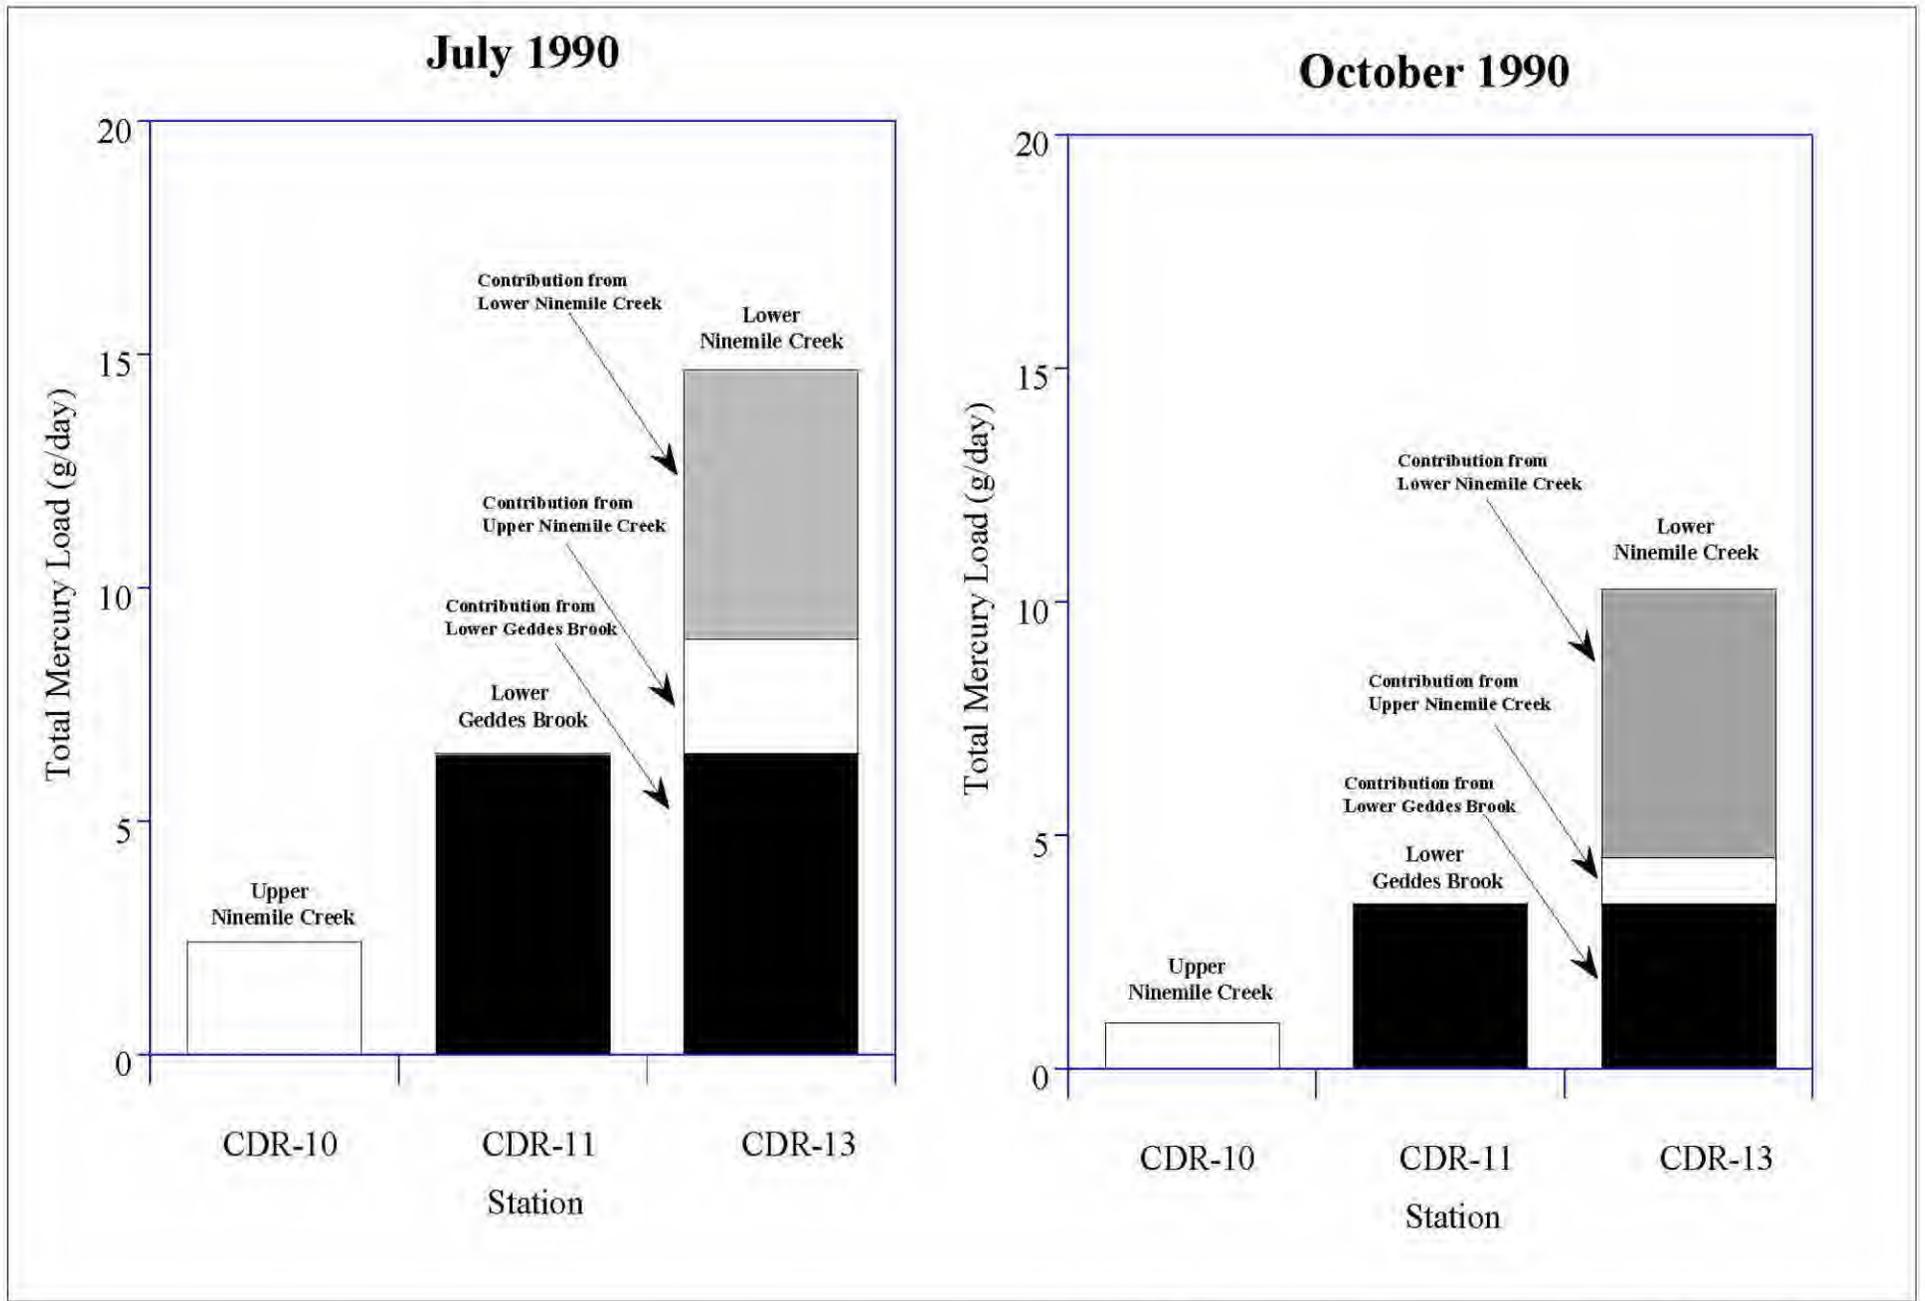
Figure 7. Comparison of Total Mercury Loads in Surface Water of Geddes Brook and Ninemile Creek in 1990

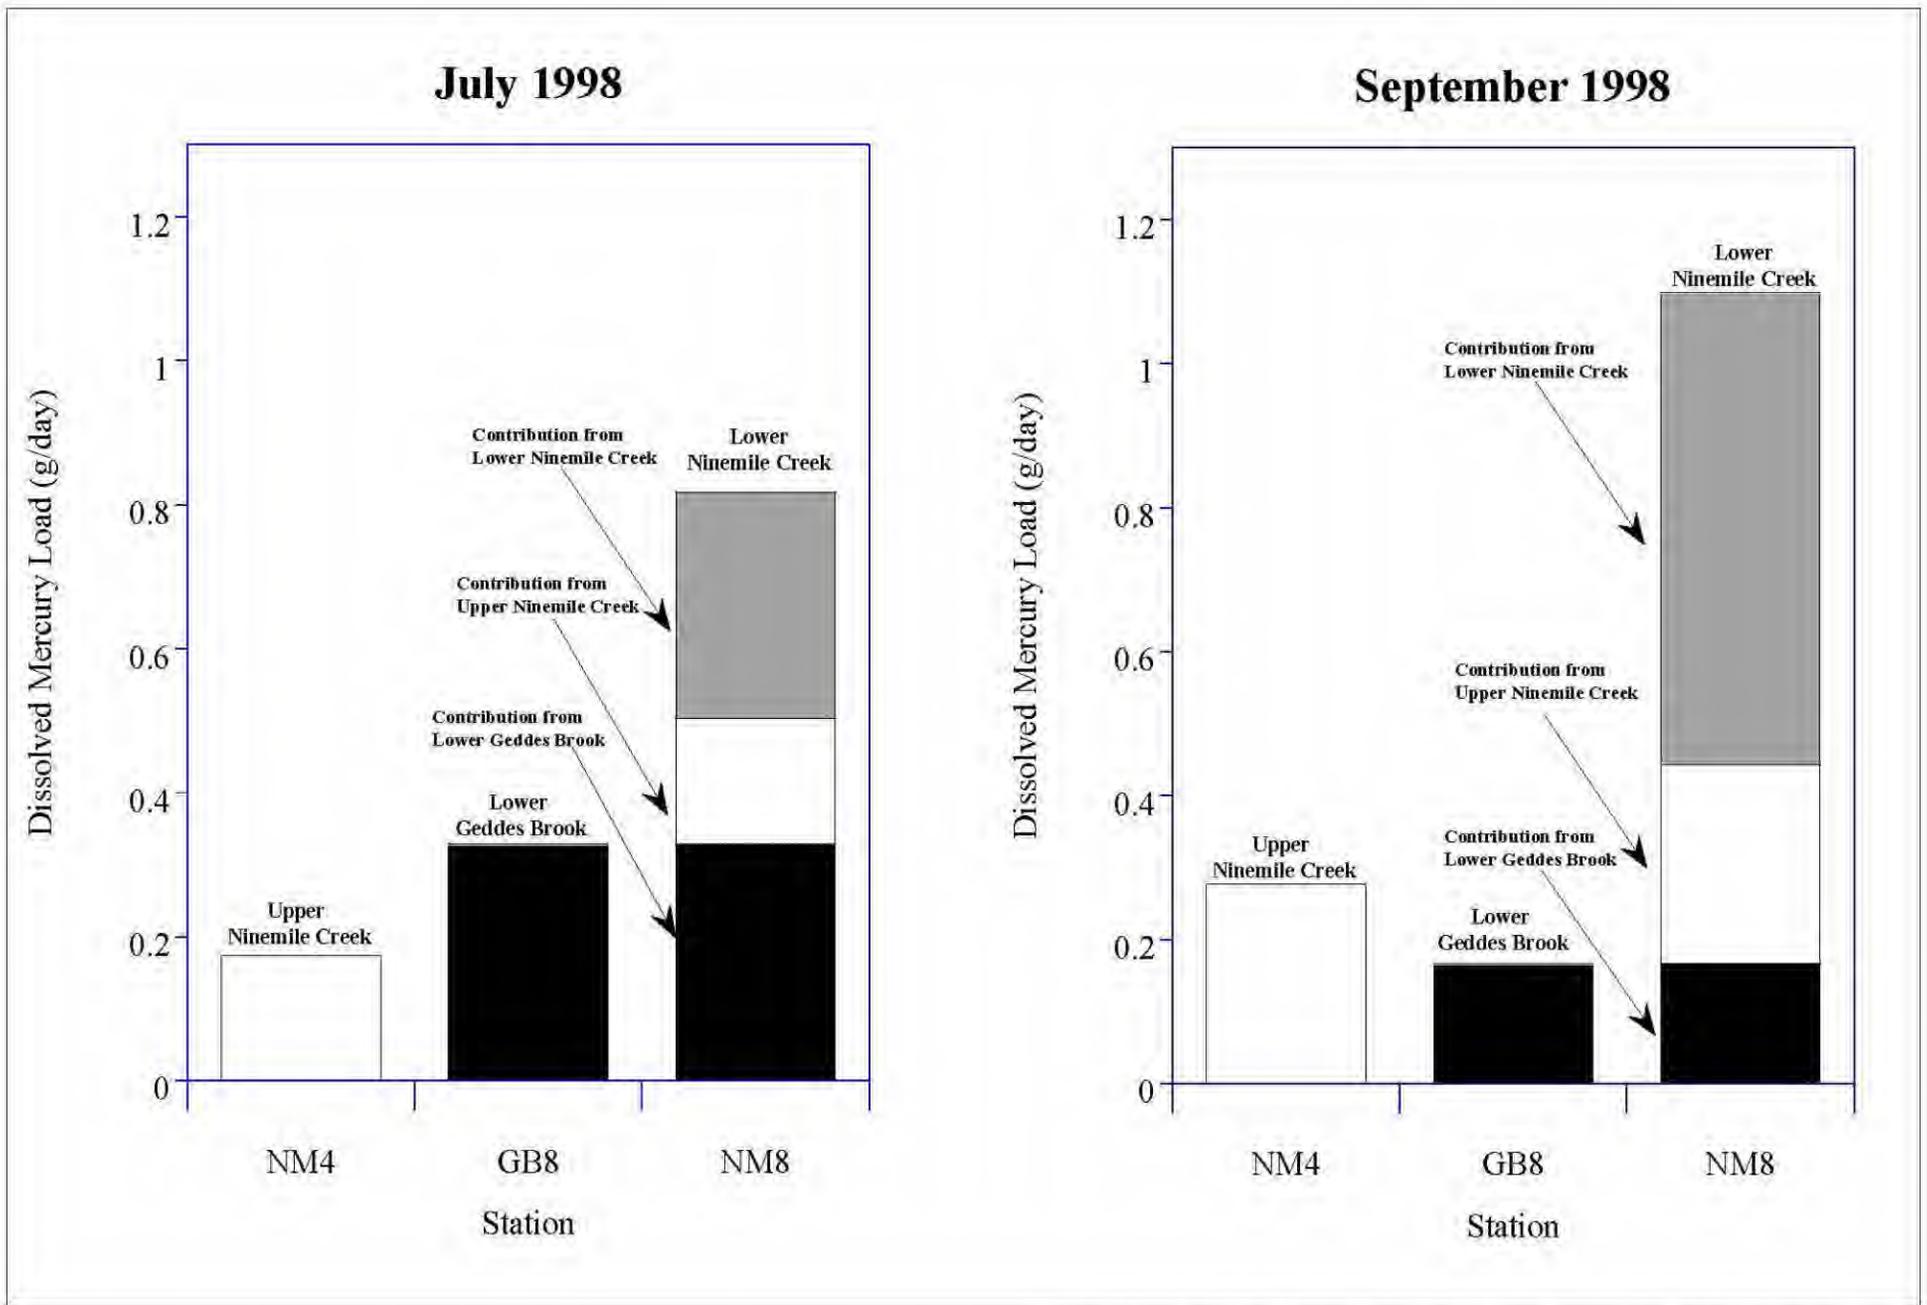
Figure 8. Comparison of Total Mercury Loads in Surface Water of Geddes Brook and Ninemile Creek in 1998

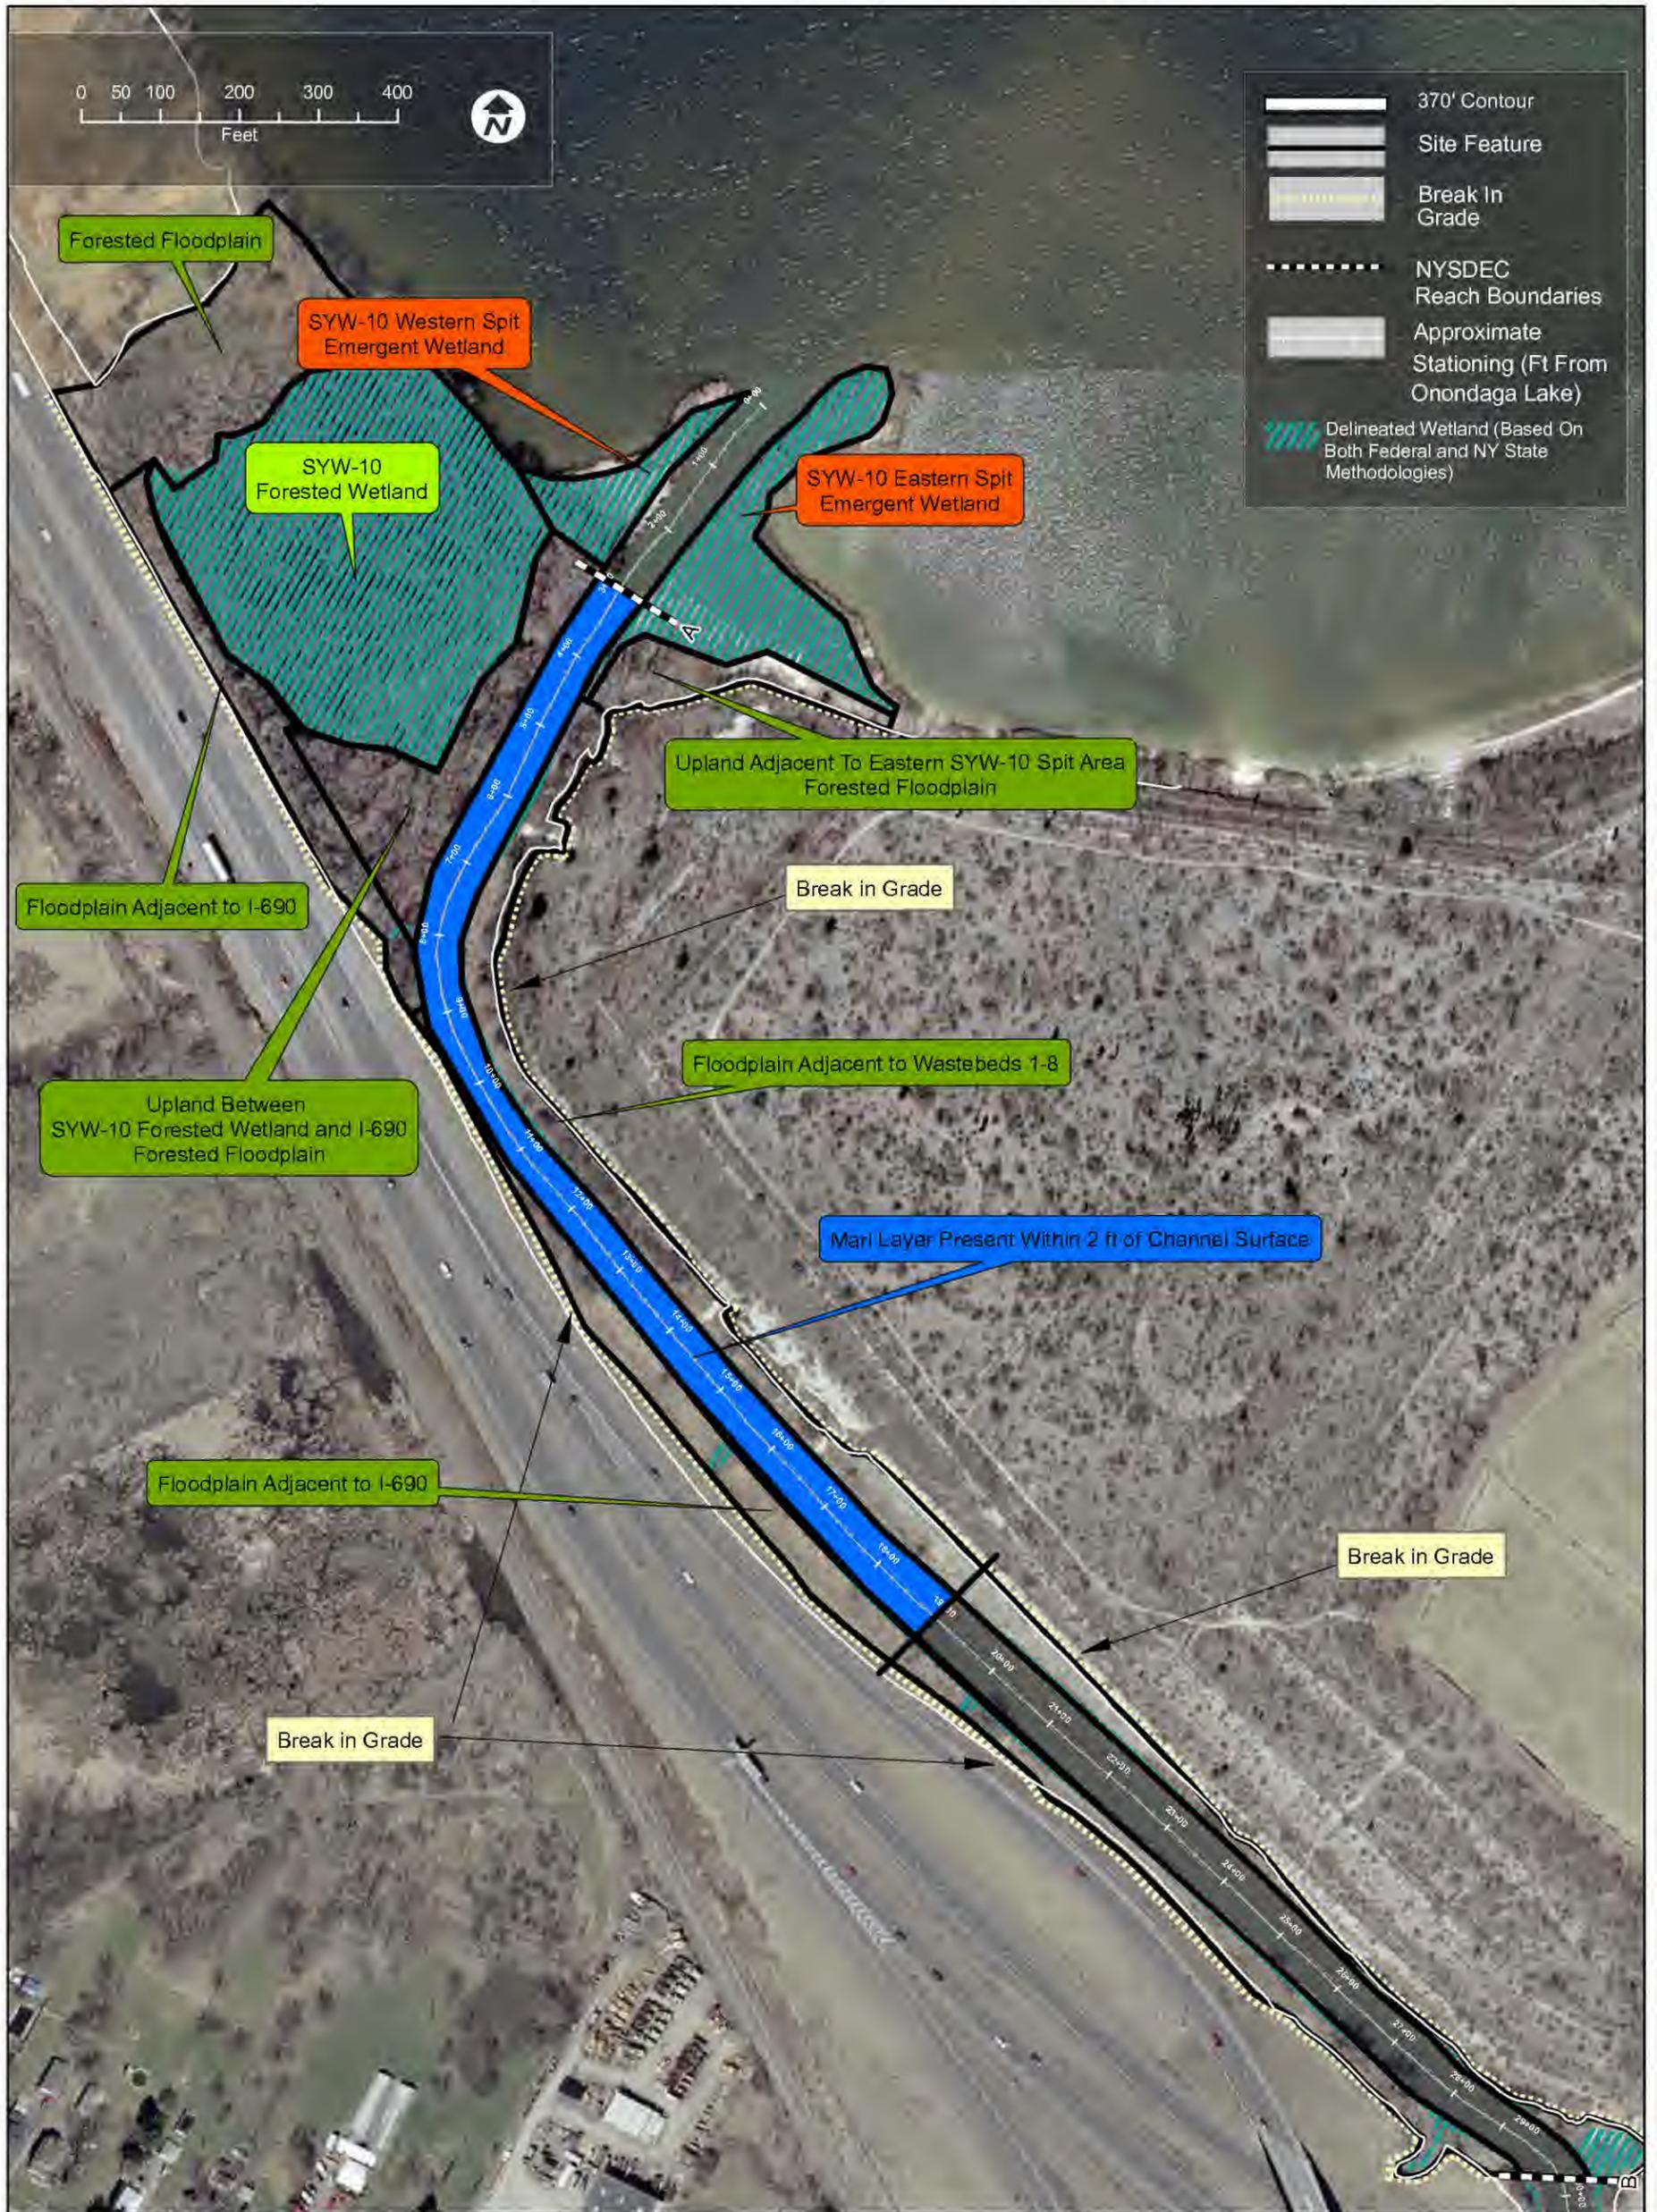
Figure 10
OU2 Site Characteristics
