NYSDEC  
 DIAMOND CLEANERS  
 Elmira, New York

NYSDEC  
OU-2 RI/FS REPORT DIAMOND CLEANERS  
Elmira, New York

Site Features  
Project 3612-06-2070  
Figure 2

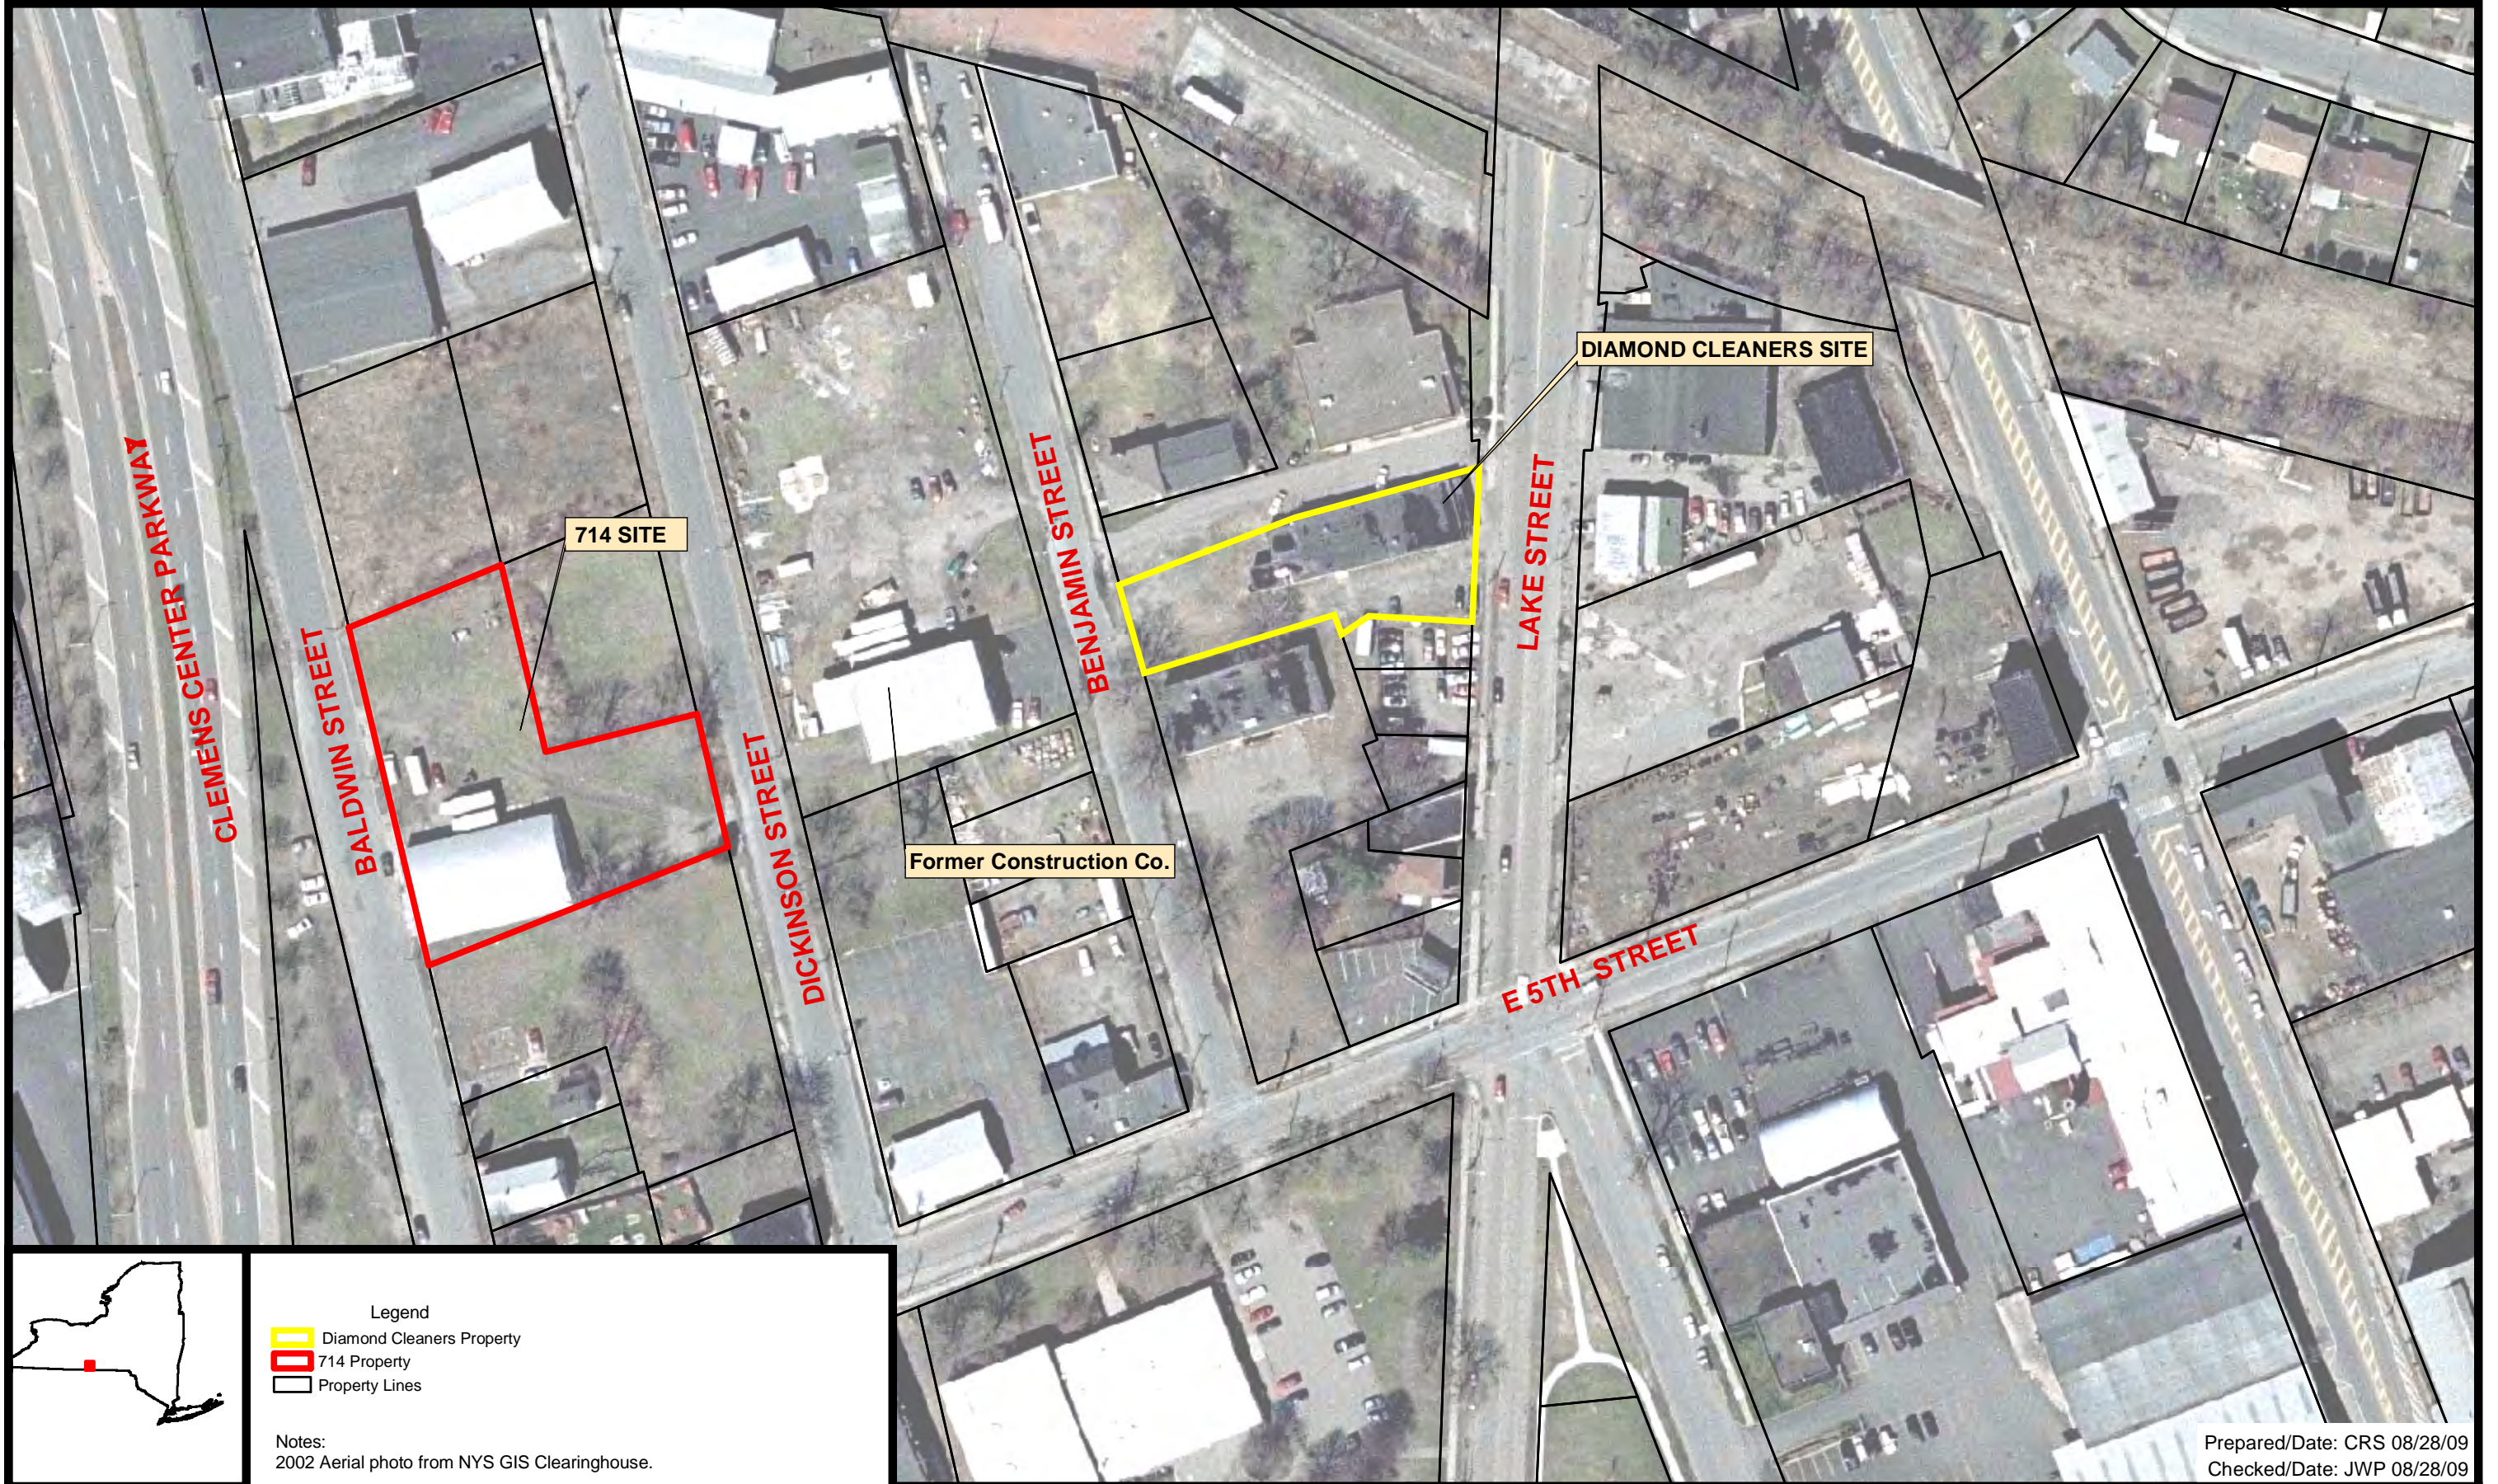
- Legend
- Diamond Cleaners Property
  - 714 Property
  - Property Lines

Notes:  
2002 Aerial photo from NYS GIS Clearinghouse.

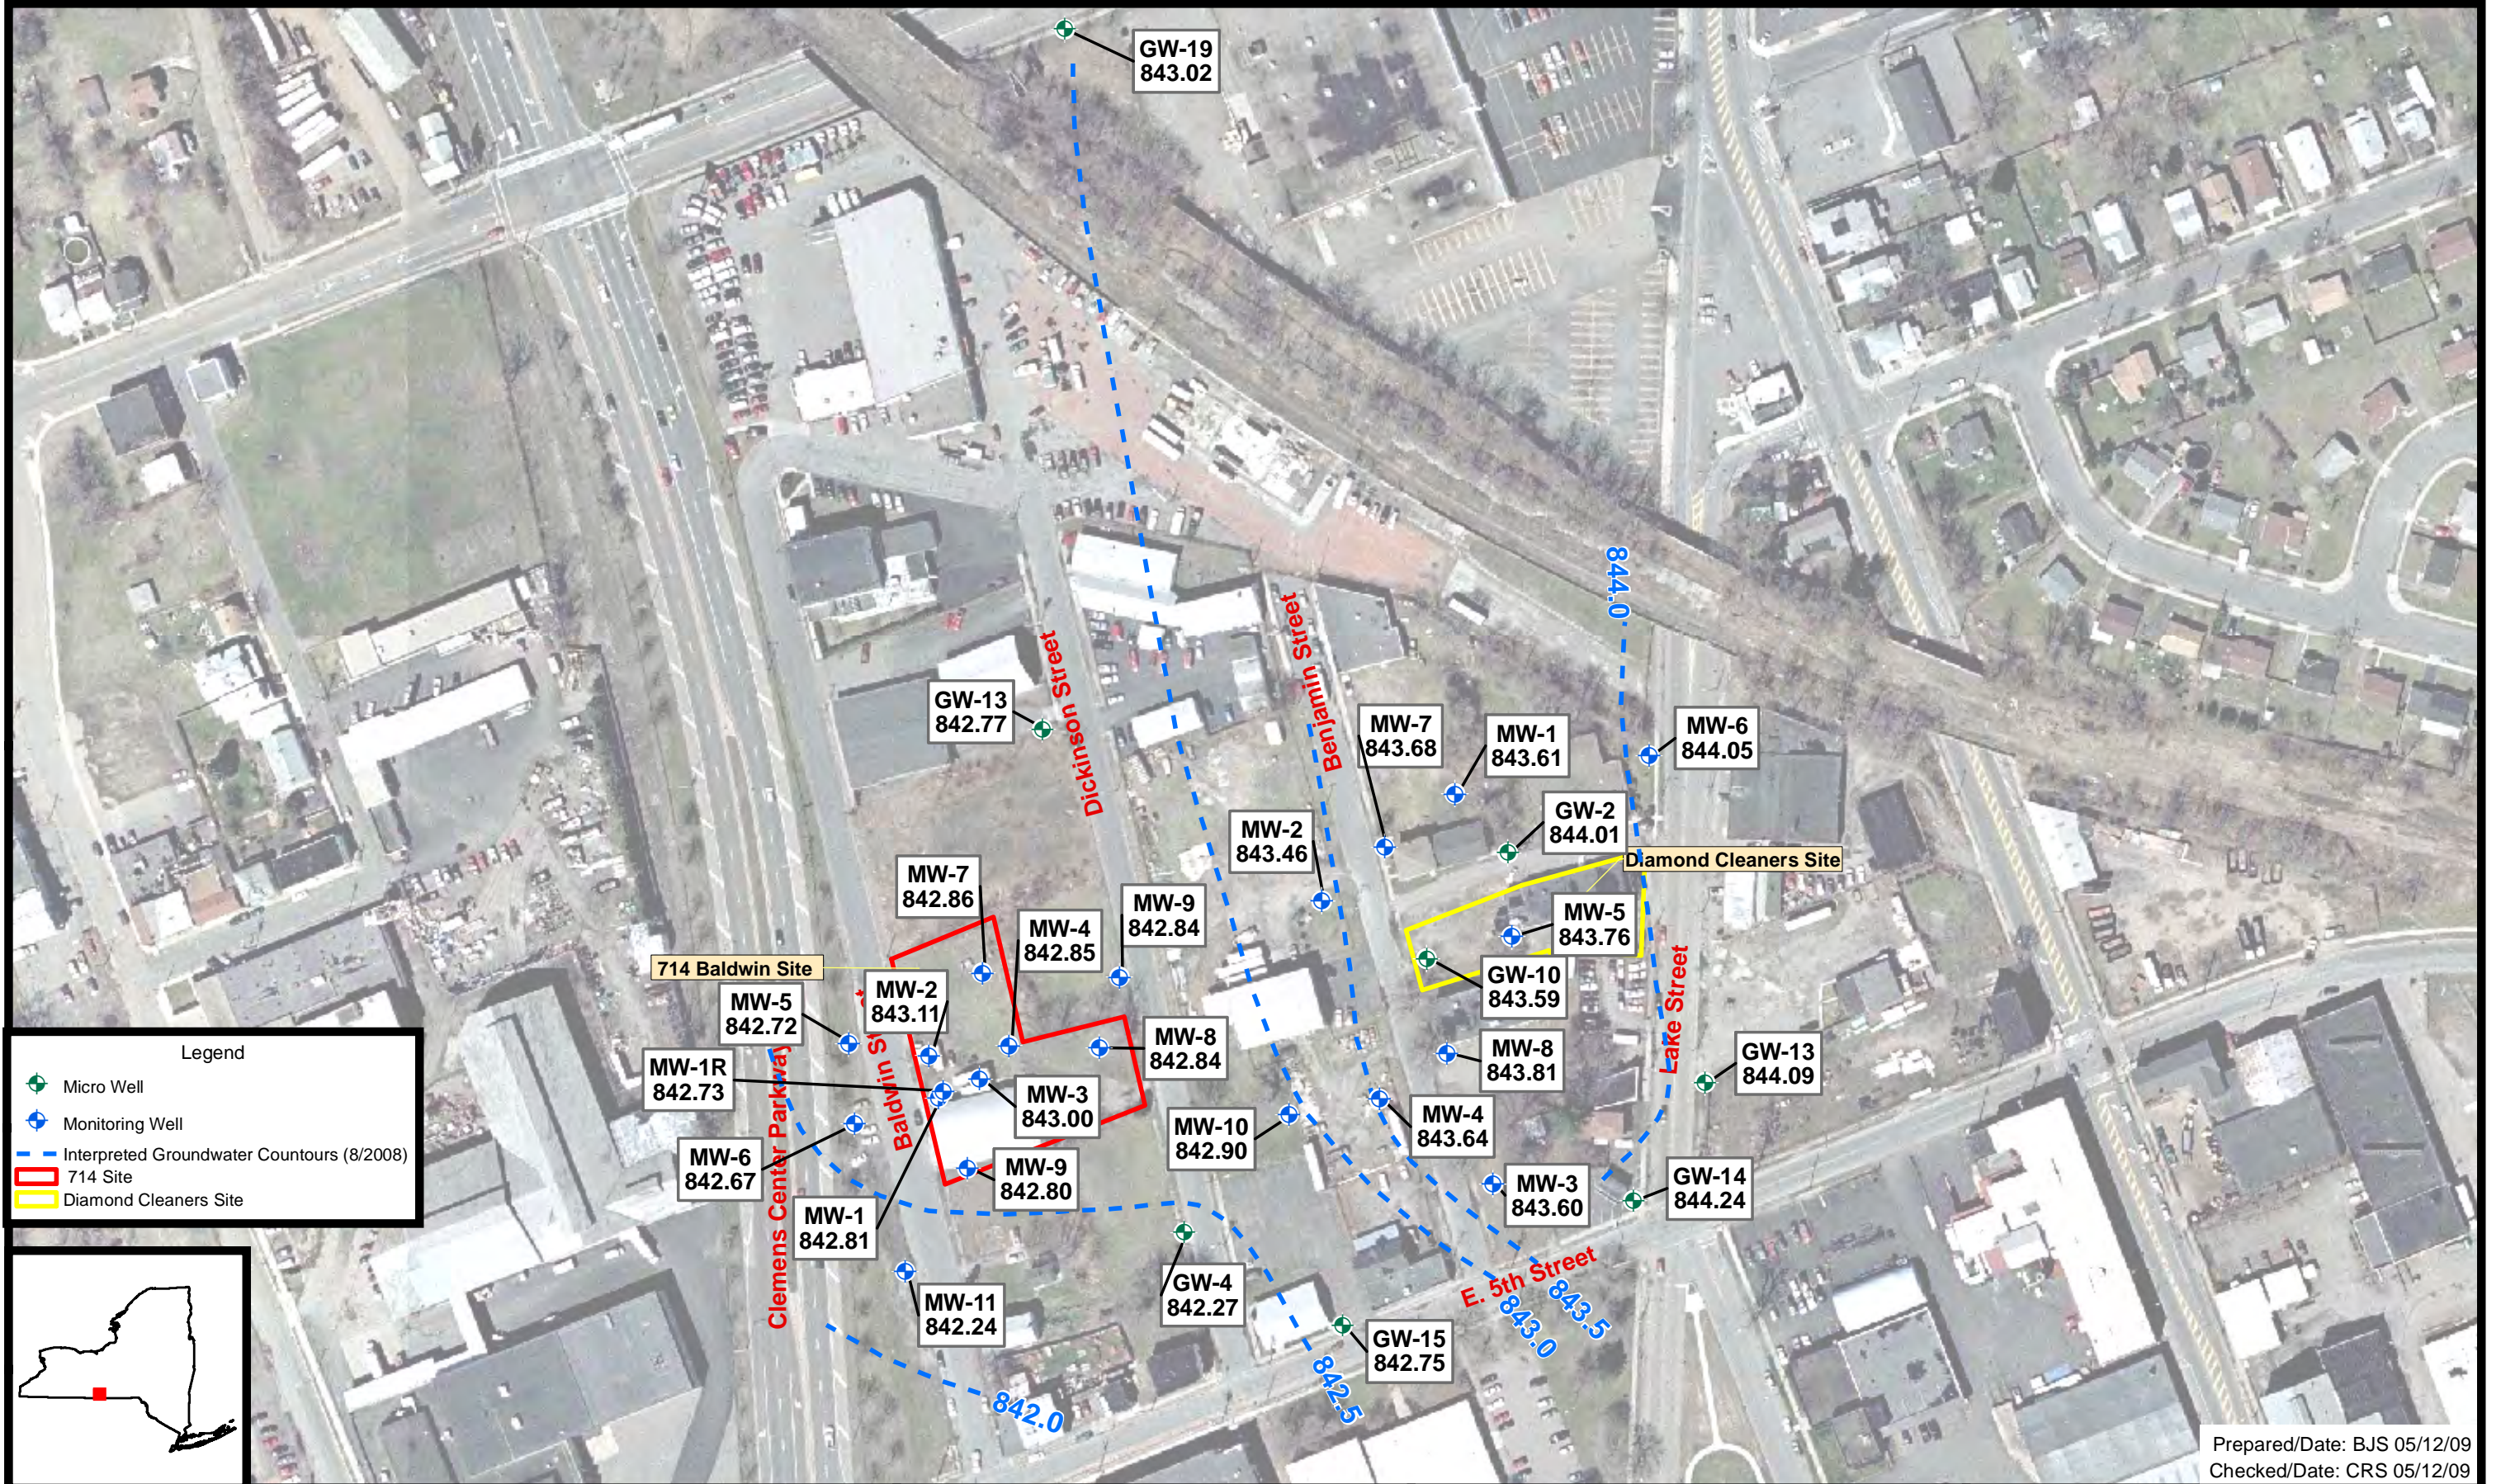
Interpreted Groundwater Contours  
August 2008  
Figure 3

2002 Aerial photograph from NYS GIS Clearinghouse.  
Wells surveyed by Joseph Lu Engineers.  
Groundwater measurements collected by MACTEC on 8/11/2008.  
Elevations in Feet above mean sea level, NAVD 1983.
