**Environmental Restoration
Record of Decision
Mohawk Valley Warehouse Site**

**Village of Mohawk, Town of German Flatts,
Herkimer County, New York
Site Number E622022**

March 2009

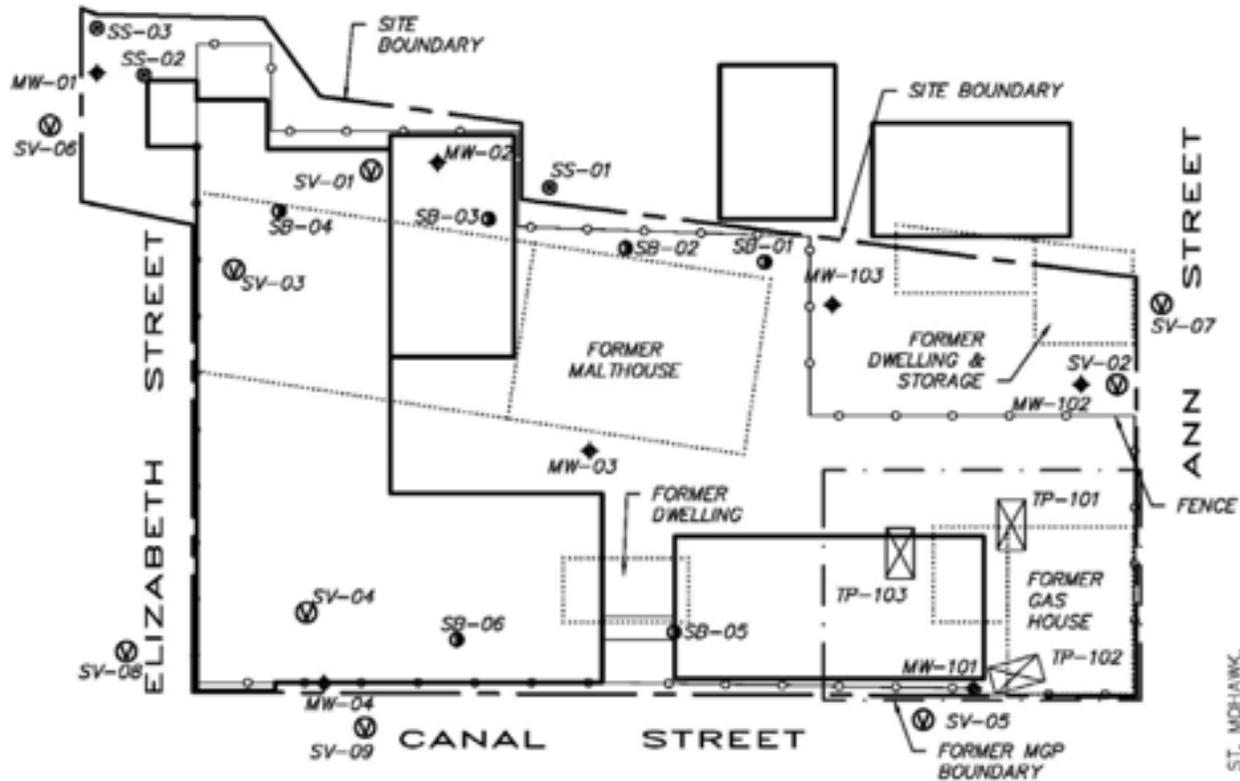
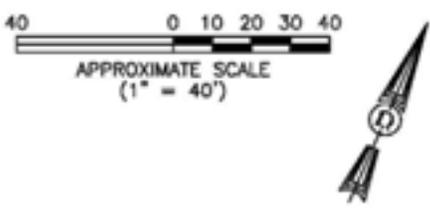
FIGURE 2
SITE PLAN, SAMPLING LOCATIONS,
AND FIELD ACTIVITIES
MOHAWK VALLEY WAREHOUSE
9 CANAL STREET
MOHAWK, NEW YORK
HRP # MOH4001.WM
SCALE 1" = 40'±

- ◆ - MONITORING WELL (MW-101 TO MW-103)
- ⊠ - TEST PIT (TP-101, TP-102)

- ◆ - MONITORING WELL SAMPLING LOCATION (MW-01 TO MW-04)
- - SOIL BORING SAMPLING LOCATION (SB-01 TO SB-06)
- ⊙ - SOIL VAPOR SAMPLING POINT (SV-01 TO SV-02)
- - SURFACE SOIL SAMPLING LOCATION (SS-01 TO SS-03: ONSITE, SS-04: OFFSITE)

The RI tasks consisted of a ground penetrating radar survey to locate any additional underground storage tanks, installation of groundwater monitoring wells, sampling to evaluate groundwater quality, and several soil borings to collect and analyze soil and soil vapor samples. The sampling locations are shown on Figure 2.
