**Record of Decision**  
**LILCO - Rockaway Park MGP Site**  
**Rockaway Park, Queens County**  
**New York**  
**Site Number 2-41-029**

# **DECLARATION STATEMENT - RECORD OF DECISION**

## **LILCO - Rockaway Park MGP Inactive Hazardous Waste Disposal Site Rockaway Park, Queens County, New York Site No. 2-41-029**

**LILCO - Rockaway Park MGP Site  
Rockaway Park, Queens County, New York  
Site No.2-41-029  
September, 2004**

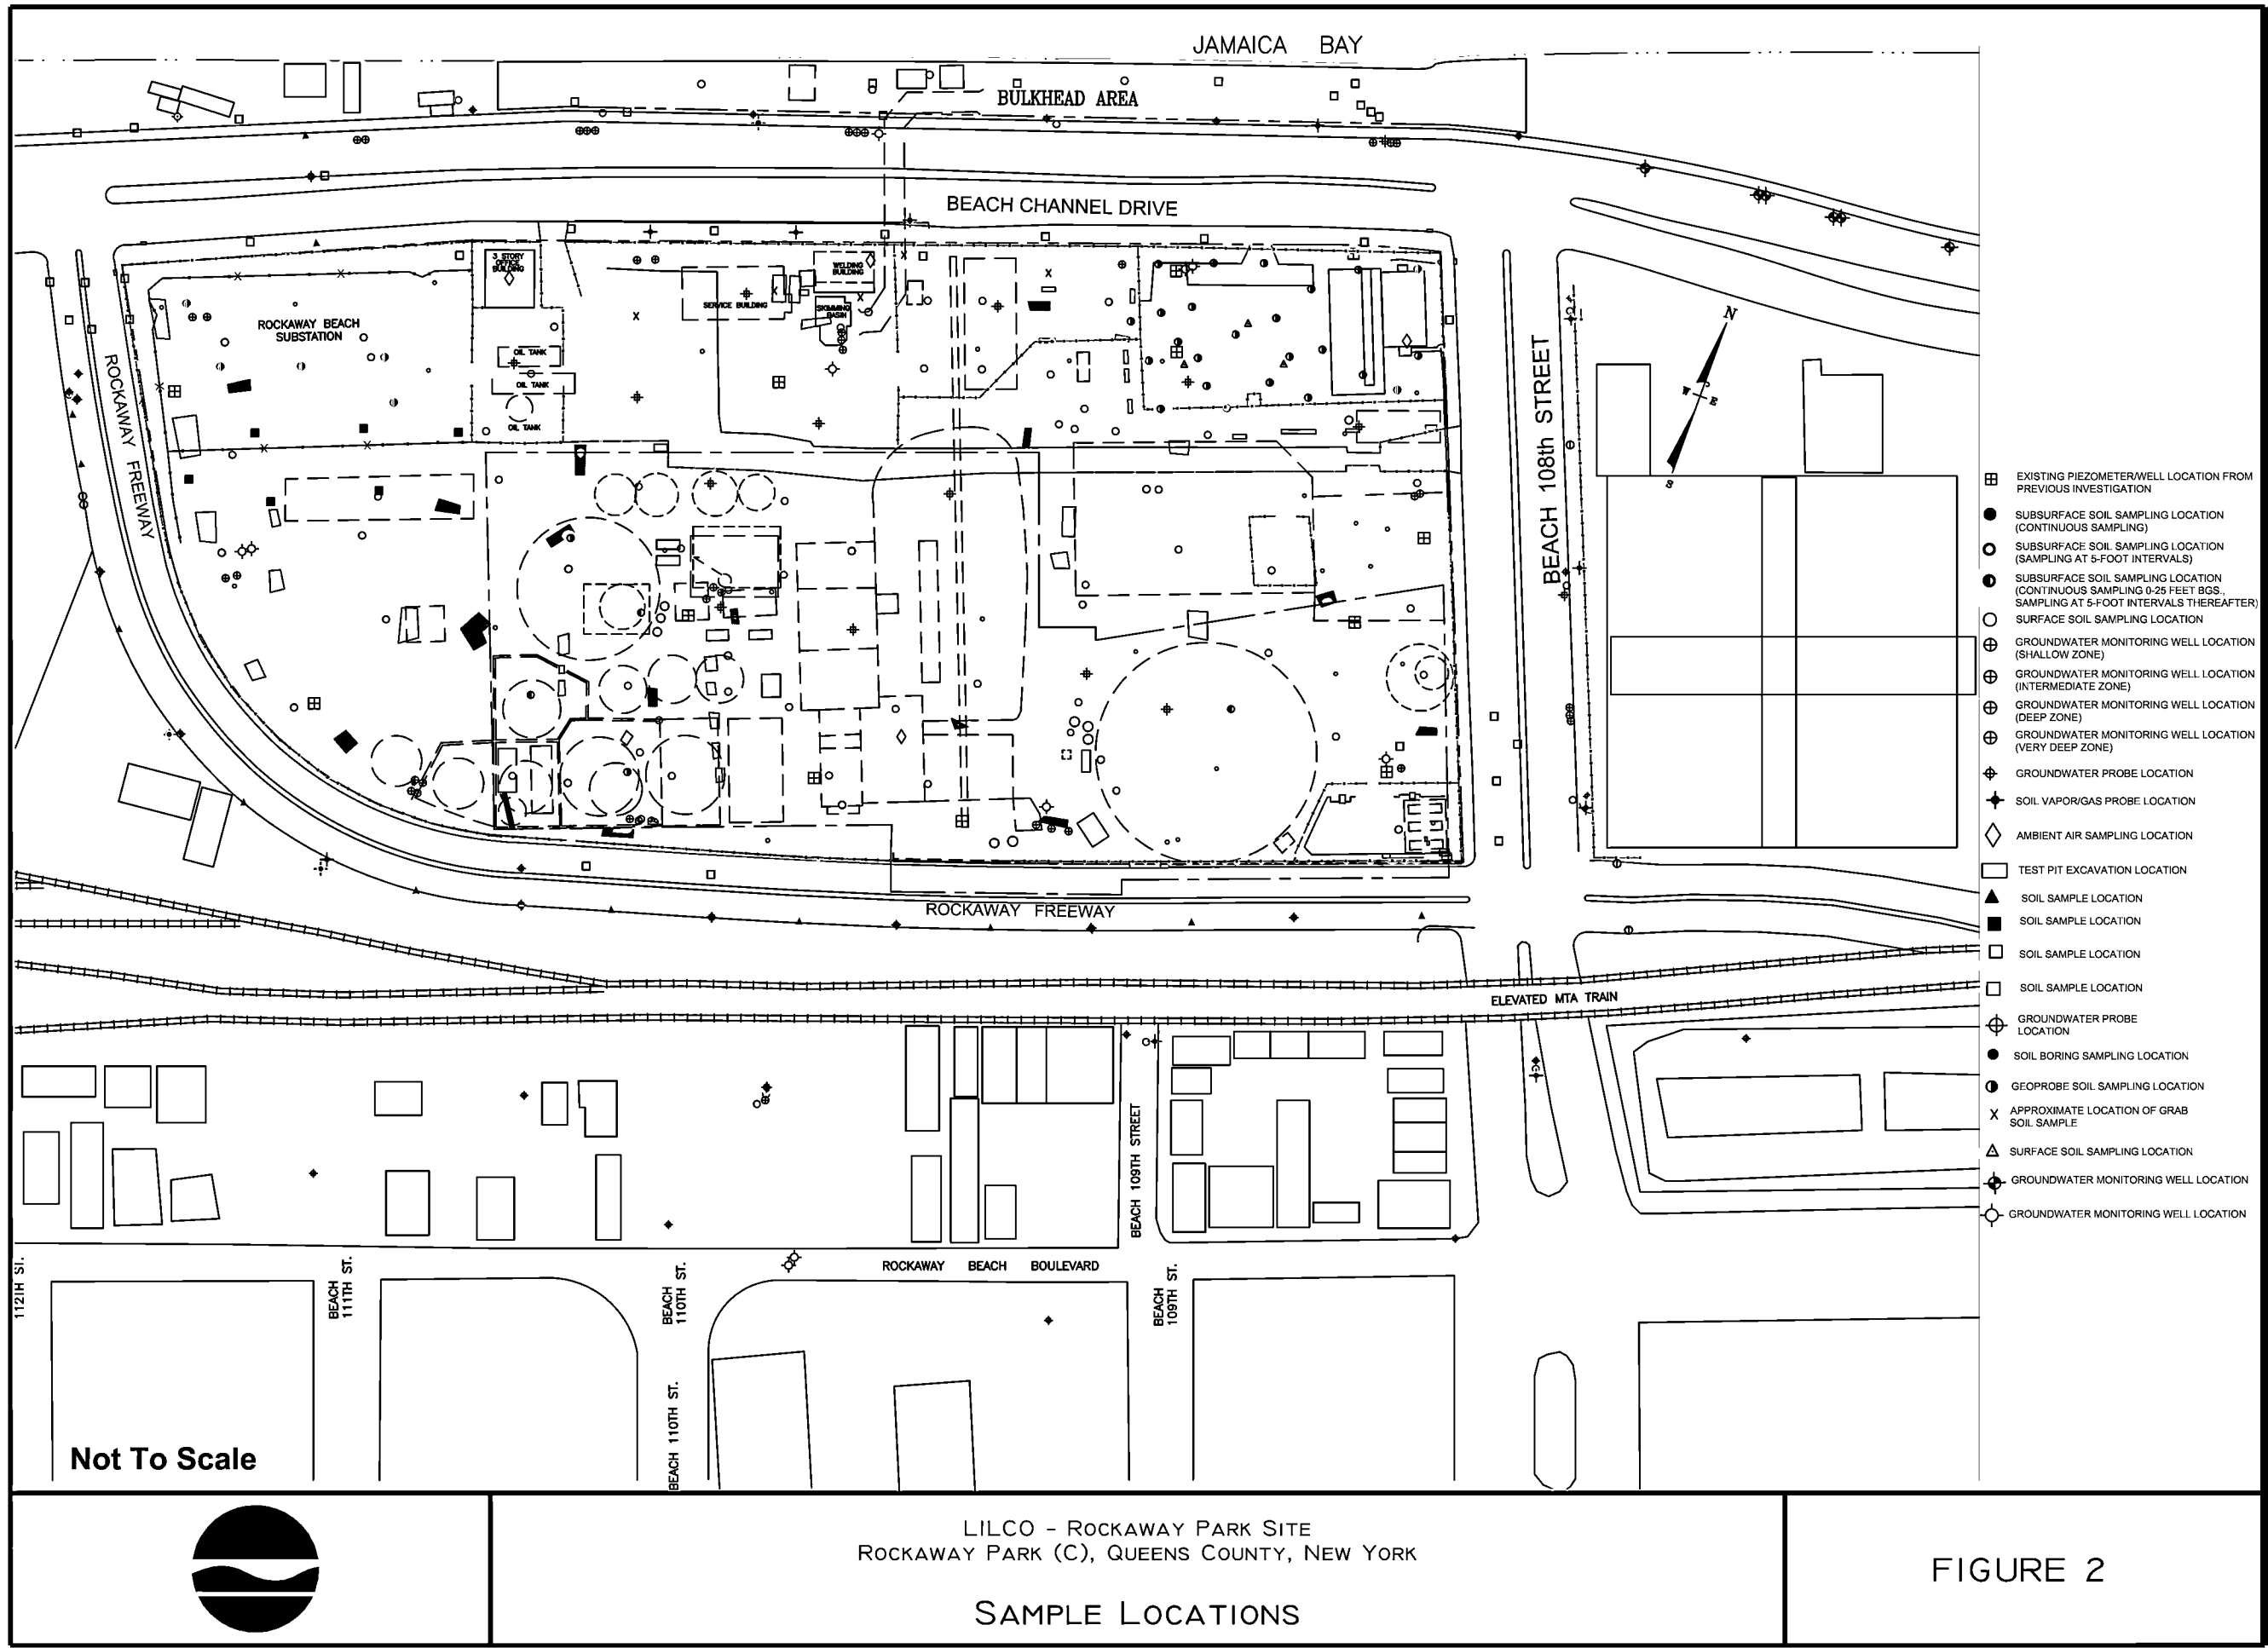
- ⊞ EXISTING PIEZOMETER WELL LOCATION FROM PREVIOUS INVESTIGATION
- SUBSURFACE SOIL SAMPLING LOCATION (CONTINUOUS SAMPLING)
- SUBSURFACE SOIL SAMPLING LOCATION (SAMPLING AT 5-FOOT INTERVALS)

- ⦿ SUBSURFACE SOIL SAMPLING LOCATION (CONTINUOUS SAMPLING 0-25 FEET BGS. SAMPLING AT 5-FOOT INTERVALS THEREAFTER)
- SURFACE SOIL SAMPLING LOCATION
- ⊕ GROUNDWATER MONITORING WELL LOCATION (SHALLOW ZONE)

The site is located in the Rockaway Park section of the Rockaway Peninsula in Queens County. The site is approximately nine acres in area located in an urban setting, adjacent to Jamaica Bay. The site is bounded by Beach 108<sup>th</sup> Street on the east, Beach Channel Drive to the north and Rockaway Freeway to the south and west. The majority of the site is undeveloped, with a vacant three-story office building and several open storage structures present on the site. It should be noted that a one-acre parcel in the northwest corner of the property is no longer considered part of the site. That portion was eliminated from the site description in 2000 as part of a redefinition of the site boundaries based upon available data. A new electric substation was built at this location (see Figure 3) to allow an existing 80 year-old substation located on the northeast corner of the site to be abandoned and subsequently demolished. The site location is noted on Figure 1 and the site layout is provided on Figure 2.

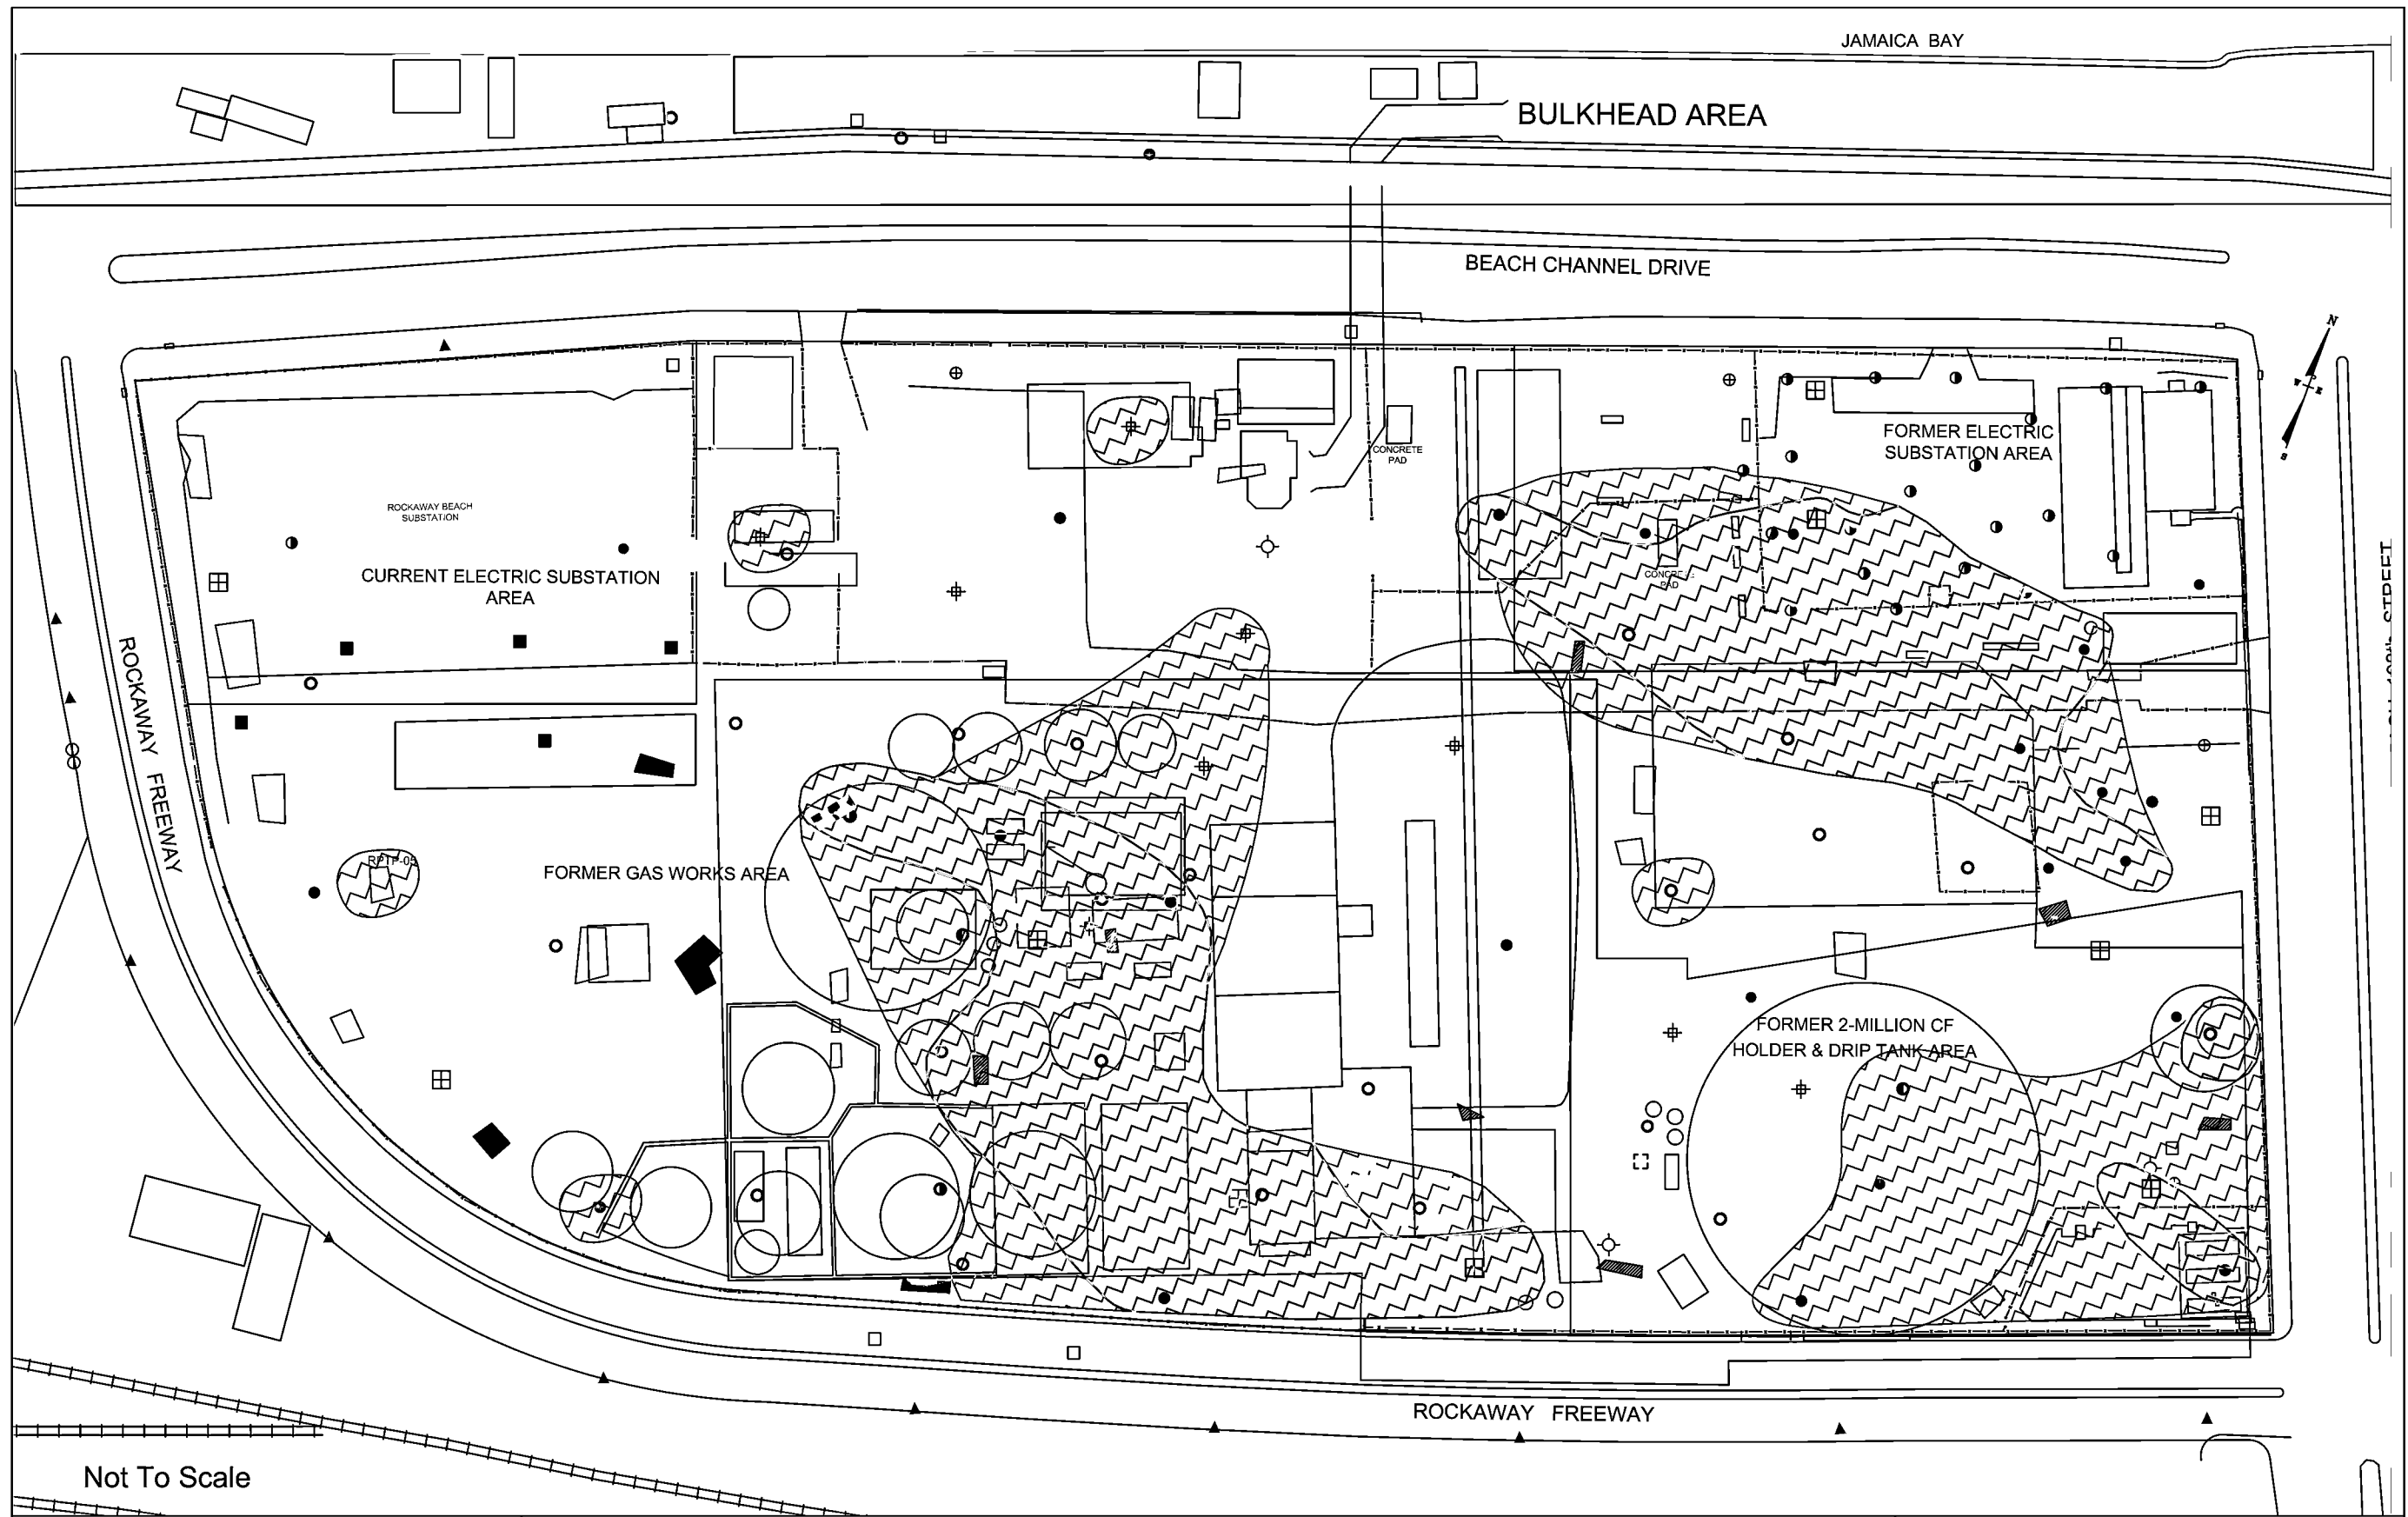
FIGURE 3

STAINING AND/OR NAPHTHALENE/HYDROCARBON ODORS

DNAPL EXTENT (0-8')

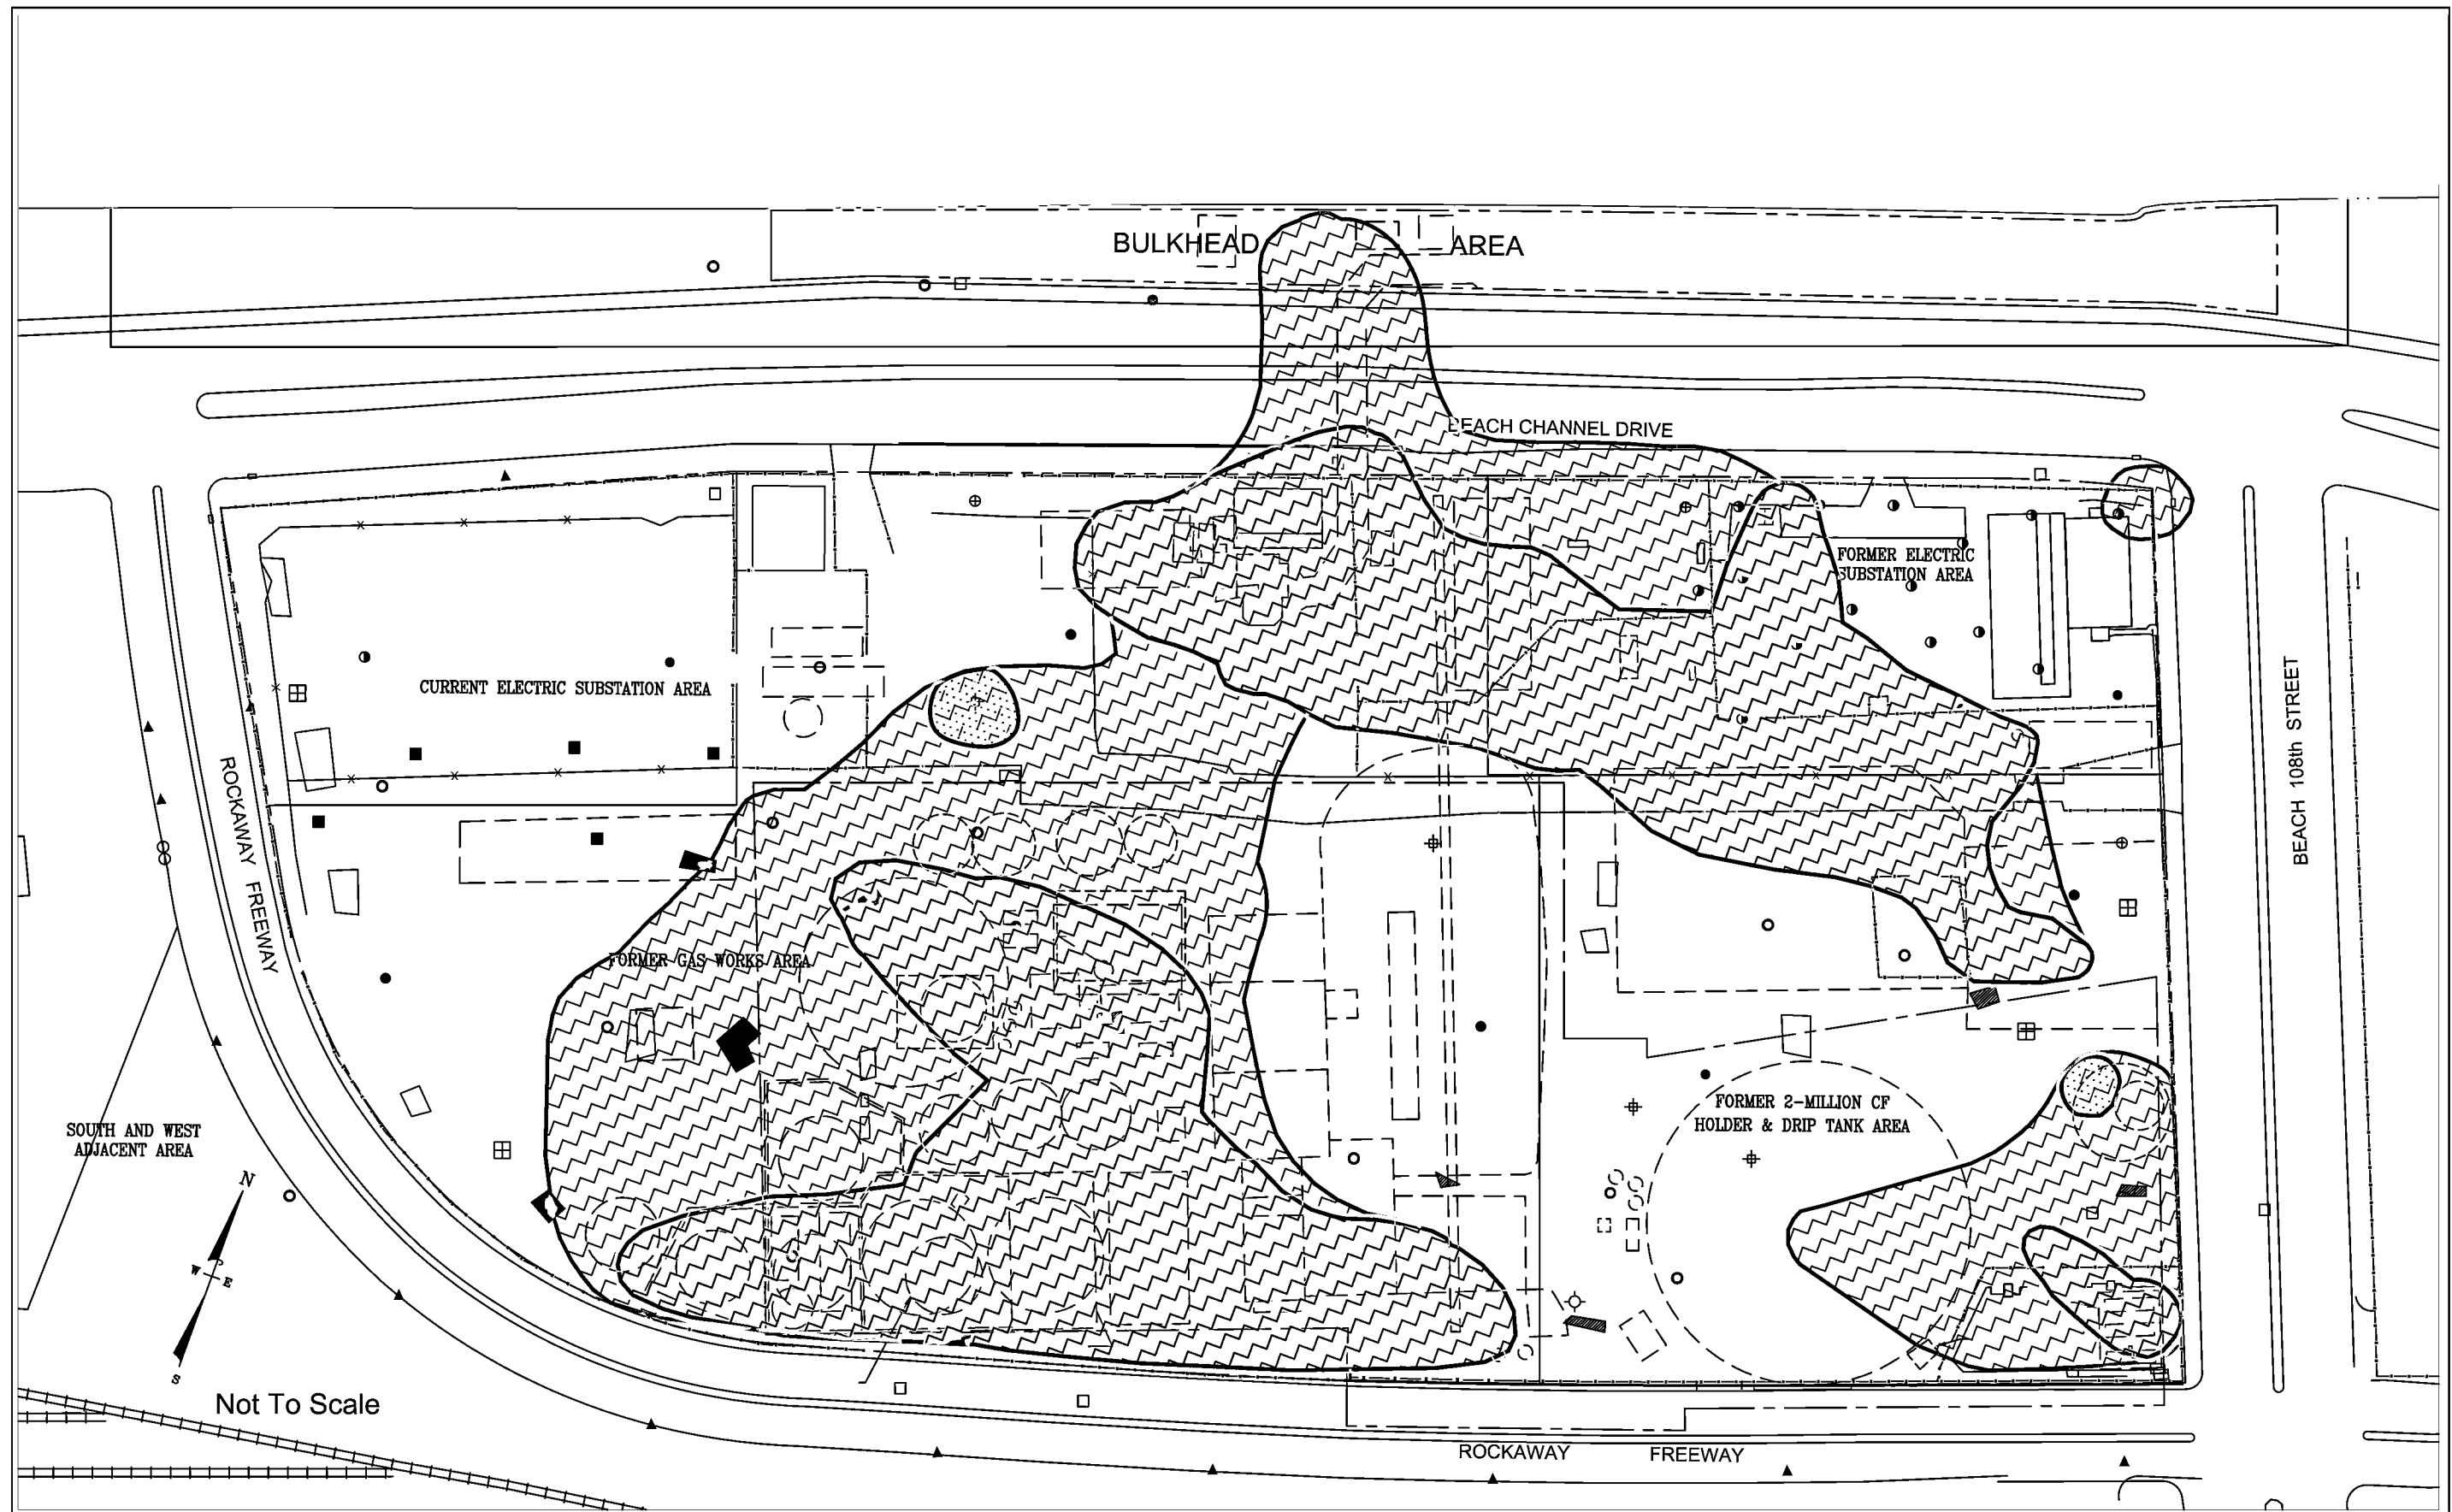
FIGURE 4

DNAPL EXTENT ( BELOW 8' )

The waste materials of concern for this site are the purifier waste deposits and the MGP tar deposits. The primary waste material found on the site is MGP tar. The source areas for MGP tar at the Rockaway Park site are typical of those found at other MGP sites. The gas holders, tar separator, and skimming basin are the main sources of MGP tar. The MGP tar can be found under nearly the entire site. At some locations the tar extends from the surface to over 90 feet below grade, with leading traces (e.g. sheens and odors) found as deep as 120 feet below grade. The extent of this material is noted on Figures 3 and 4. Additionally, a small portion of the MGP tar mass has been found in small, slightly coarser bands of sand to the north of the site, along the north side of Beach Channel Drive.

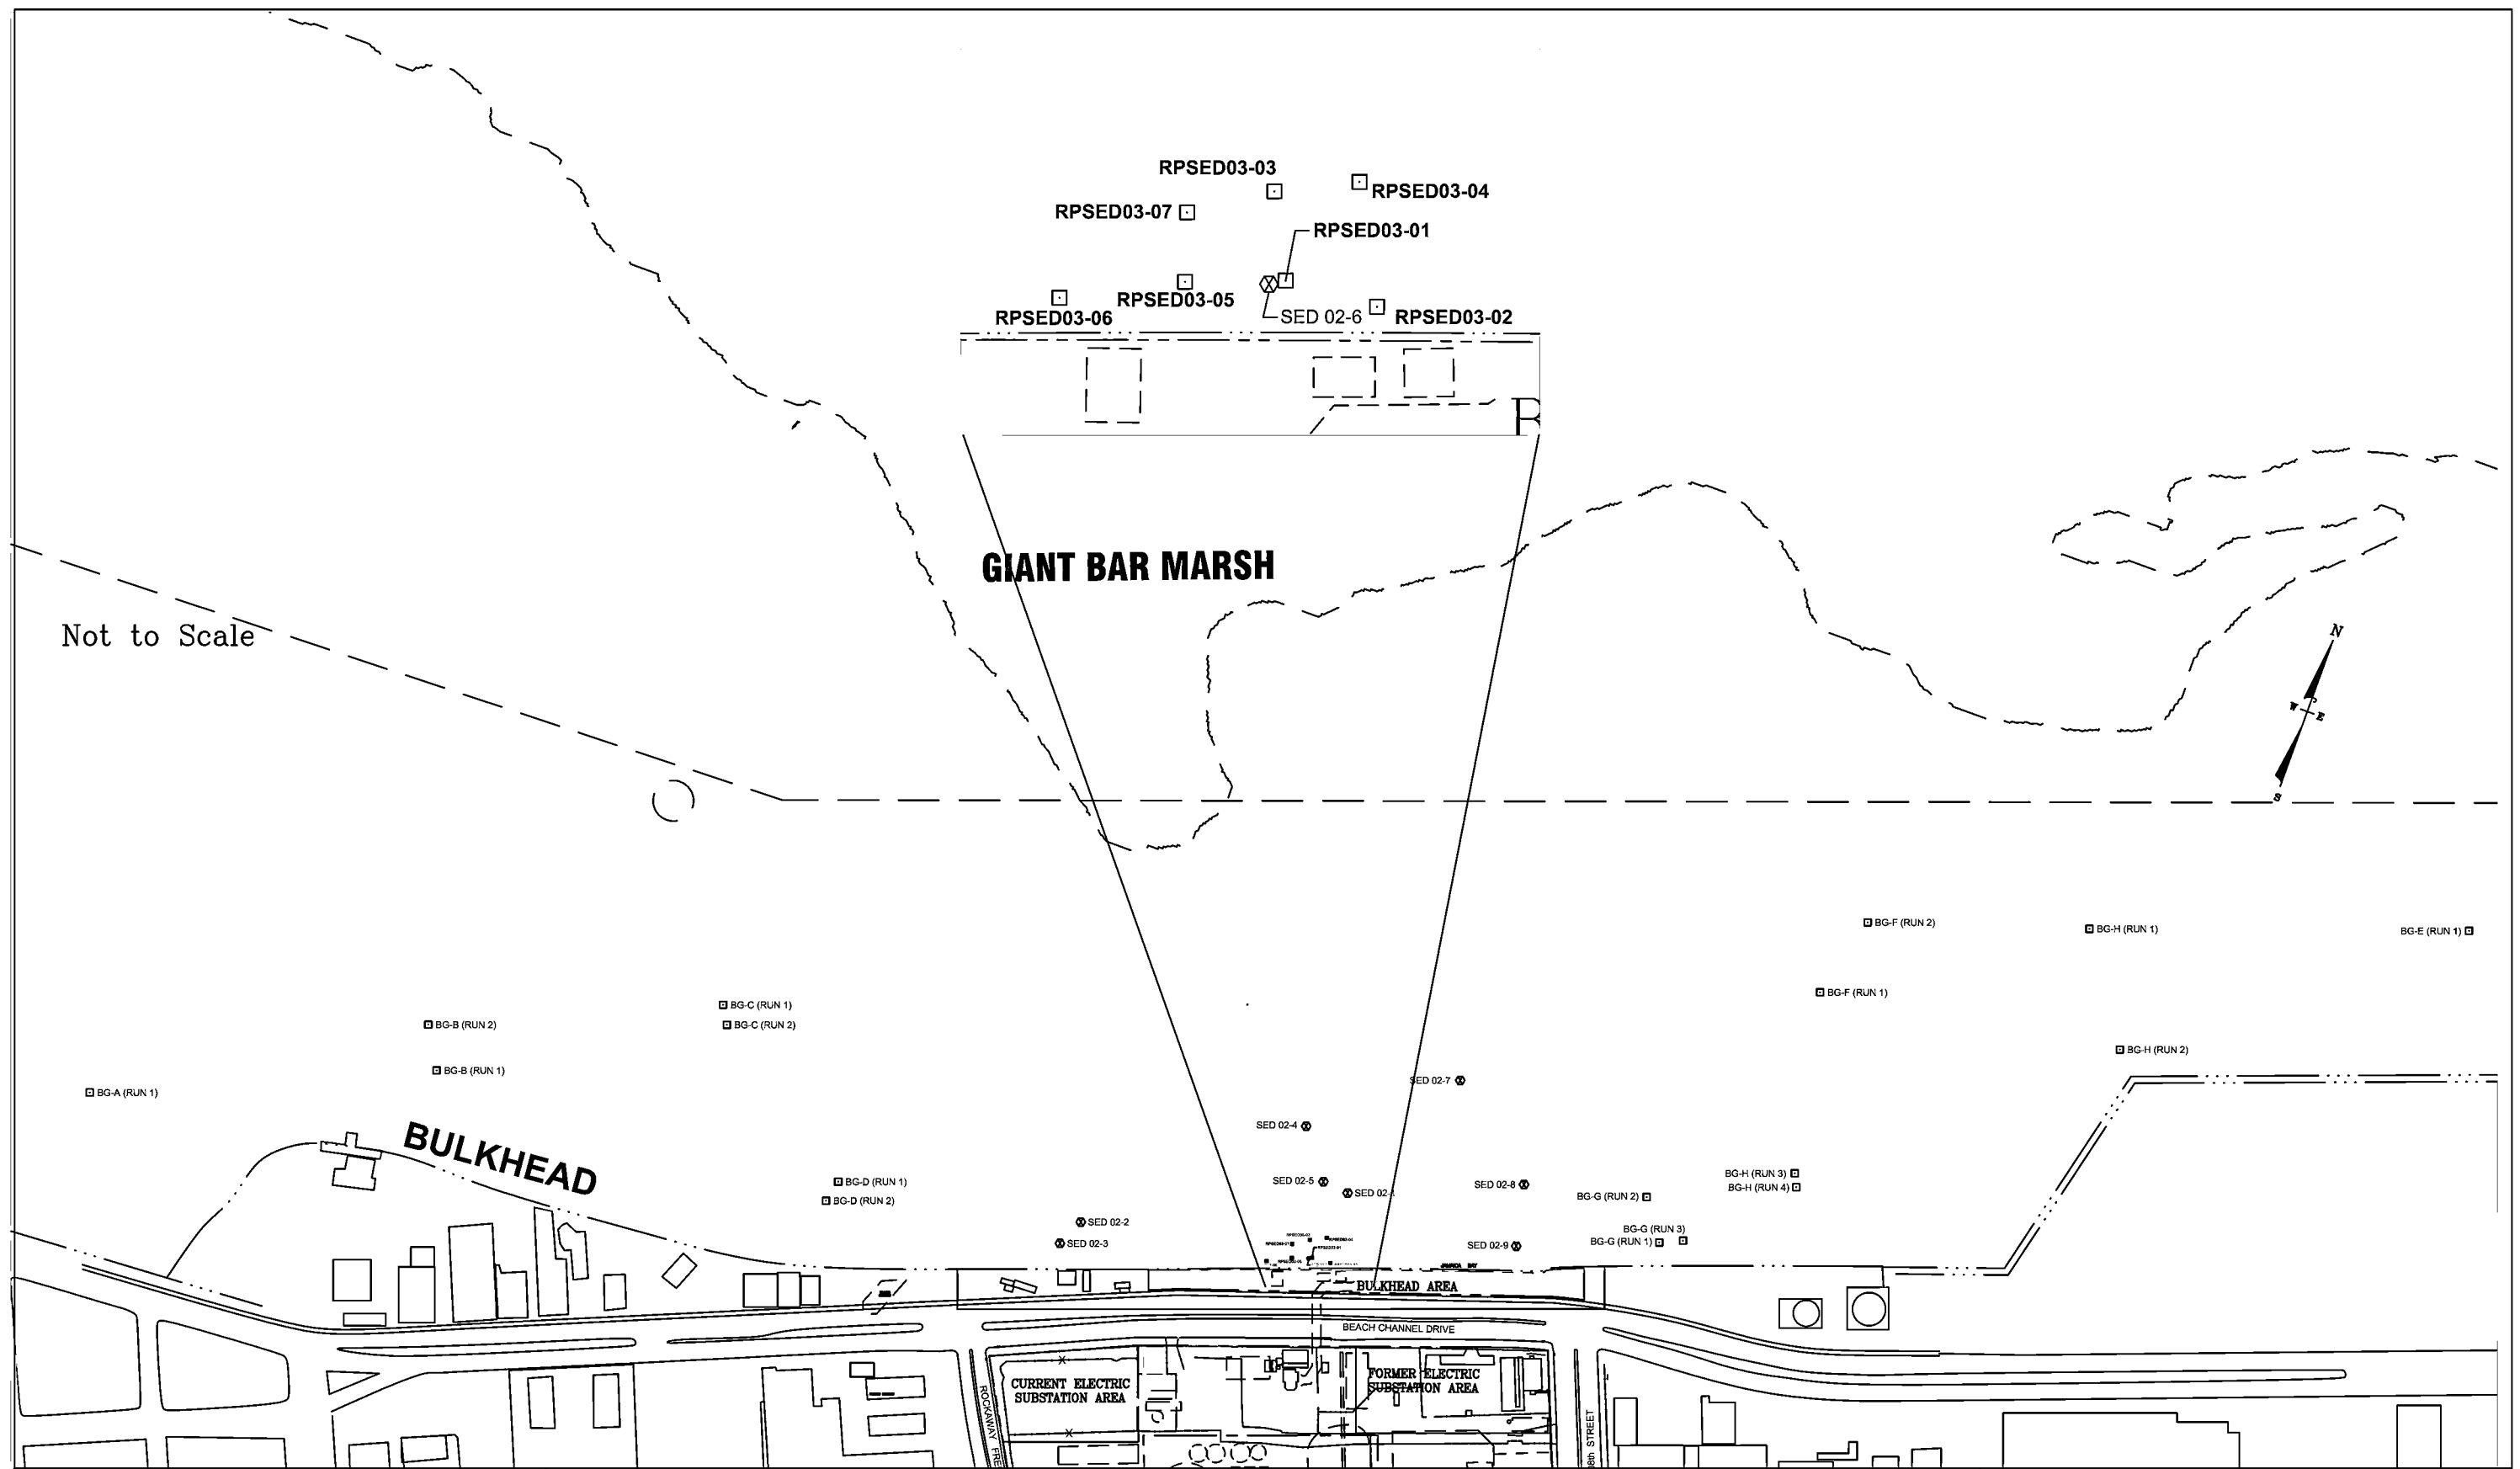
FIGURE 5

LILCO - Rockaway Park Site  
 Rockaway Park (C), QUEENS COUNTY, NEW YORK  
 SEDIMENT SAMPLE LOCATIONS

Sediment samples, in this case the sandy bottom of Jamaica Bay, were collected in the vicinity of the bulkhead adjacent to the MGP site, from the surface, as well as at depth. The majority of the samples contained only minor levels of BTEX and PAHs and no cyanide. These levels are considered to represent background conditions and can be attributed to non-point sources. The only exceptions were in three samples taken only a few feet from the bulkhead, directly north of the site where a thin seam of visually contaminated material was encountered at two to four feet below the sediment surface. This is where the highest VOC and PAH levels were located. It is believed that this is an isolated area associated with a free phase contaminant which does not represent a human health or environmental exposure risk. The only elevated level of cyanide came from a sample at the eastern edge of the bulkhead just off the shore line, at 0.35 ppm. This isolated cyanide contamination does not represent a significant exposure potential to humans or the environment. The locations of the sediment samples are noted in Figure 5.

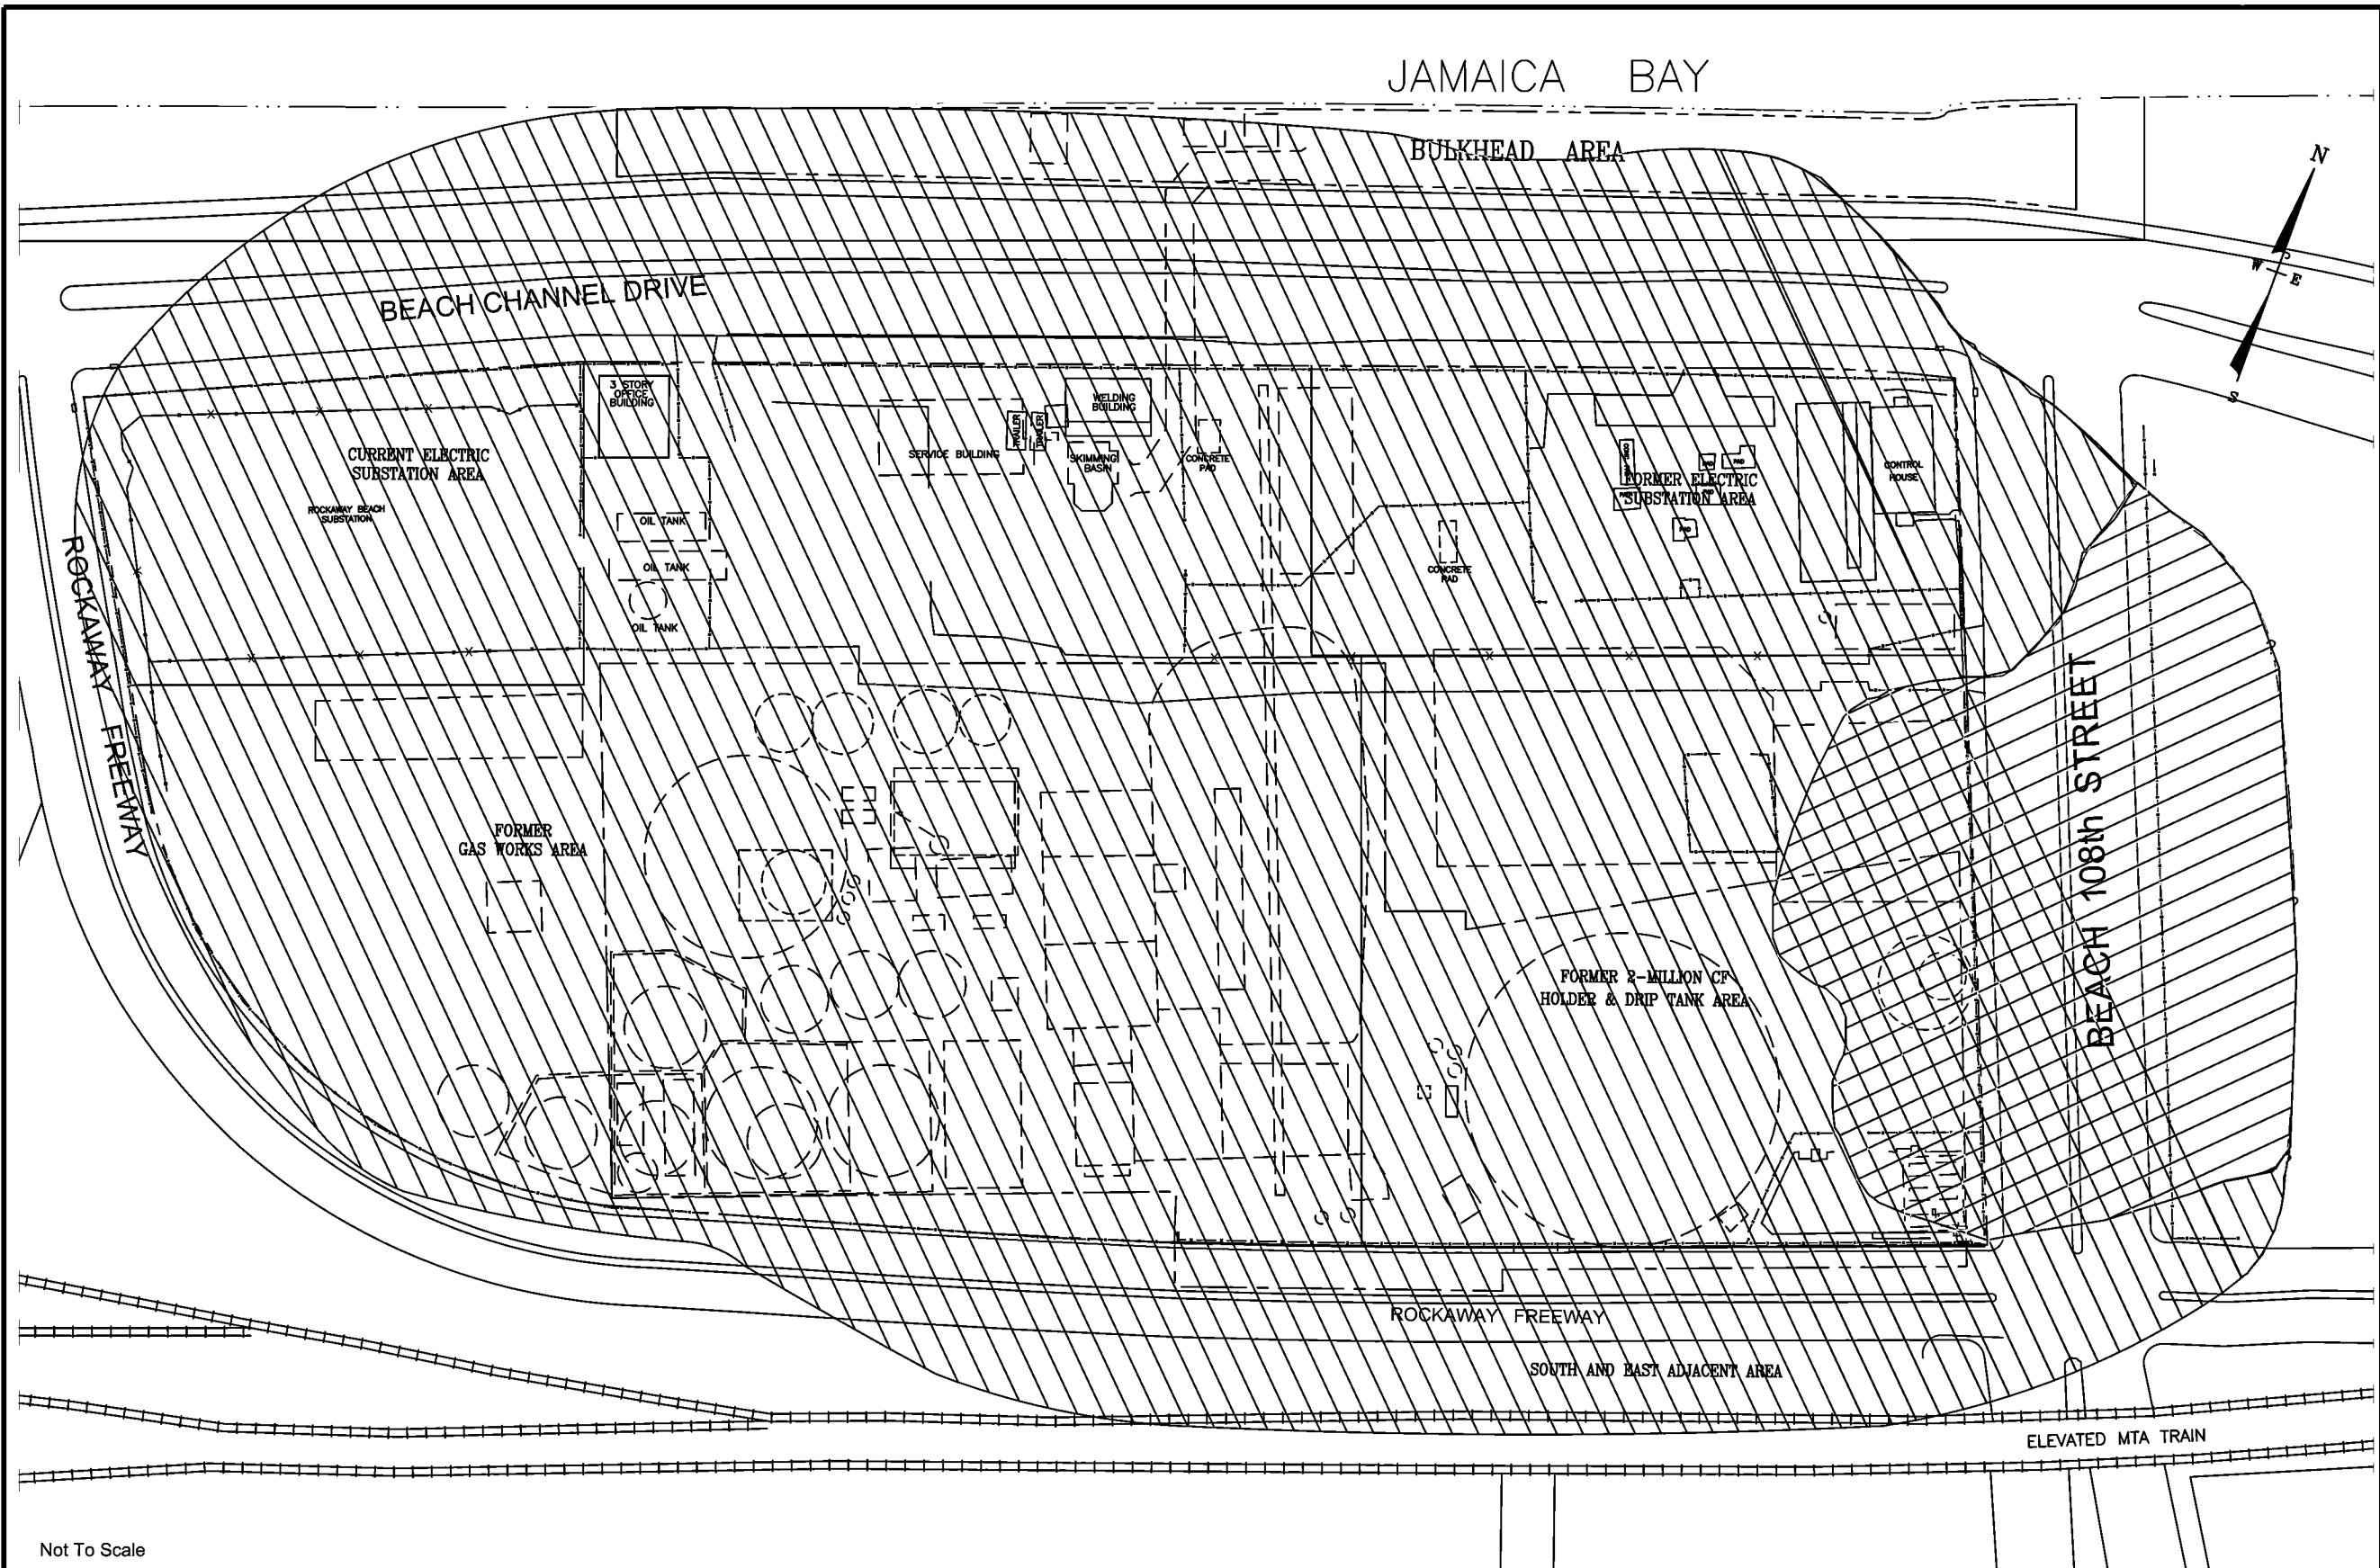
FIGURE 6

LILCO - ROCKAWAY PARK SITE  
 ROCKAWAY PARK (C), QUEENS COUNTY, NEW YORK  
**EXTENT OF GROUNDWATER PLUMES**

Groundwater contamination is evident across the entire site, extending only a small distance beyond the site limits. The limited off-site migration of the groundwater contamination is believed to be due to the large tidal influence on the groundwater flow beneath the site and the natural break down of those contaminants away from the source areas. There are two plumes originating on the site as shown on Figure 6. One is associated with the DNAPL source areas and is present under most of the site with a small portion of it proceeding to the north. A second plume, containing only BTEX compounds travels from the southeast corner of the site to the northeast and across Beach 108<sup>th</sup> Street. This second plume terminates under the wastewater treatment plant to the east of the site. The BTEX compounds found in the plumes are at levels much higher than the PAHs, as would be expected due to their higher solubility. The maximum concentrations for the individual BTEX compounds ranges from 9,900 ppb to 61,000 ppb. The maximum concentration was for benzene. Less than half of the samples collected have contaminant levels that exceed the SCGs for the individual BTEX compounds. The maximum PAH concentrations range from 410 ppb to 9,860 ppb, excluding naphthalene. With the

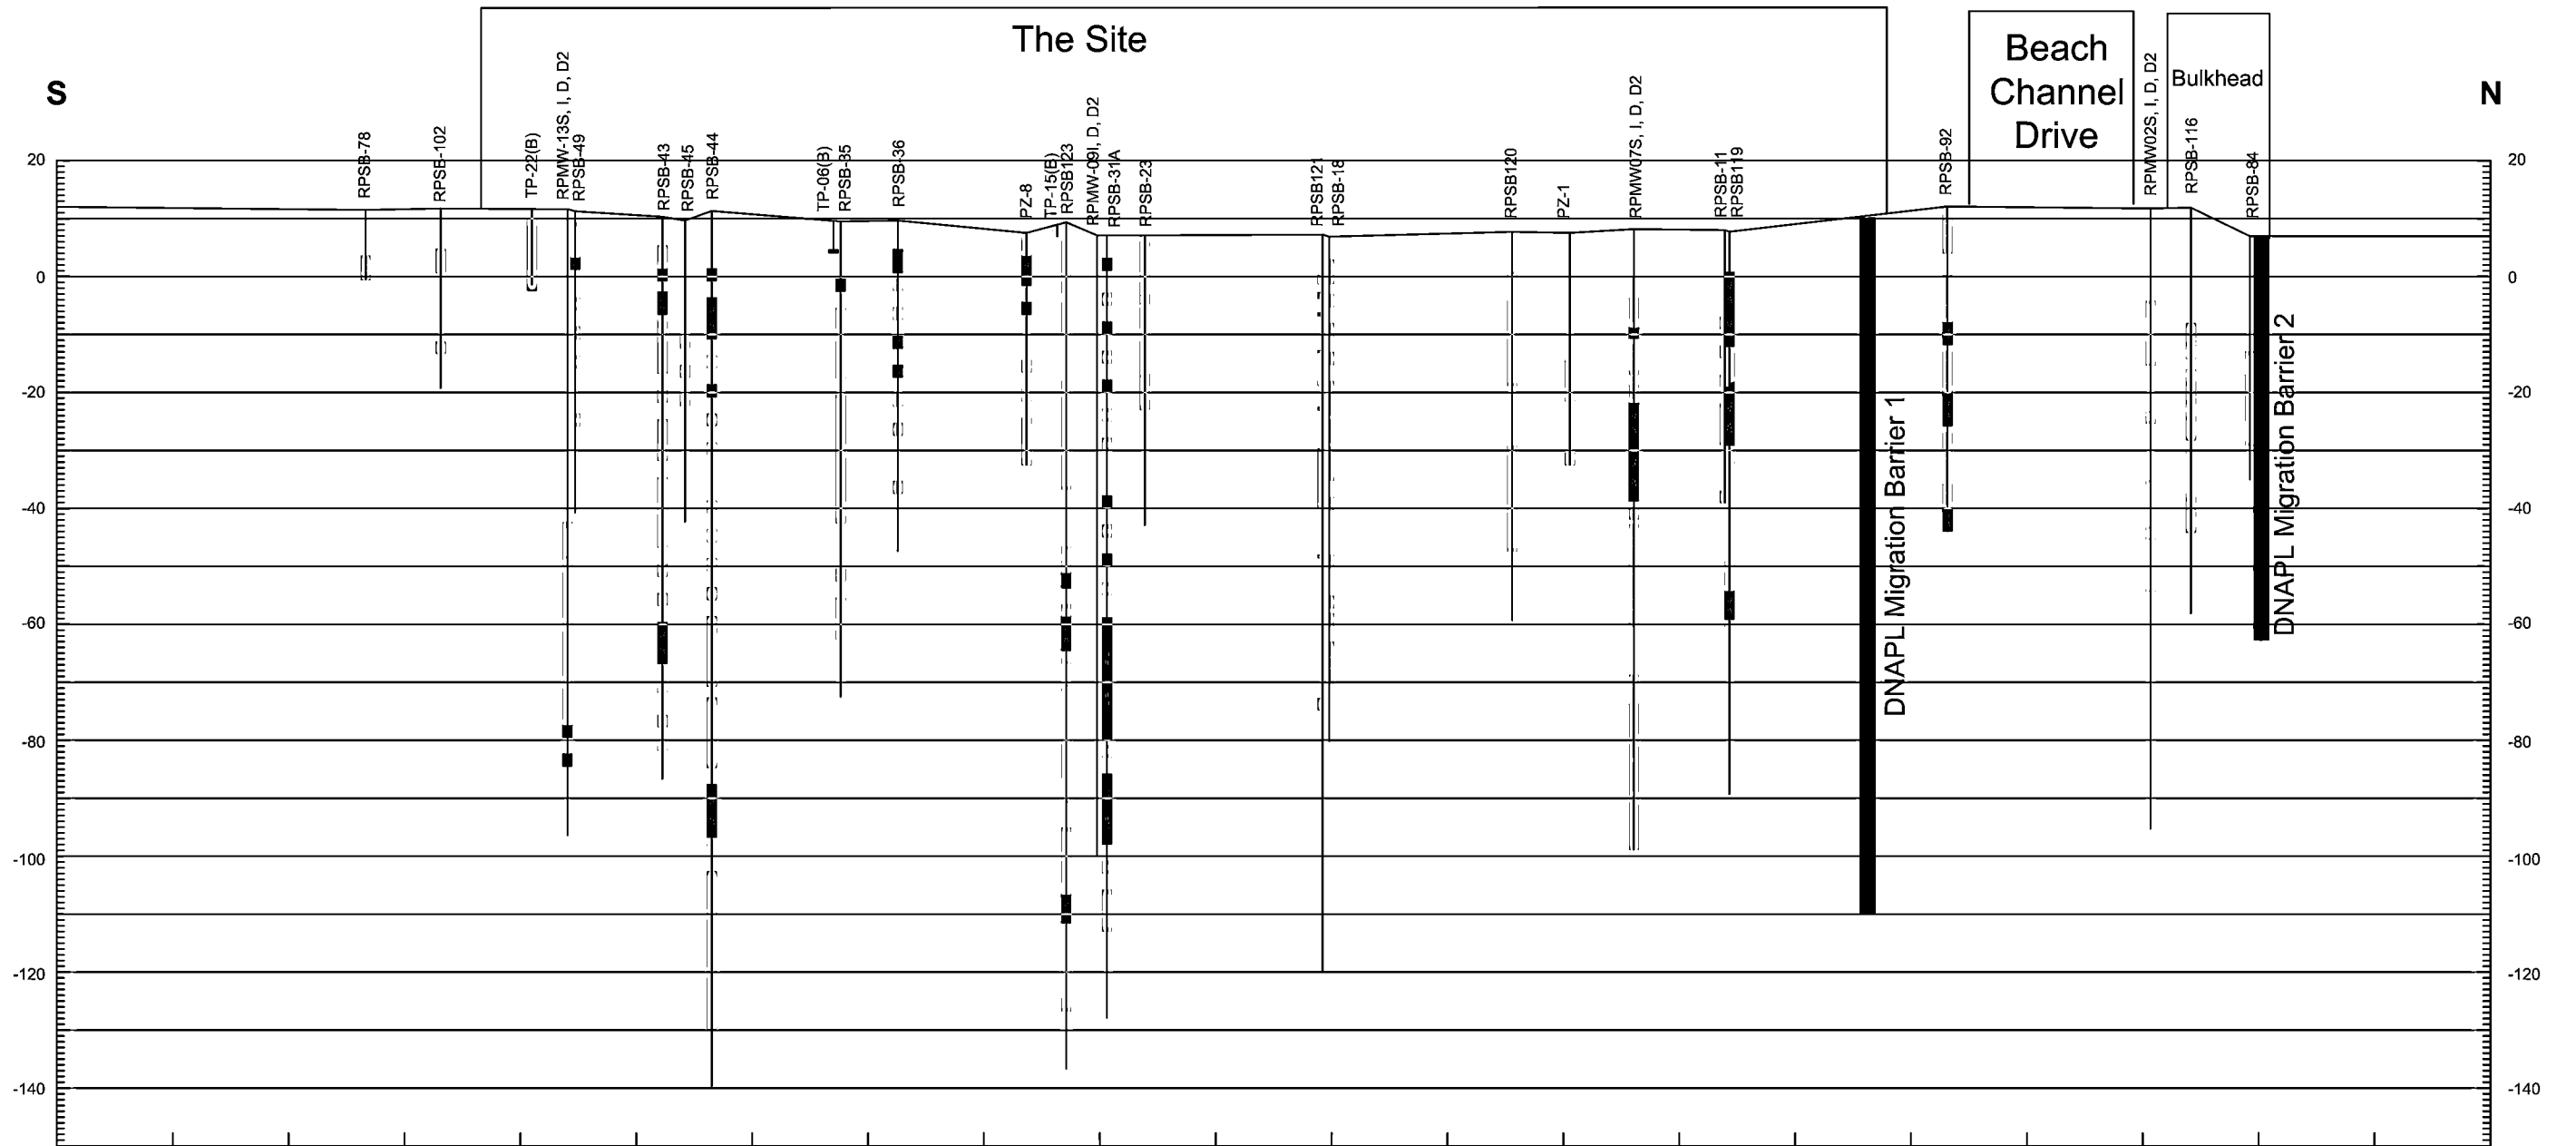
# South to North Cross-Section

- LEGEND:**
- SOLID TAR
  - TAR SATURATED
  - BLEBS, GLOBS, LENSES, GRAIN-COATING, SHEENS
  - STAINING
