**NYSDEC
Division of Water**

**A Primer on Aquatic Plant Management
in New York State**

April 2005

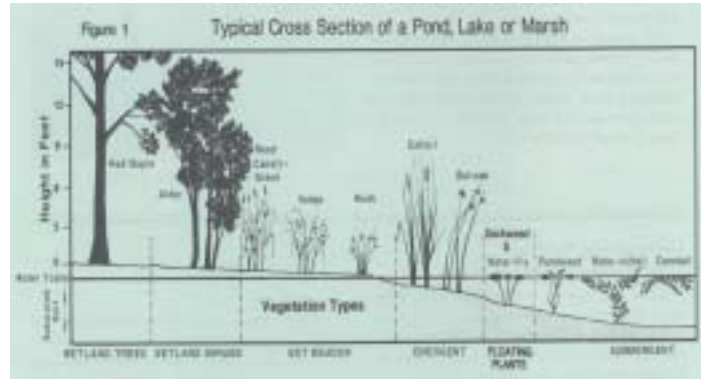
Just beyond the emergent plants, **floating-leaf plants**, such as water lilies, watershield, and more delicate unrooted plants such as duckweed and watermeal, are found. Like emergent plants, they are rooted under the water (sometimes with thick, hearty rootstocks (**rhizomes**)), but the floating leaves usually constitute the bulk of the plant mass. These floating leaves shield out the light transmitted below the plant, reducing the amount of underwater plant growth (within the stems of the floating leaf plants as well as other low-lying plants). These plants grow in water from a few inches deep (the duckweed and watermeal, which look like surface algae from a distance) to as much as 6-8 feet deep. Although floating-leaf plants tend to grow in the most heavily used parts of lakes and ponds, they are usually not associated with nuisance conditions.

Beyond this area occur **submersed plants** such as pondweeds and milfoil. These are perhaps the most diverse of the aquatic plants, ranging from tiny grass-like plants that barely peek above the sediment layer, well-hidden in up to 20 feet of water, to very tall, very conspicuous leafy plants that look a little like redwoods when viewed from the lake bottom. Some of these plants sprout a floating leaf or rosetta of leaves, and even a spike of flowers above the surface, although the bulk of the plant still resides under the water surface. Others grow to the lake surface and then spread laterally, forming a dense canopy that ultimately prevents other plants from growing under their shade. These observations reinforce the notion that the definitions of **submersed** and **floating-leaf** are somewhat arbitrary, for several plants could easily be considered as members of both groups, and plants in both groups still take up residence in the littoral zone. Several submergent plant species are regularly associated with nuisance conditions, owing to their status as exotic plants.

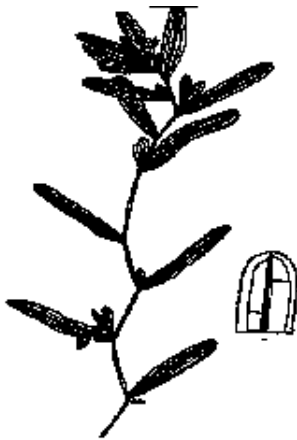
3. Curly-leafed pondweed (*Potamogeton crispus*) was probably introduced in the mid-1800s in the northeastern United States, and is found sporadically throughout the state. It is characterized by a lasagna-like curled leaf and a very early growing season. In New York lakes, the plants usually start growing under the ice and die back by late June. It spreads by seeds and sprigs. It grows in a variety of settings, but generally grows best in relatively shallow water. Curly-leafed pondweed control strategies are most often employed in the eastern and southern portions of the state.

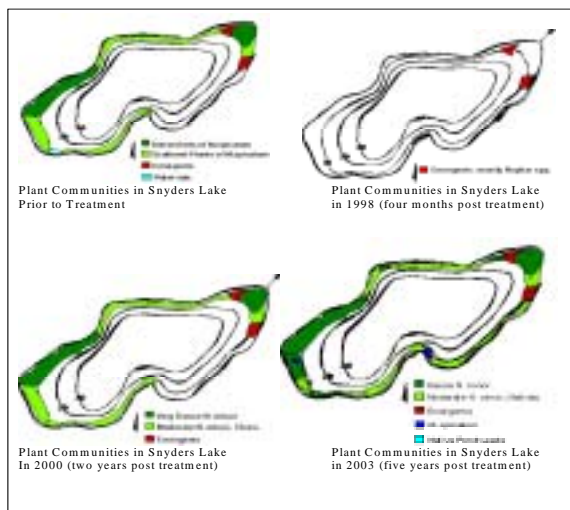
Results (cont): After 2001, milfoil recolonized large patches of the littoral zone, although it was still much less dominant than prior to treatment, due to the well-established brittle naiad beds. The milfoil spread to some areas not previously occupied by any macrophytes. The coverage and density of the milfoil/brittle naiad beds were significant enough to trigger a spot treatment with endothal in the summer of 2004 in the areas of the lake with the highest macrophytes coverage (and, perhaps not coincidentally, the highest sedimentation rate).

Most antidotal information from lake residents and visitors indicate a general satisfaction with the results of the initial treatment, with few reported complaints from anglers about the lack of a fishing edge or loss of any year-classes. Water quality conditions were relatively stable throughout the treatment and subsequent response period, and reports of blue-green algal blooms or other water quality complaints were less common than in most previous five-year periods, despite the potential available of nutrients not taken up by the rooted plants. However, this may have been more a function of more favorable weather conditions.
