**NYSDEC
Division of Water**

**A Primer on Aquatic Plant Management
in New York State**

April 2005

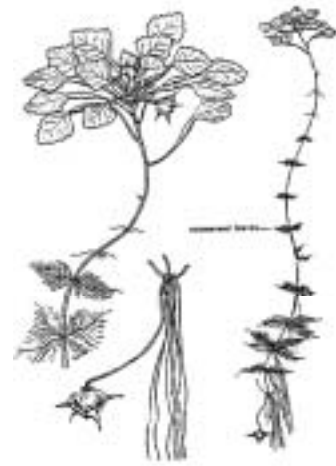
2. (Eurasian) water chestnut (*Trapa natans*) was introduced in North American and New York State in Collins Lake in Scotia in 1882, although it was found a few years earlier in an herbarium in Massachusetts. From this “epicenter”, it has largely migrated along the Lake Champlain, Mohawk River and Hudson River systems (and problems associated with water chestnut are mostly restricted to these areas), although it has been increasingly found in small lakes and ponds. It is conspicuous for a surface rosetta of leaves and a woody, spiked nutlet that serves as a seed for future generations of the plant (and is viable in bottom sediments for several decades). Water chestnut grows primarily in sluggish shallow water in mucky sediments.

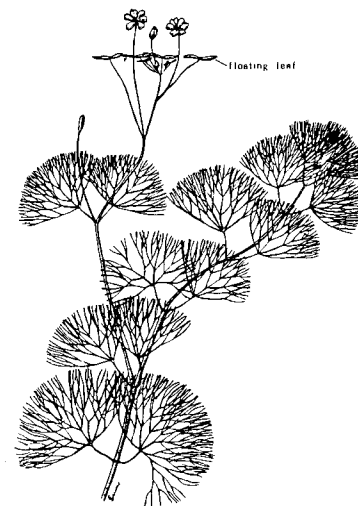
4. Fanwort (*Cabomba caroliniana*) is native to the southern states but not native to New York State or the northeastern states. It has historically been limited to Long Island (although the first sightings in New York State may have occurred in Orange County in the early 1930s), where it grows primarily in shallow water, as in most other New England states. However, in recent years it has been found in deepwaters of the isolated lakes in the southeastern Adirondacks and on both sides of the Lower Hudson River basin. It has thread-like leaves that fan out on opposite sides of the stem; while it has white or pink flowers, these rarely appear in fanwort in New York state lakes. It spreads by seeds, not by fragmentation or other asexual means. Fanwort control is mostly limited to Long Island.
