Flood Damage Reduction Segment / System Inspection Report

Name of Segment / System: Greene -- West Greene (Birdsall Creek)

Corps of Engineers Inspector: A. Zarnoski, P.E. ; J. Reed; W. Wynn Date of Inspection: 9/2/2008

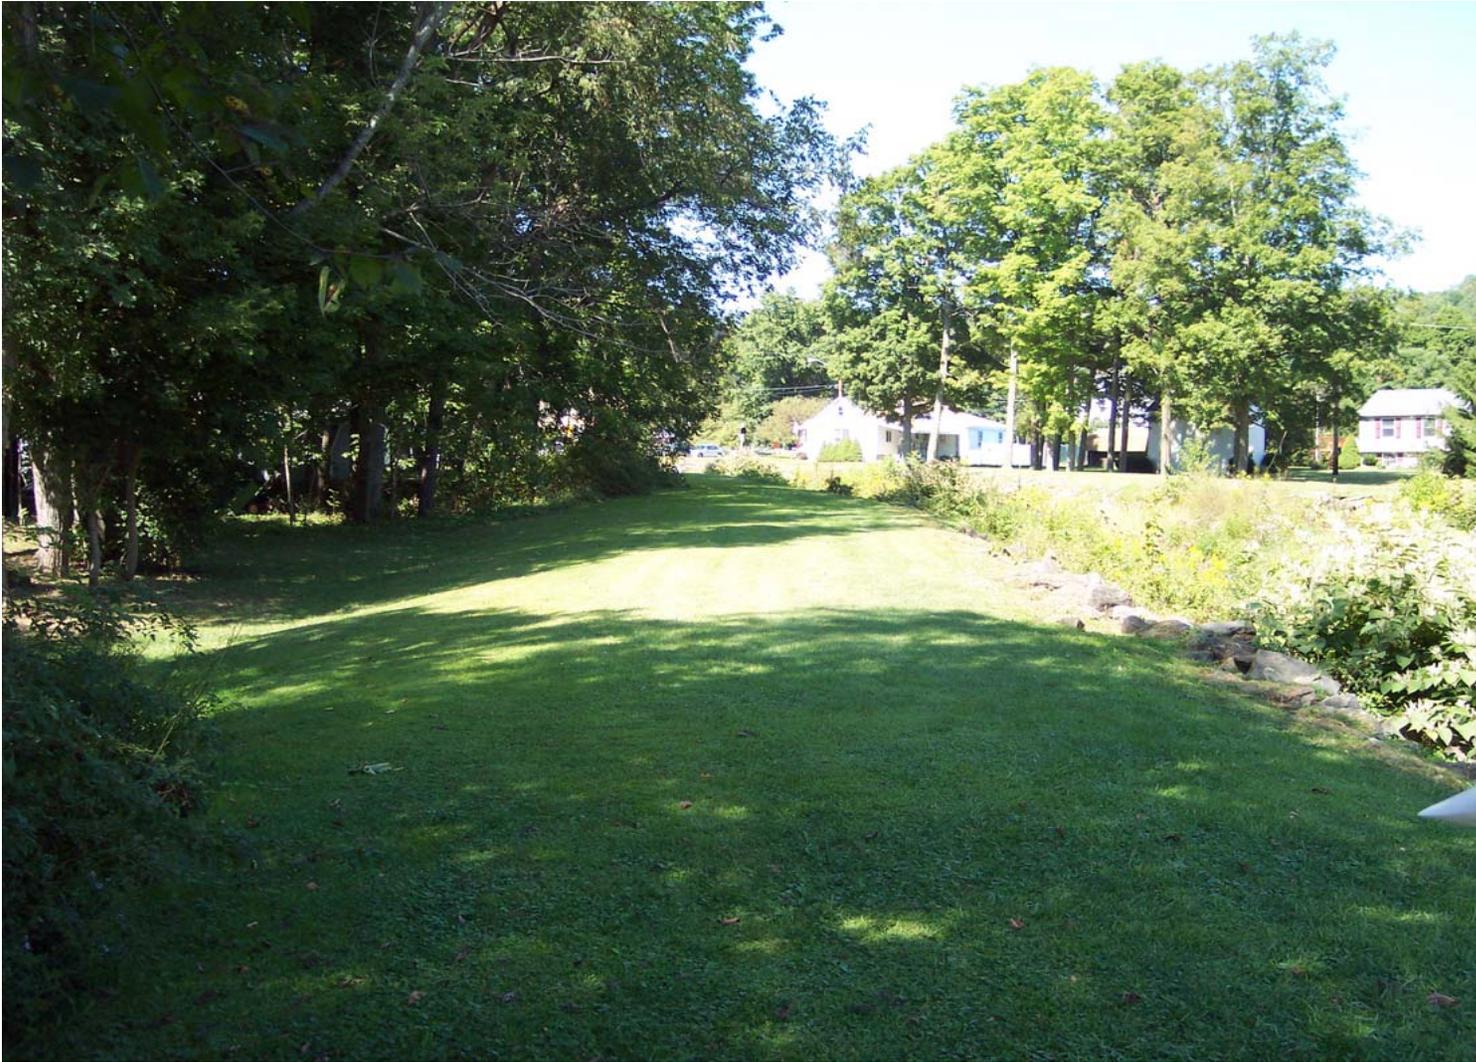
Rated Item	Rating	Rating Guidelines		Location/Remarks/Recommendations
1. Unwanted Vegetation Growth ¹	M	A	The levee has little or no unwanted vegetation (trees, bush, or undesirable weeds), except for vegetation that is properly contained and/or situated on overbuilt sections, such that the mandatory 3-foot root-free zone is preserved around the levee profile. The levee has been recently mowed. The vegetation-free zone extends 15 feet from both the landside and riverside toes of the levee to the centerline of the tree. If the levee access easement doesn't extend to the described limits, then the vegetation-free zone must be maintained to the easement limits. Reference EM 1110-2-301 or Corps policy for regional vegetation variance.	NYSDEC needs to survey to locate property boundaries and then cut unwanted vegetation accordingly. After survey is completed remove brush back to extent that property lines allow. (Approx. Sta. 12+00)

Inspect ID: GRNW_2008_a_0001 **Name:** Vegetation on Levee Slope **Caption:** Vegetation on Levee Slope

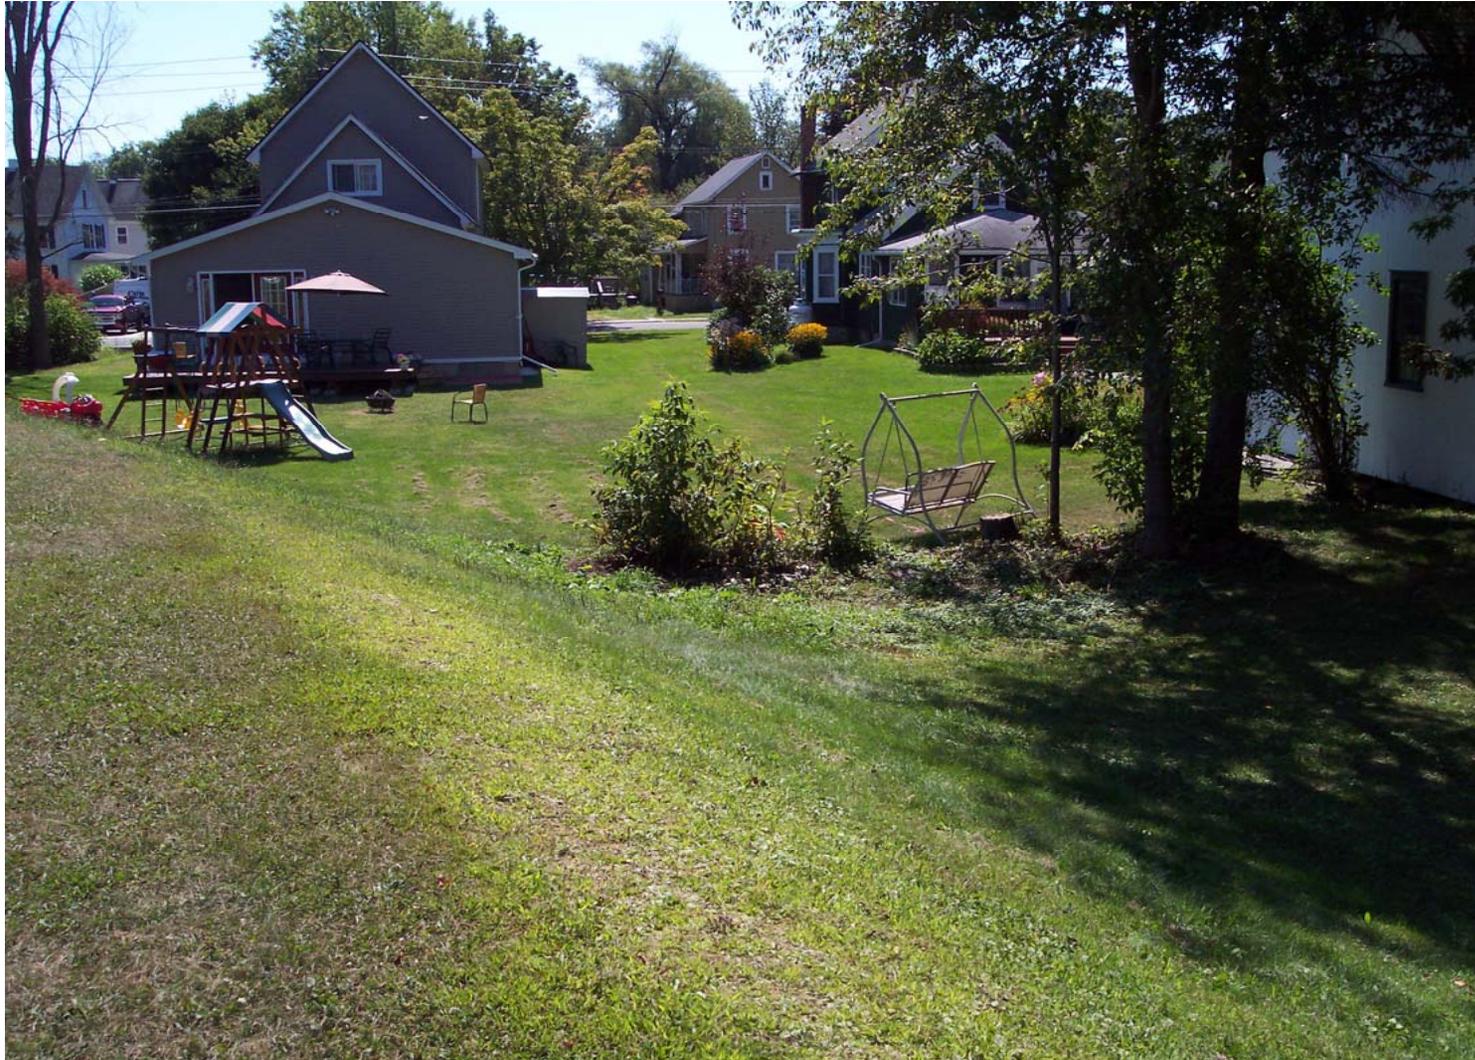
3. Encroachments	M	A	No trash, debris, unauthorized farming activity, structures, excavations, or other obstructions present within the easement area. Encroachments have been previously reviewed by the Corps, and it was determined that they do not diminish proper functioning of the levee.	NYSDEC should survey to define property boundaries in the surrounding area and then remove encroachments accordingly. At time of inspection the only encroachment noted was a children's playset located near the downstream end of the project.
		M	Trash, debris, unauthorized farming activity, structures, excavations, or other obstructions present, or inappropriate activities noted that should be corrected but will not inhibit operations and maintenance or emergency operations. Encroachments have not been reviewed by the Corps.	
		U	Unauthorized encroachments or inappropriate activities noted are likely to inhibit operations and maintenance, emergency operations, or negatively impact the integrity of the levee.

Inspect ID: GRNW_2008_a_0001 **Name:** Encroachment **Caption:** Children's playset located near toe of levee.

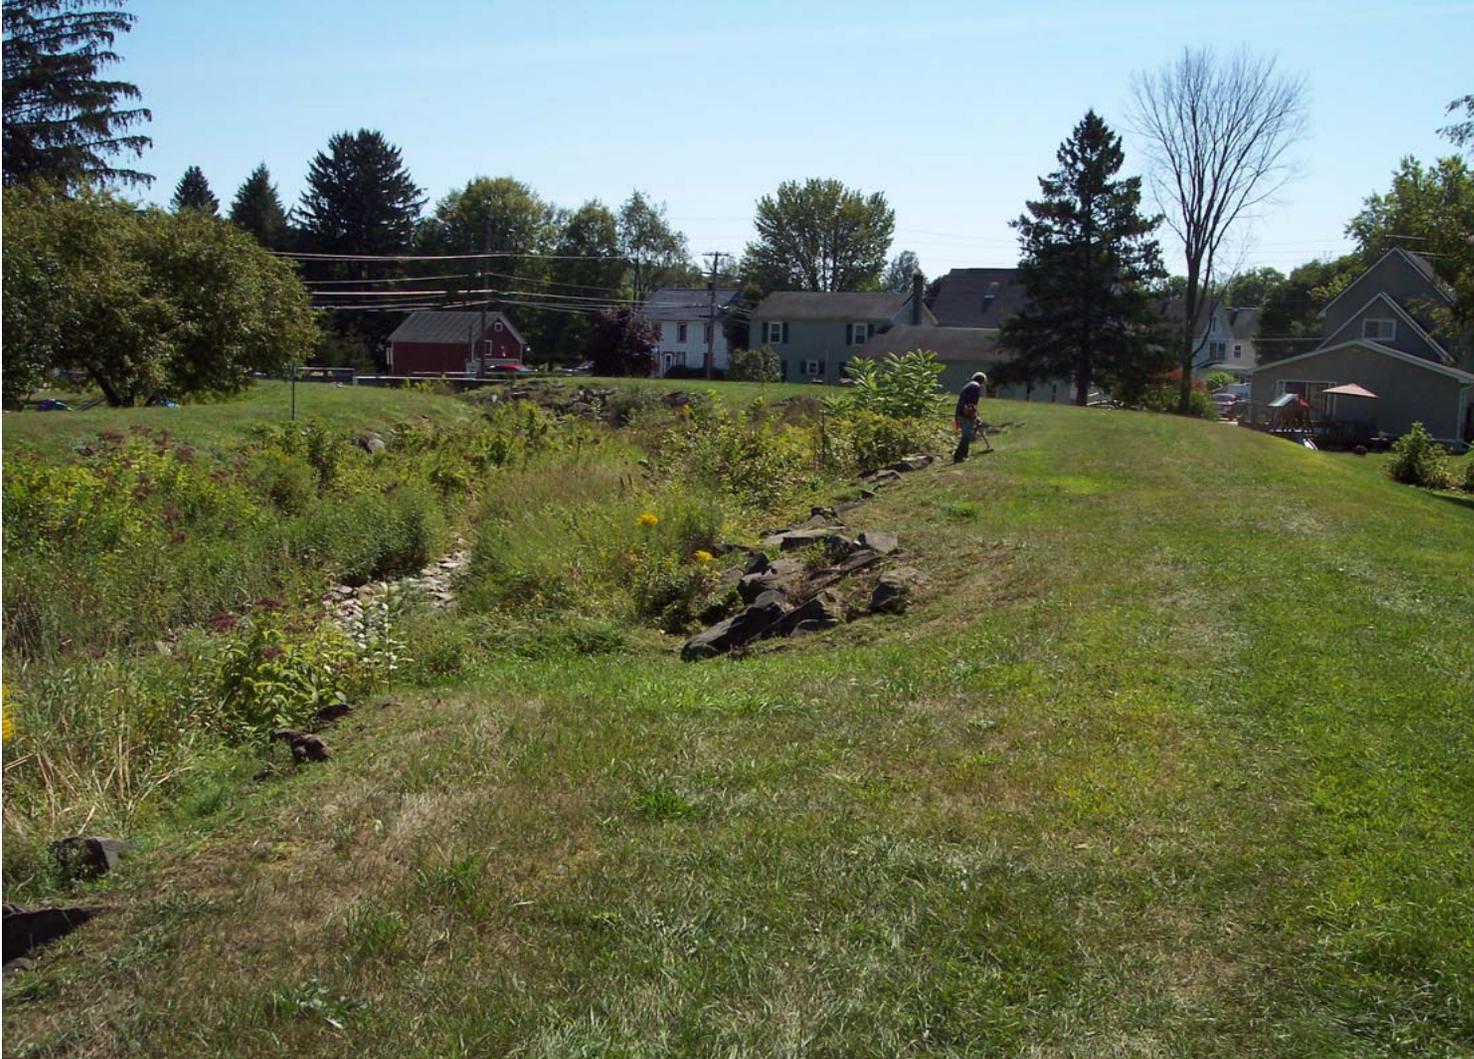
Rated Item	Rating	Rating Guidelines		Location/Remarks/Recommendations
1. Vegetation and Obstructions	M	A	No obstructions, vegetation, debris, or sediment accumulation within the channel. Concrete channel joints and weep holes are free of grass and weeds.	At the time of inspection, NYSDEC was in the process of removing and trimming the vegetation in the channel which consists of weed growth. This process is expected to be completed in two weeks, from the date of this inspection.
		M	Obstructions (including log jams), vegetation, debris, or sediment are minor and have not impaired channel flow capacity, but should be removed. Sediment shoals have not developed to the extent that they can support vegetation other than non-aquatic grasses. A limited volume of grass and weeds may be present in concrete channel joints and weep holes.	
		U	Obstructions (including log jams), vegetation, debris or sediment have impaired the channel flow capacity. Sediment shoals are well established and support woody and/or brushy vegetation. Sediment and debris removal required to re-establish flow capacity.

Inspect ID: GRNW_2008_a_0001 **Name:** Ongoing Brush Removal in Channel **Caption:** Ongoing Brush Removal in Channel
