Flood Damage Reduction Segment / System Inspection Report

**US Army Corps
of Engineers®**

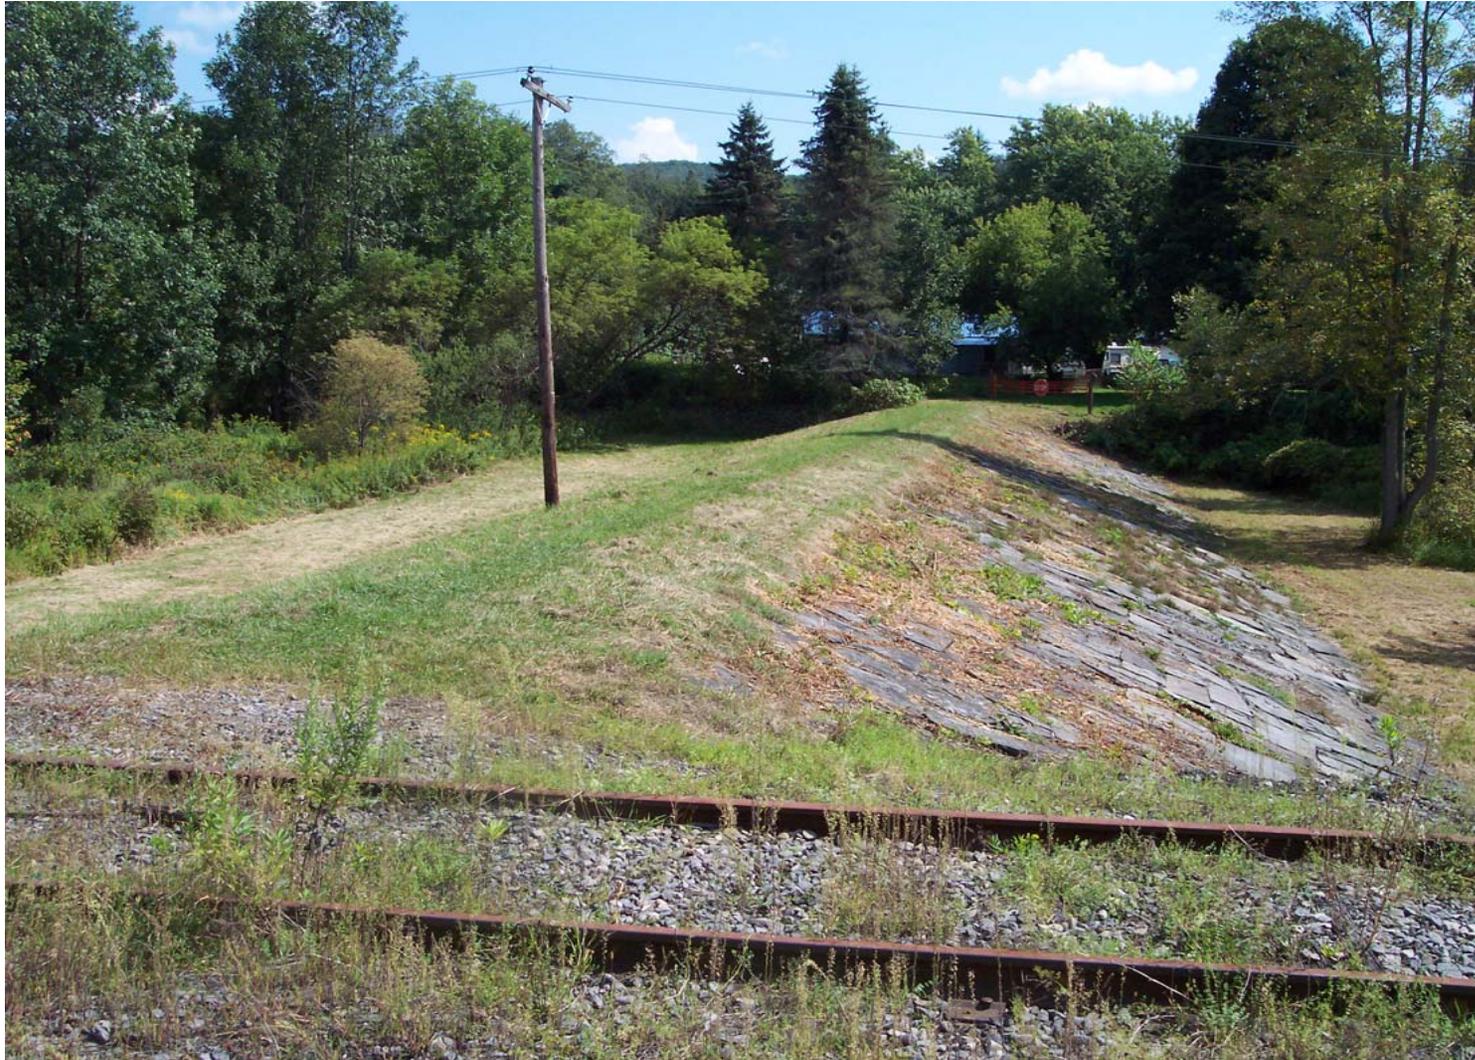
Inspect ID: OXFR_2008_a_0001 **Name:** Levee Embankment **Caption:** Upstream levy tie-in with riprap on landside of levee.

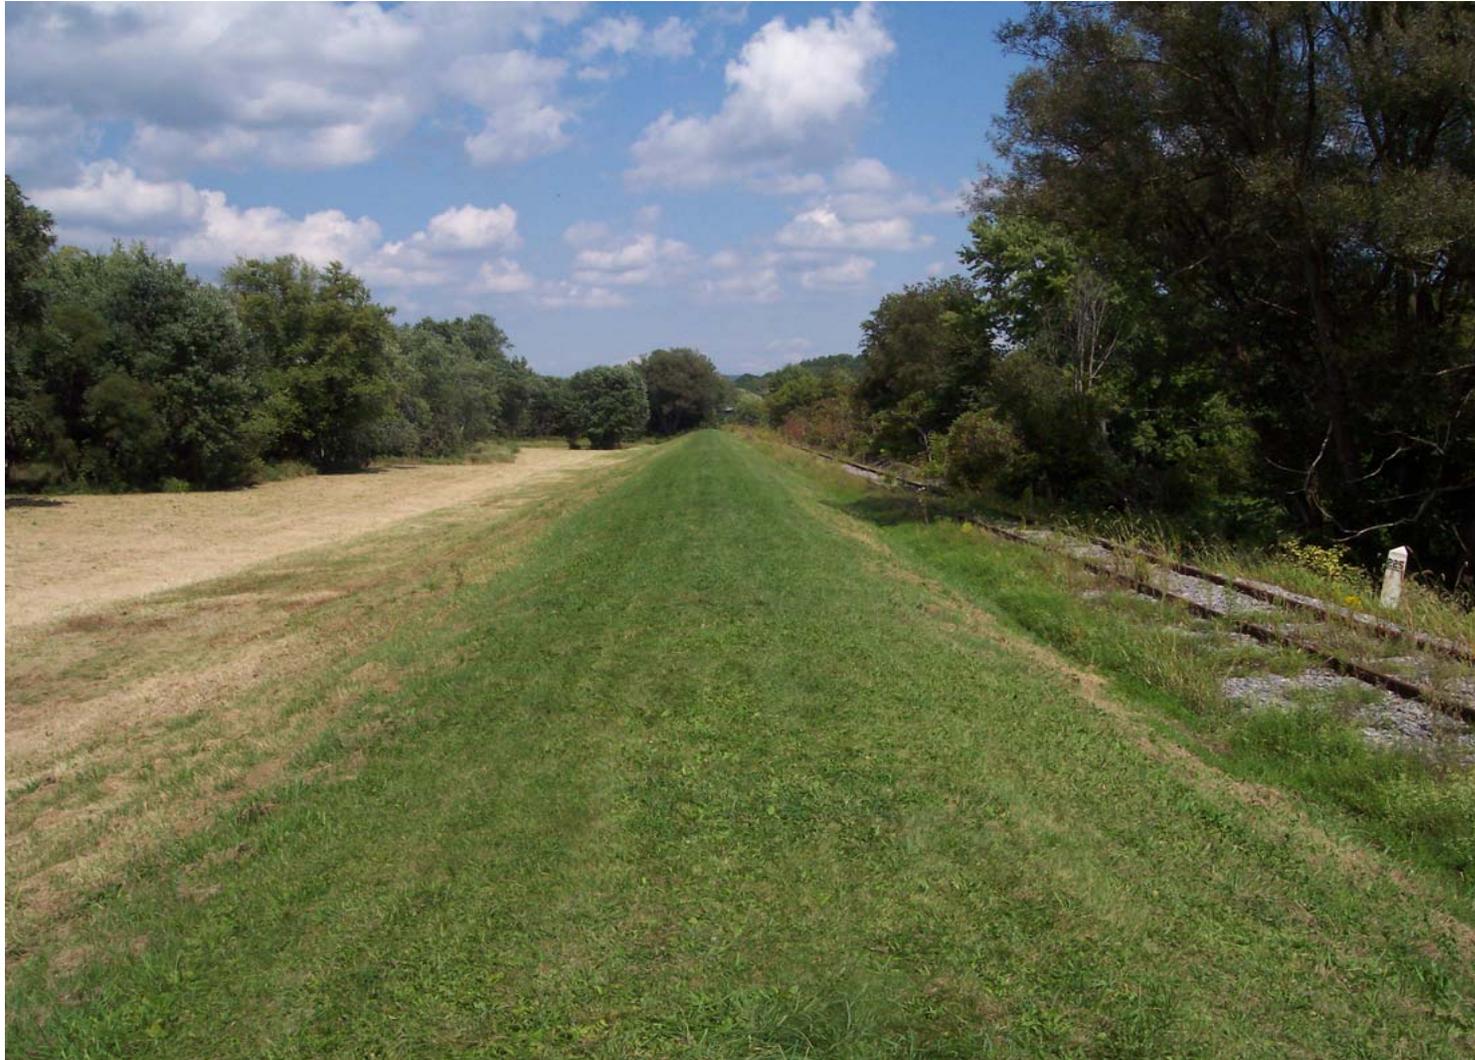
Inspect ID: OXFR_2008_a_0001 **Name:** Levee Embankment **Caption:** Typical Levee Embankment

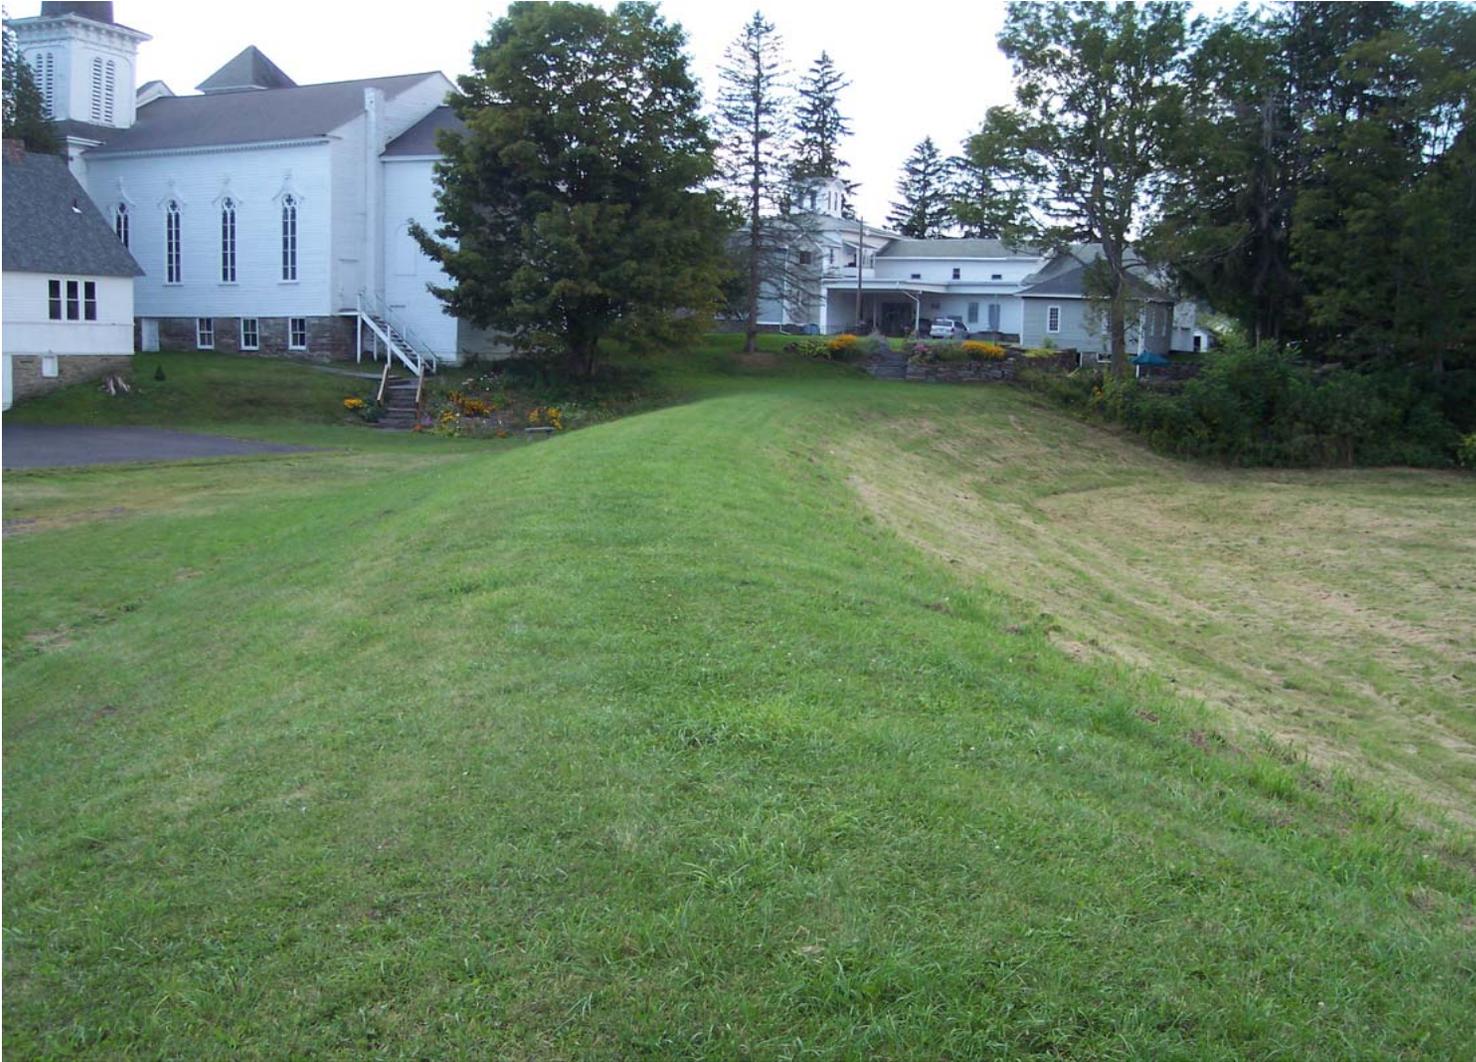
Inspect ID: OXFR_2008_a_0001 **Name:** Levee Embankment **Caption:** Downstream levee tie-in.

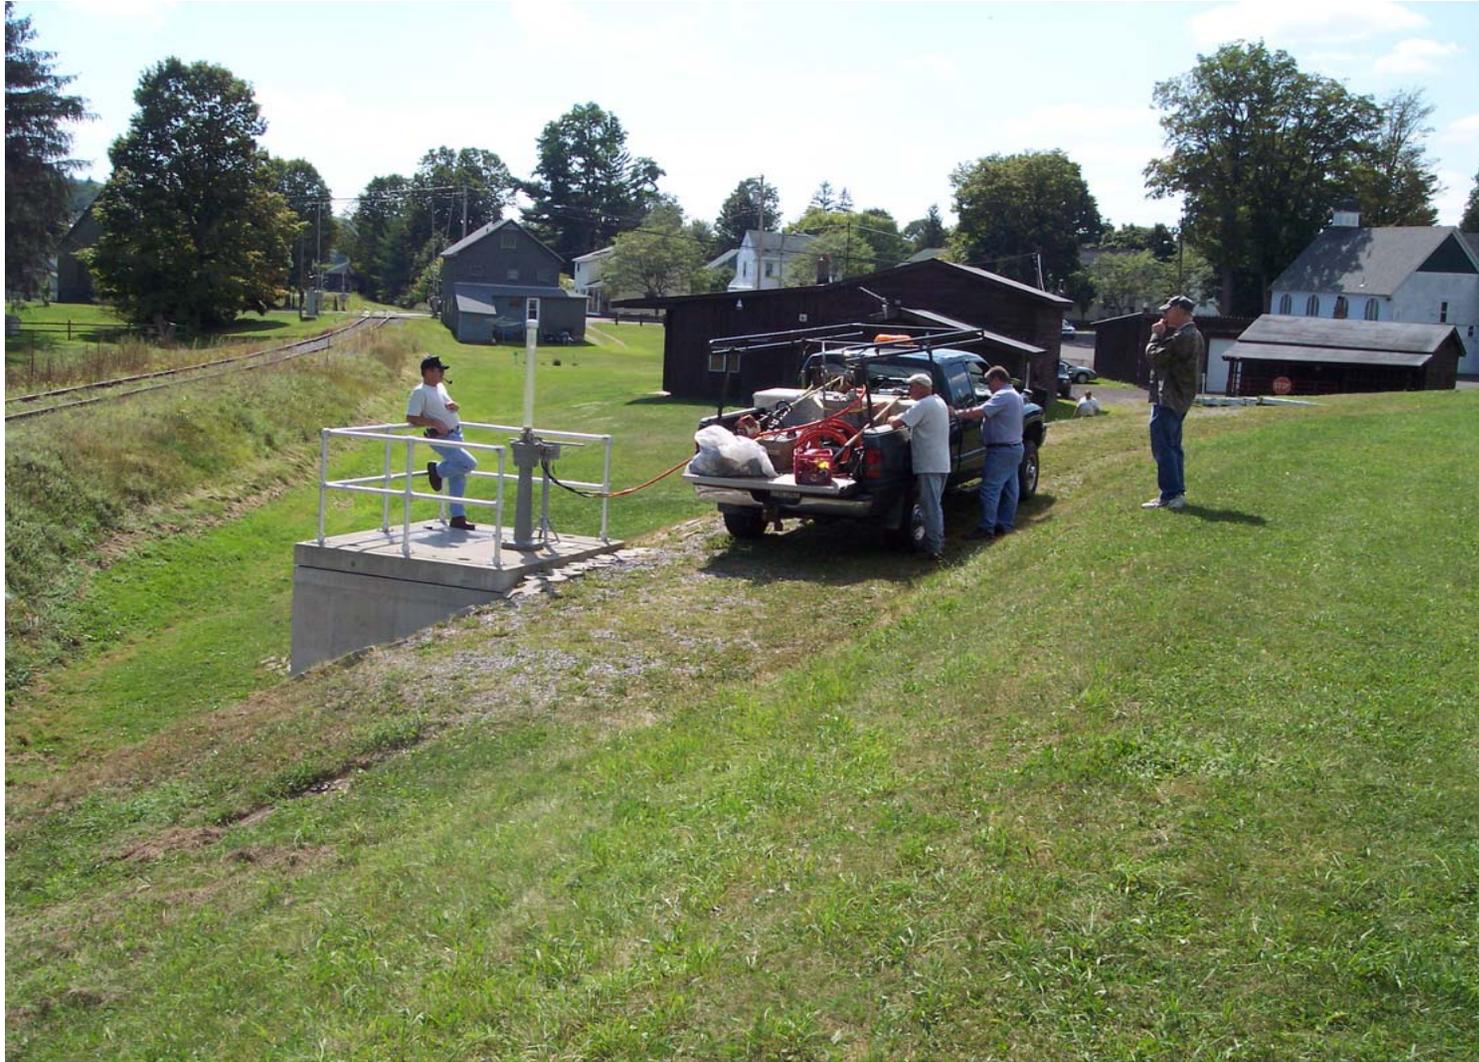
Inspect ID: OXFR_2008_a_0001 **Name:** Interior Drainage System **Caption:** Sluice Gate Being Operated

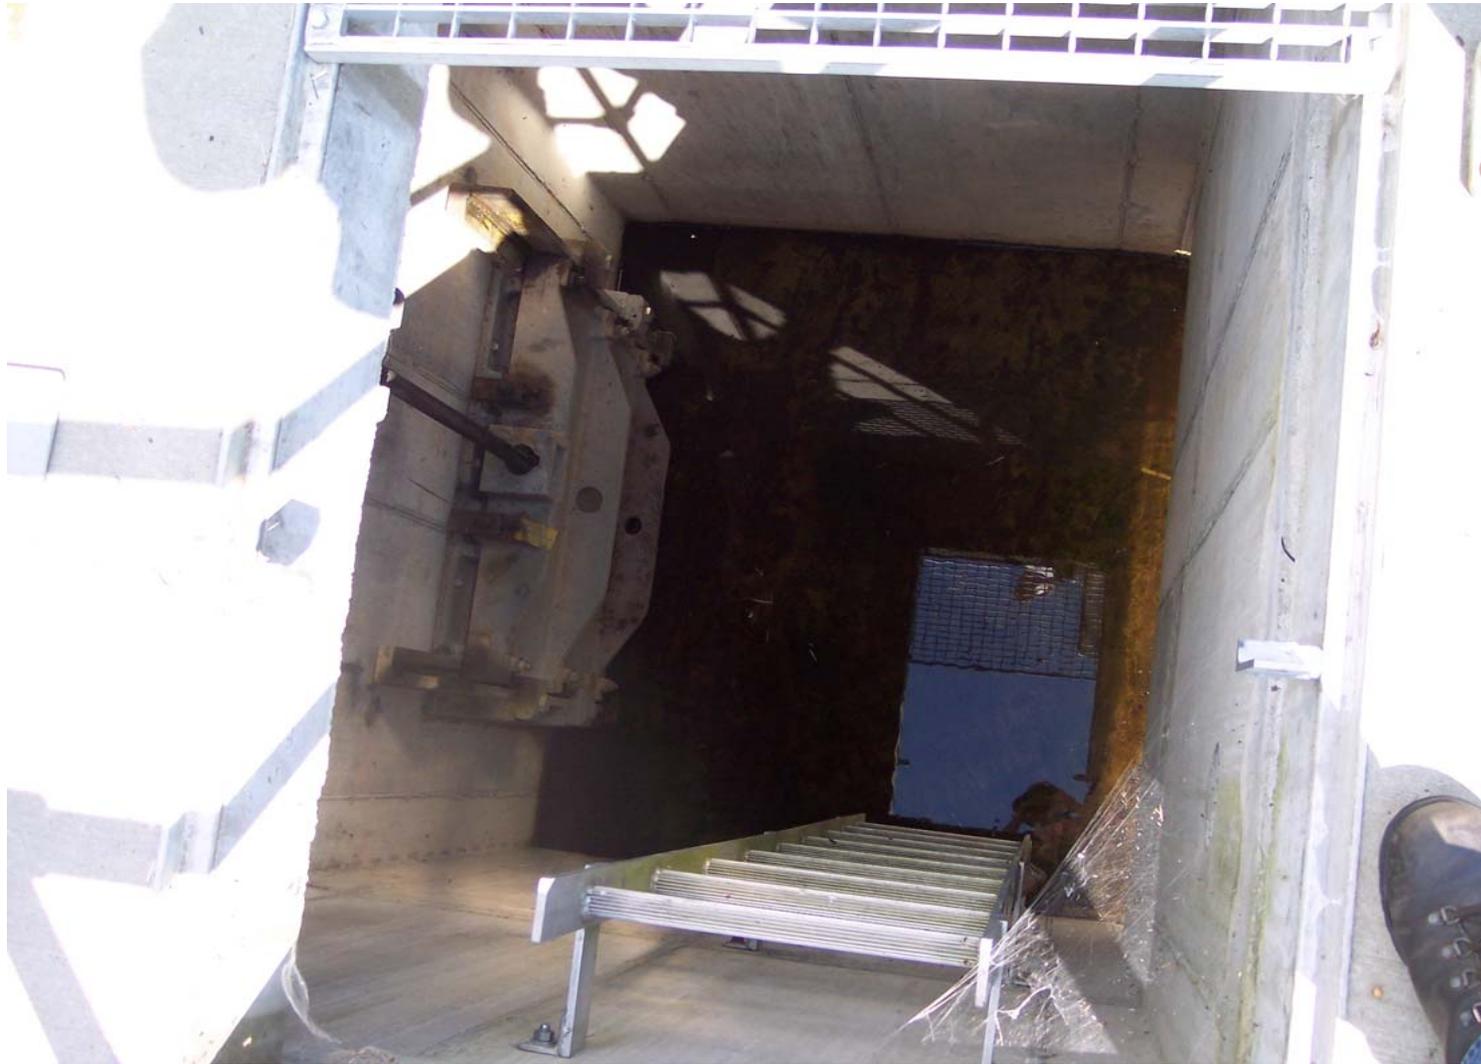
Inspect ID: OXFR_2008_a_0001 **Name:** Interior Drainage System **Caption:** View of sluice gate inside of drainage structure.
