2016 Third Quarter Groundwater Monitoring Report

Claremont Polychemical Corporation Site

Contract/WA No. D007625-19; Site No. 130015

October 31, 2016

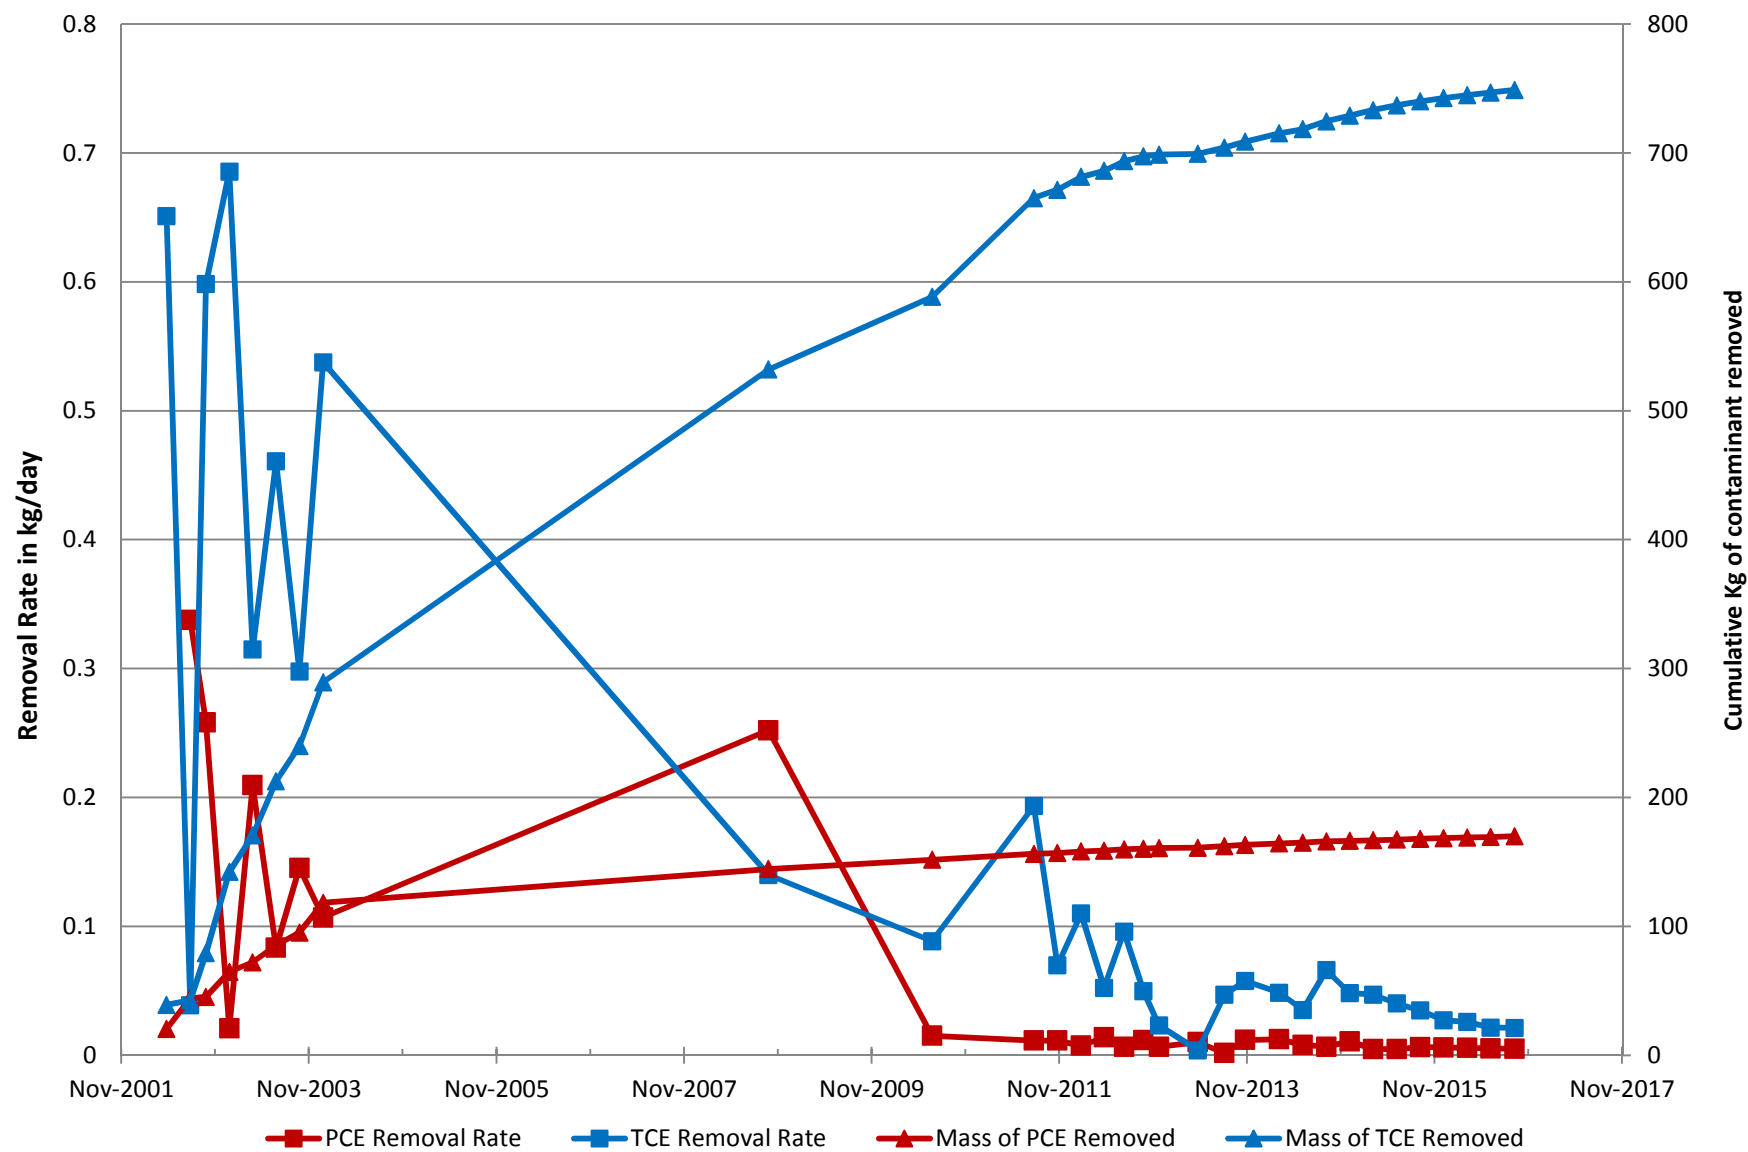
Figure 5

VOC Removal vs Time (PCE, TCE)

To evaluate the treatment system's contaminant influent removal rate, HDR reviewed available GWET system influent and effluent analytical results from monthly operation and maintenance records. Approximately 947 kilograms (2,087 pounds) of VOCs have been removed to date. Mass removal peaked in 2003 at 289 kilograms and in 2015 was 16 kilograms. Cumulatively, most of the mass removed has been TCE (749 kilograms) and PCE (170 kilograms). A plot of historic mass removal rates and cumulative PCE and TCE mass removal is presented as Figure 5.

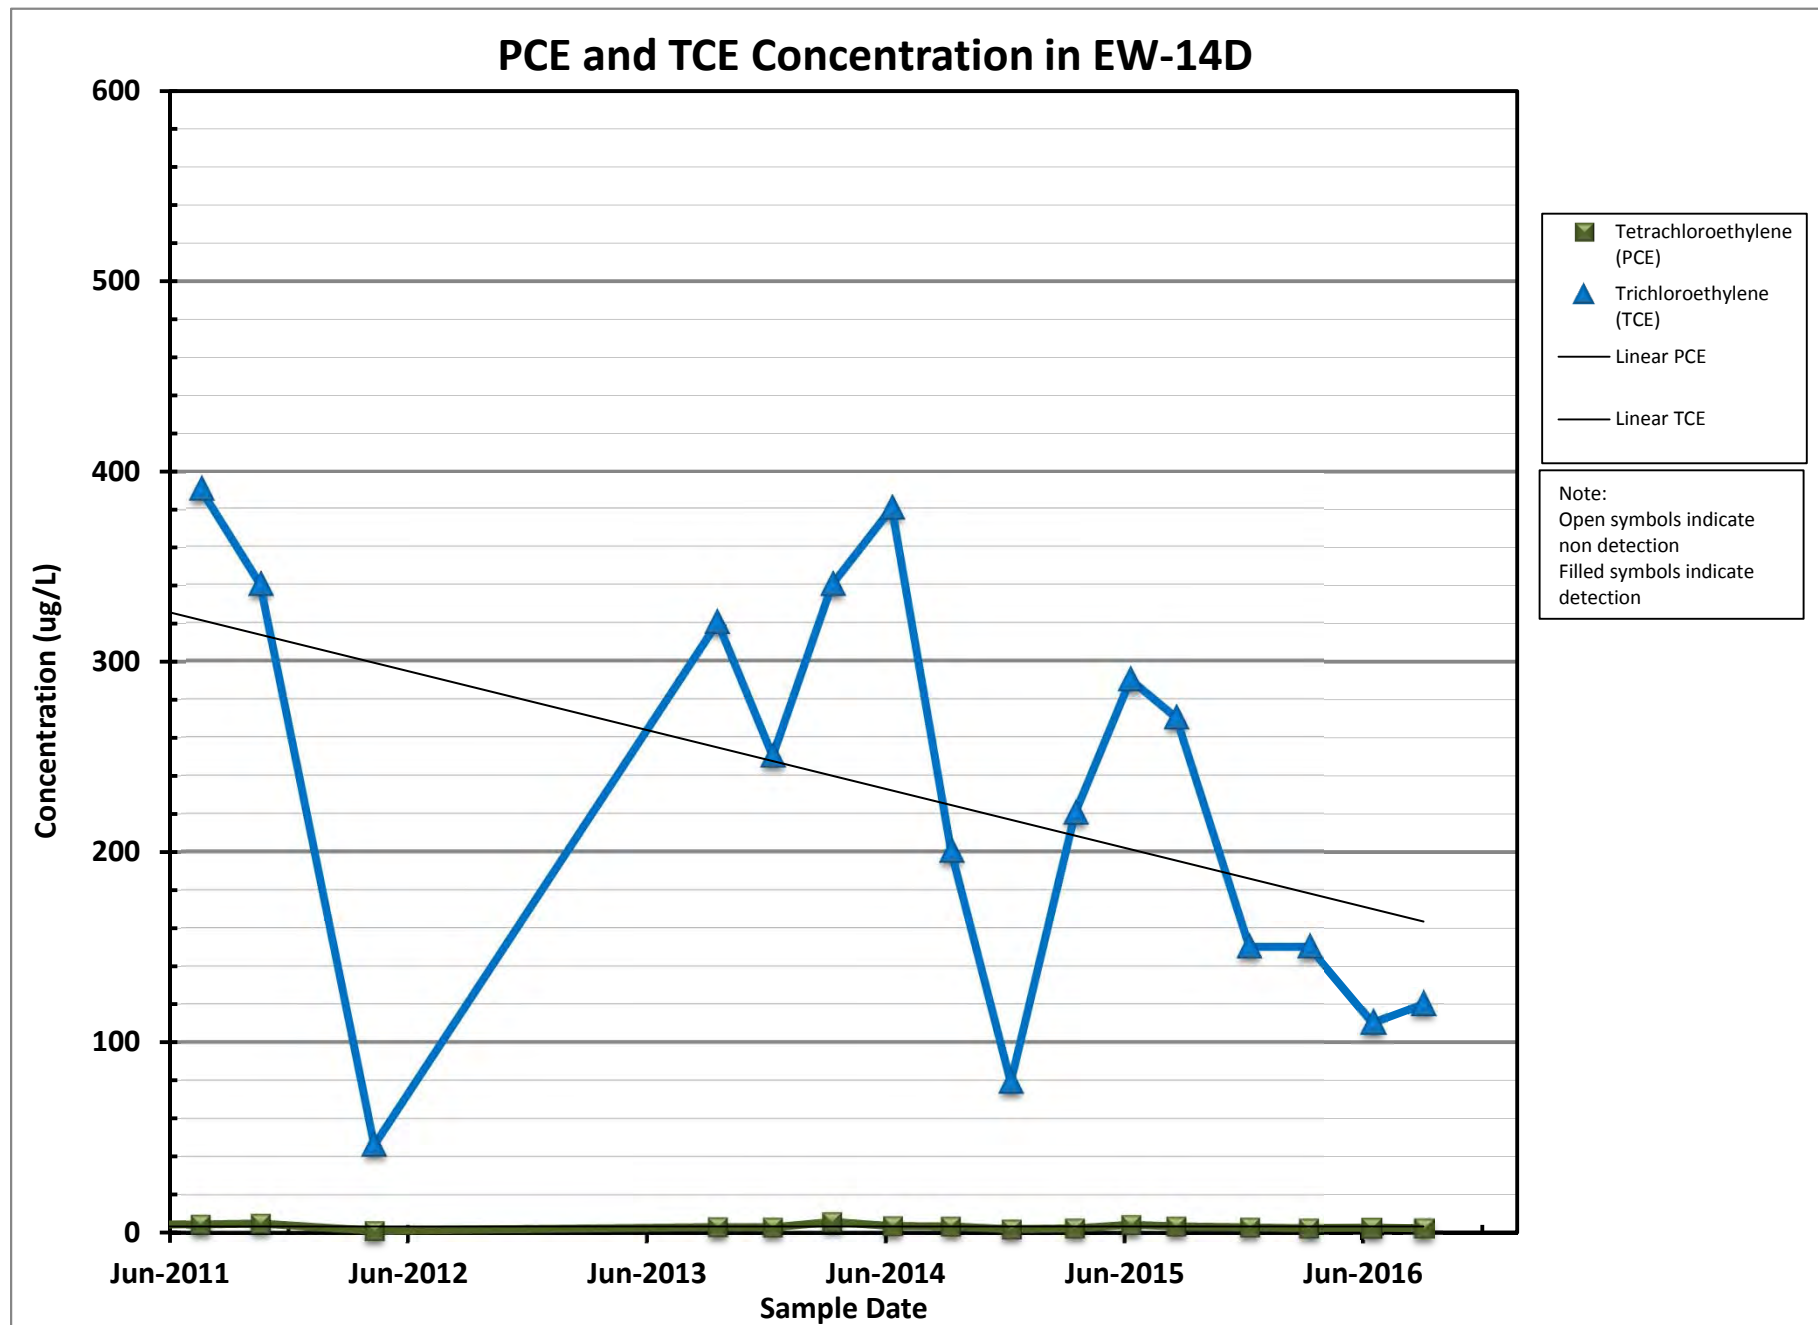
Figure 20

Well EW-14D. The groundwater contamination at EW-14D is high in TCE, similar to the off-site, upgradient plume (Figure 26). The PCE concentration, however, is below the criterion. Well EW-14D has the greatest variability in TCE concentrations of all of the wells evaluated for contaminant concentration trends. In the past year, TCE concentrations have been decreasing with the exception of the third quarter with a slight increase (Figure 20).

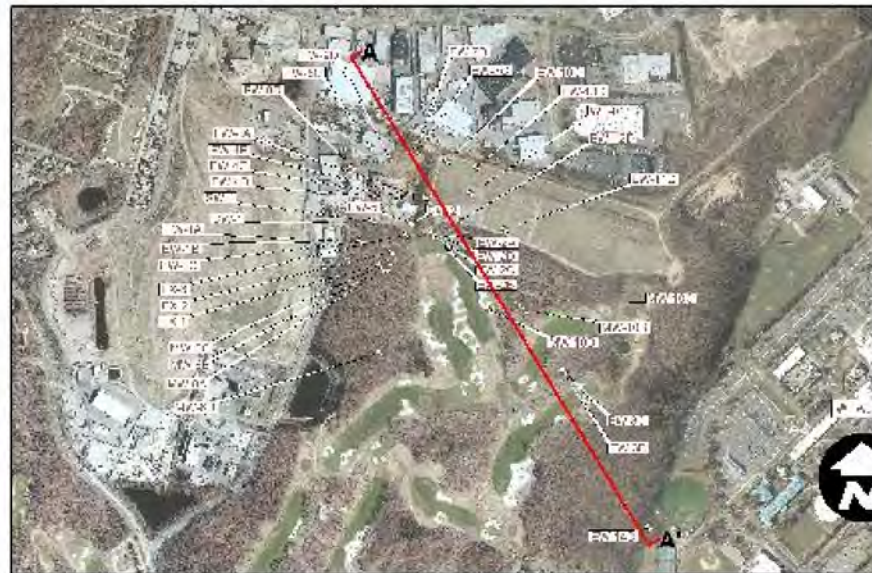
Figures 27, 28 and 29 depict PCE concentrations in wells to the east, center, and to the west of the Site and show the vertical extent of PCE. PCE was detected at 14 µg/L at 198 feet bgs in EW-7C (Figure 27, Cross Section A – A'); 9.3 µg/L at 291 feet bgs at EW-4D (Figure 28, Cross Section B – B'); and 93 µg/L at 70 feet bgs at well SW-1 (Figure 29, Cross Section C – C').

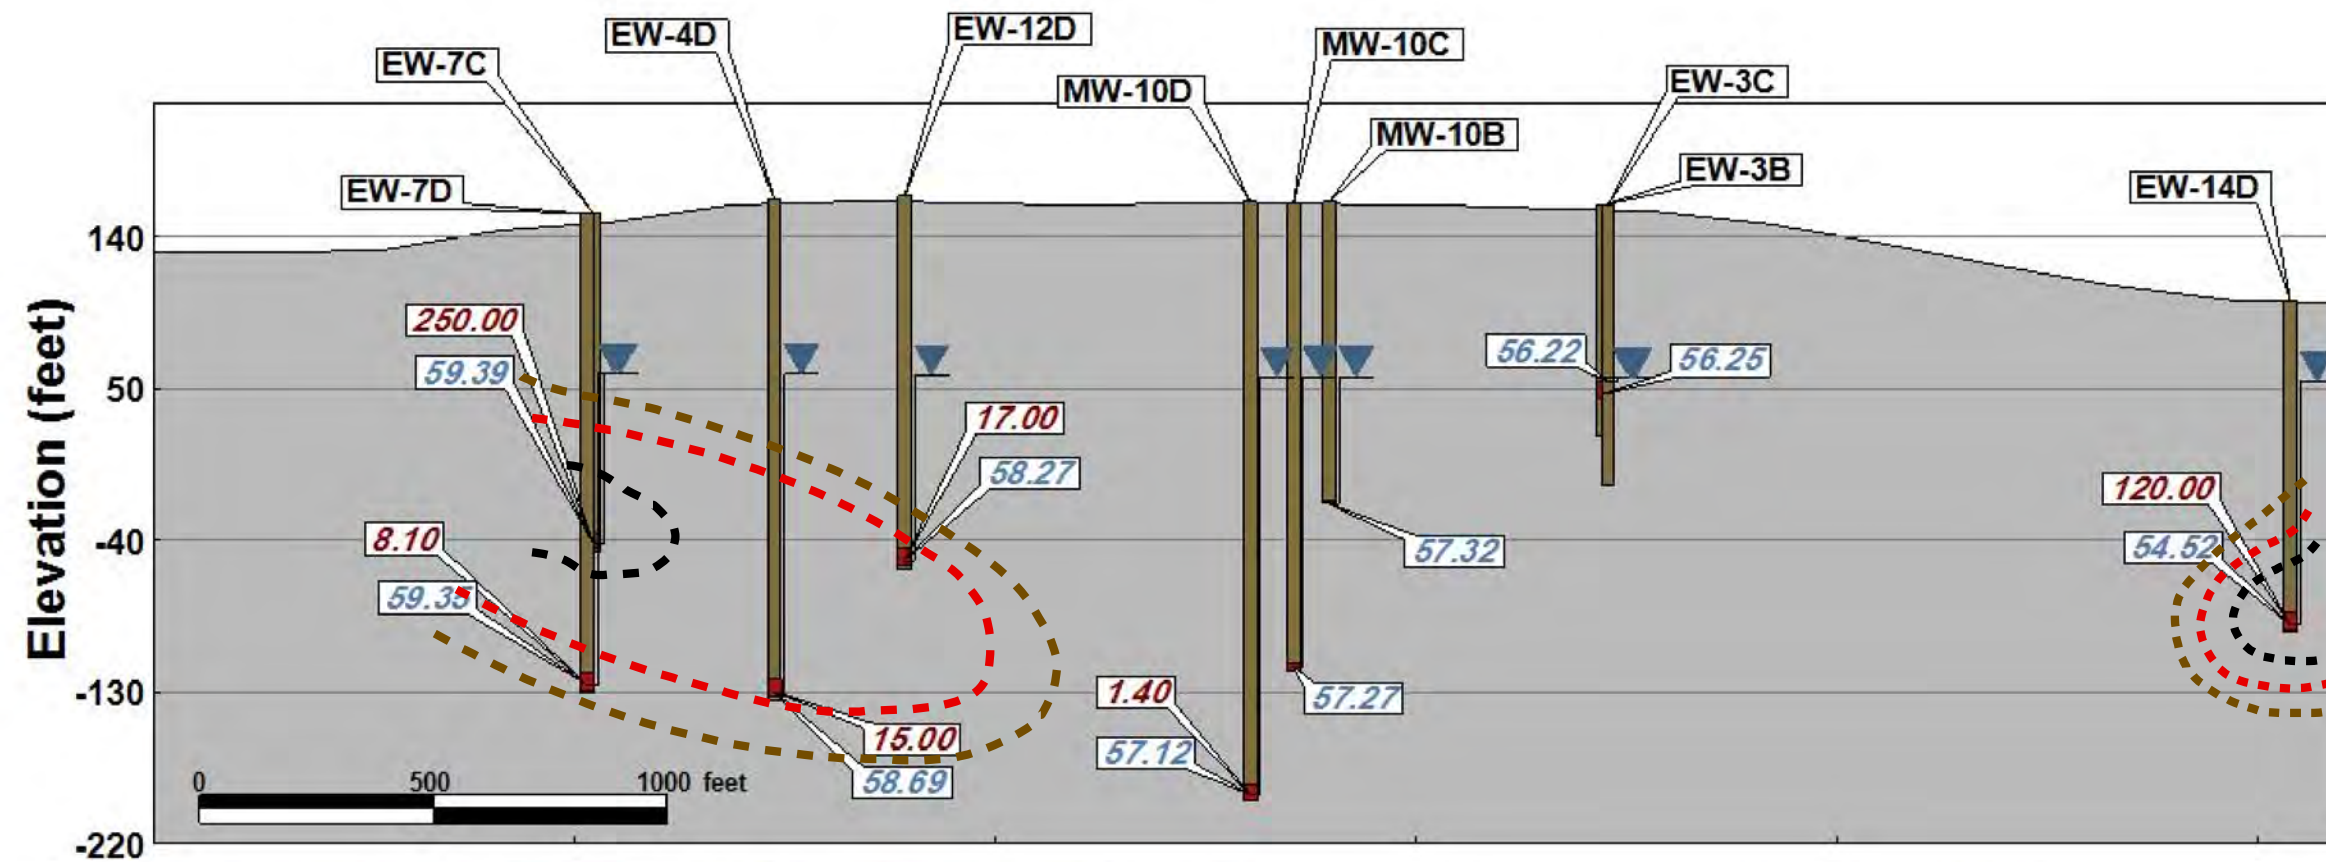
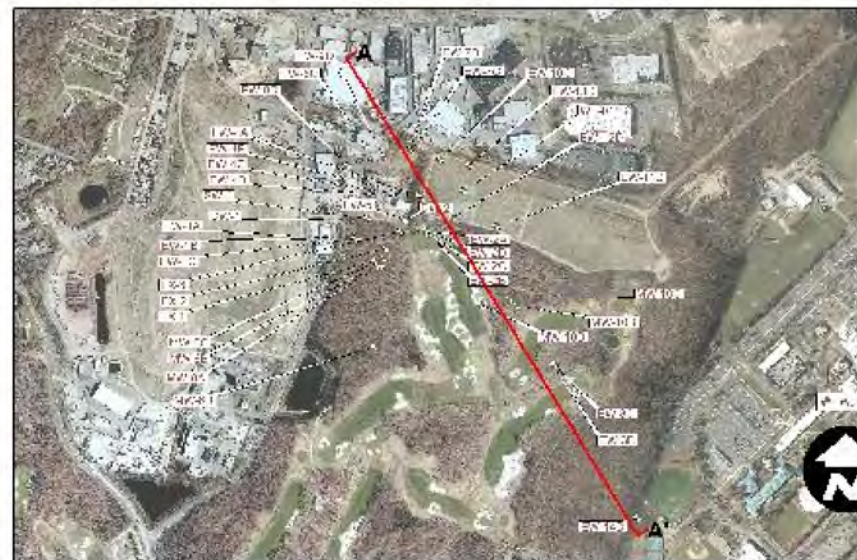
Figures 30 and 31 depict TCE concentrations in wells to the east and west of the Site and show the vertical extent of TCE. TCE was detected at 250 µg/L at 198 feet bgs at well EW-7C and 120 µg/L at 191 feet bgs at well EW-14D (Figure 30, Cross Section A – A'). TCE was detected at 4.7 µg/L at 70 feet bgs at well SW-1 (Figure 31, Cross Section B – B').
