PHASE II REMEDIAL INVESTIGATION REPORT
(VOLUME 2 OF 3: APPENDICES A, B & C)

PALL CORPORATION
30 SEA CLIFF AVENUE
GLEN COVE, NEW YORK

Enviro-Sciences, Inc.
312 East Main Street
Patchogue, New York 11772
(631) 207-9005

July 13, 2000

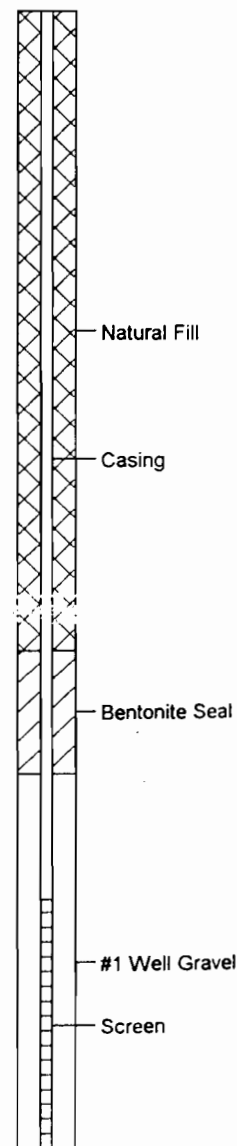
Depth in ft	Surf. Elev.	USCS	GRAPHIC	DESCRIPTION	Blow Count	% Rec- overy	PID	Well: MW-1GD Elev.:
50	-50	SP		Gravelly sand, light brown, fine to coarse sand, some clay	22 43 50		0.1	
52	-52							
54	-54							
56	-56							
58	-58							
60	-60	SM		Sandy silt, fine to medium sand, brown	30		0.1	
62	-62	ML		Sandy silt, fine to medium sand, brown	50-31			
64	-64							
66	-66							
68	-68							
70	-70	SM		Silty sand, brown, fine to medium grained	22 43 42		0.1	
72	-72							
74	-74							
76	-76	SP		Silty sand, brown, fine to medium grained	18 47 50-31		0.1	
78	-78							
80	-80	SM		Silty sand, light brown, fine to medium grained	22 40 44 39		0.0	
82	-82							
84	-84							
86	-86	SP		Sand, light brown, fine to coarse grained	10 27 30		0.0	
88	-88							
90	-90	SP		Sand, light brown, fine to coarse grained	22 43 50-51		0.0	
92	-92							
94	-94							
96	-96	SM		Silty sand, light brown, fine to medium grained	18 40 50-41		0.0

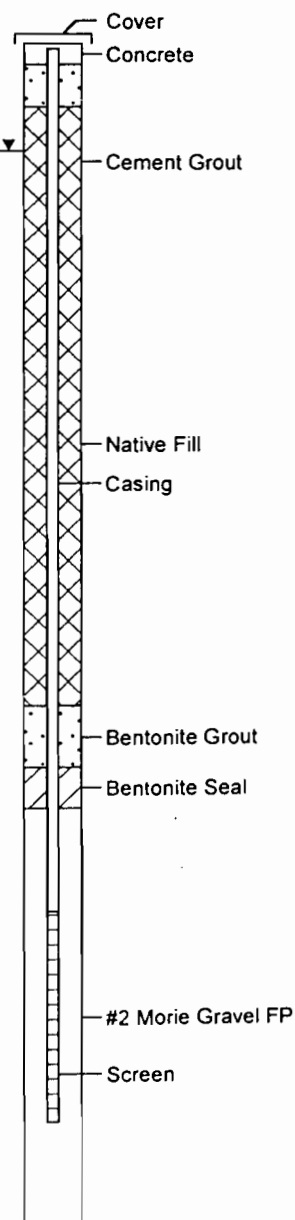
Well: MW-1PI
 Elev.: 87.64

32	56							
34	54							
36	52	CL		Light gray clay of medium plasticity, no rocks/pebbles. No odor	142	45	0.0	
38	50							
40	48	ML		Saturated, light brown, silty clay w/ some fine grained sands. No odor. No rocks/pebbles.	134	45	0.0	
42	46							
44	44							
46	42	CL		Saturated, light brown clay. No rocks/pebbles. No odor	41	50	0.0	
48	40	ML		Saturated, silty clay w/ fine sand. No rocks/pebbles. No odor				
50	38							
52	36	CL		Saturated, light brown-gray clay of medium to low plasticity. No rocks/pebbles. No odor	21	45	0.0	
54	34							
56	32	SM		Saturated, silty sand, light brown w/ no rocks/pebbles.	82	40	0.0	
58	30							
60

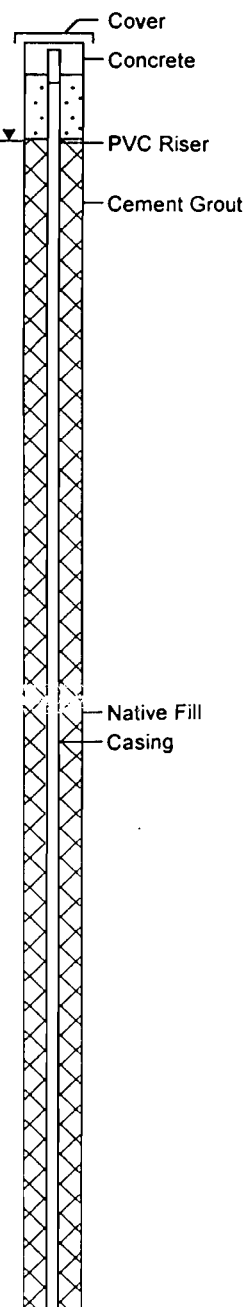
Well: MW-4PD
 Elev.: 84.97

34	51							
36	49	SW		Saturated, light brown sand, fine to medium grained. No rocks/pebbles. No odor	62	55	0.0	
38	47							
40

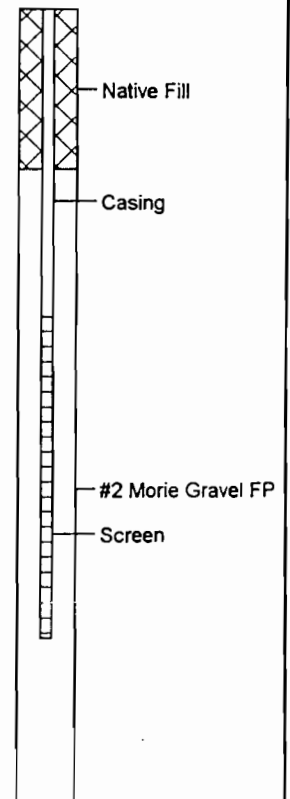
Well: MW-6PD
Elev.: 87.64

Saturated, light brown-gray w/ some redish color, clay sand, no rocks/pebbles, not odor	60	40	0.0	
108	-19							
110	-21							
112	-23							
114	-25							
116	-27							
118	-29							
120

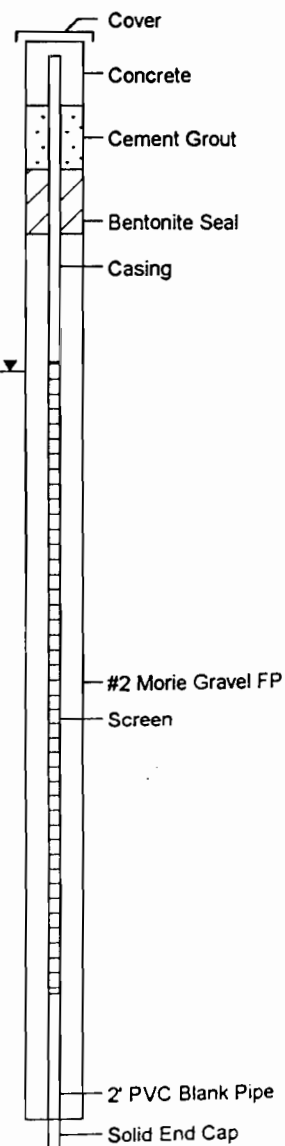
Well: MW-8PS
Elev.: 88.51

Depth in ft	Surf. Elev. 88.51	USCS	GRAPHIC	DESCRIPTION	Blow Count	% Rec- overy	PID
0	88			Hand digging, dark brown, fine grained silty sand w/ trace small rocks/pebbles, no odor			
2	86	SM					0.0
4	84						
6	82	SM		Saturated, dark brown silt w/ fine grained sand, trace small rocks/pebbles, no odor	21	50	0.0
8	80						
10	78	SP		Saturated, light brown, fine grained sand with a little amount of small rocks/pebbles, no odor	49	70	0.0
12	76						
14	74	SW		Saturated, light brown, medium grained sand w/ some small rocks, no odor	41	60	0.0
16	72						
18	70						
20

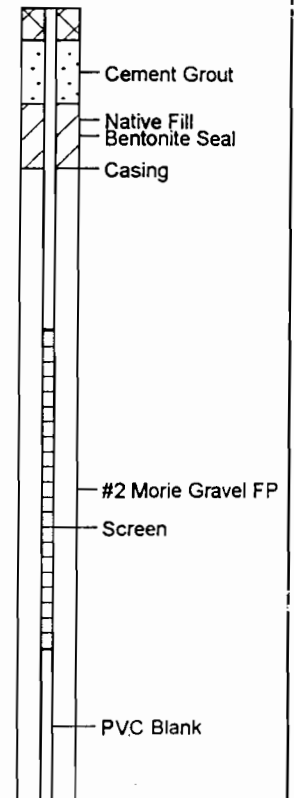
Well: MW-10PD
Elev.: 84.31

Saturated, light gray, medium grained sand. No rocks/pebbles. No odor	109	75	0.0
108	-24						
110	-26						
112	-28						
114	-30						
116	-32						
118	-34						
120

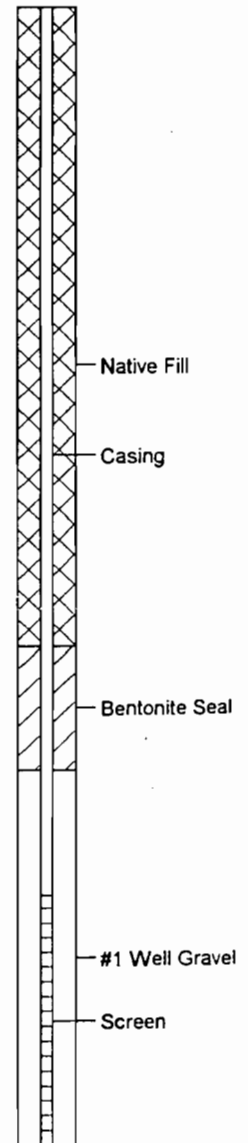
Depth in Feet	Surf. Elev.	USCS	GRAPHIC	DESCRIPTION	Blow Count	% Rec- overy	PID (ppm)	Well: MW-11PD Elev.:
50		SC		Clayey sand, brown, fine to medium grained sand, dense	24		0.5	
52					31			
54		SC		Clayey sand, brown, fine to medium grained, trace gravel, very dense	17		0.3	
56					55			
58								
60		SC		Clayey sand, brown, fine to medium grained, no gravel, dense	13		0.1	
62					26			
64								
66		SP		Gravelly sand, brown, fine to coarse sand, some clay, medium dense	16		0.4	
68					19			
70		SC		Clayey sand, brown, fine coarse, some gravel, dense	13		0.3	
72					25			
74								
76		SP		Sand, brown, fine to medium grained, little gravel and clay, dense	12		0.0	
78					36			
80		SP		Sand, light gray to off-white, fine to medium grained, dense	14		0.7	
82					23			
84					22			
86		SP		Sand, light brown to light reddish, fine to medium grained, dense	18		2.7	
88					23			
90		SP		Sand, light brown, fine to medium grained, dense	11		6.4

92					26			
94					40			
96		SP		Sand, light brown, fine to medium grained, dense	15		1.1	
98					50			
00

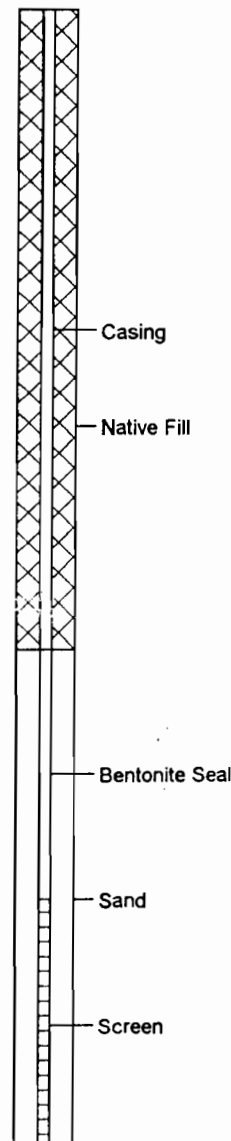
Depth in Feet	Surf. Elev.	USCS	GRAPHIC	DESCRIPTION	Blow Count	% Rec- overy	PID (ppm)	Well: MW-12PD Elev.:
50		SM		Silty sand, brown, fine to medium grained sand, medium dense	10 25		5.8	
52								
54								
56		SC CL		Silty clay, medium brown, very stiff, some sand	8 23		1.4	
58								
60		SM		Silty sand, brown, fine to medium grained, medium dense	8 25		0.6	
62								
64								
66		SP		Gravelly sand, brown, medium to coarse grained, loose	6 25		0.0	
68								
70		SM		Silty sand, brown, fine to medium grained, loose	6 25		0.2	
72								
74								
76		SP		Gravelly sand, light brown, medium to coarse grained, medium dense	6 27		0.0	
78								
80		SC		Sandy, light brown to light gray, fine grained sand, very stiff	10 32		0.0	
82								
84								
86		SC		Sand, gray, fine to medium grained, loose	8 20		0.0	
88								
90		SP		Clayey sand, gray, fine to medium sand, dense	2 5		0.8	
92								
94								
96		SC			8 20		0.8

98								
100

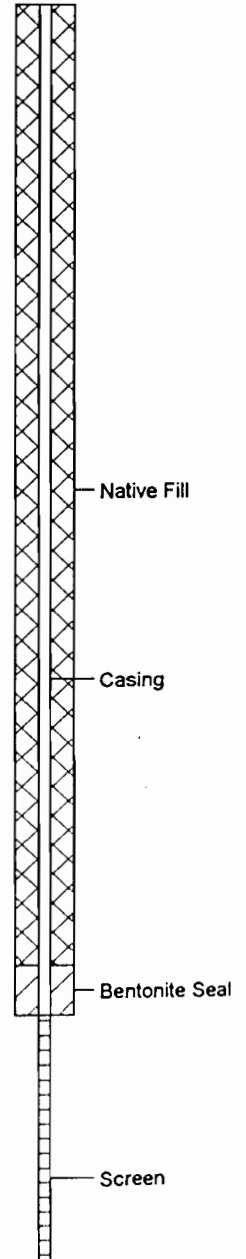
Top of Casing :
DTW :
Well Diameter : 2"
Material Construction : Sch. 40 PVC Flush Joint
Screen Slot Size : 0.020"

Depth in ft	Surf. Elev.	USCS	GRAPHIC	DESCRIPTION	Blow Count	% Rec- overy	PID	Well: MW-14PCD Elev.:
50	-50							
52	-52							
54	-54							
56	-56							
58	-58							
60	-60							
62	-62							
64	-64							
66	-66							
68	-68							
70	-70							
72	-72							
74	-74							
76	-76							
78	-78							
80	-80							
82	-82							
84	-84							
86	-86							
88	-88							
90	-90							
92	-92							
94	-94							
96	-96							
98	-98							
100
