RECORD OF DECISION

Former Garden Photoengraving Co., Inc.
Operable Unit Number 01: Source Area Remedial
Investigation
State Superfund Project
Mineola, Nassau County
Site No. 130174
March 2017

Prepared by
Division of Environmental Remediation
New York State Department of Environmental Conservation

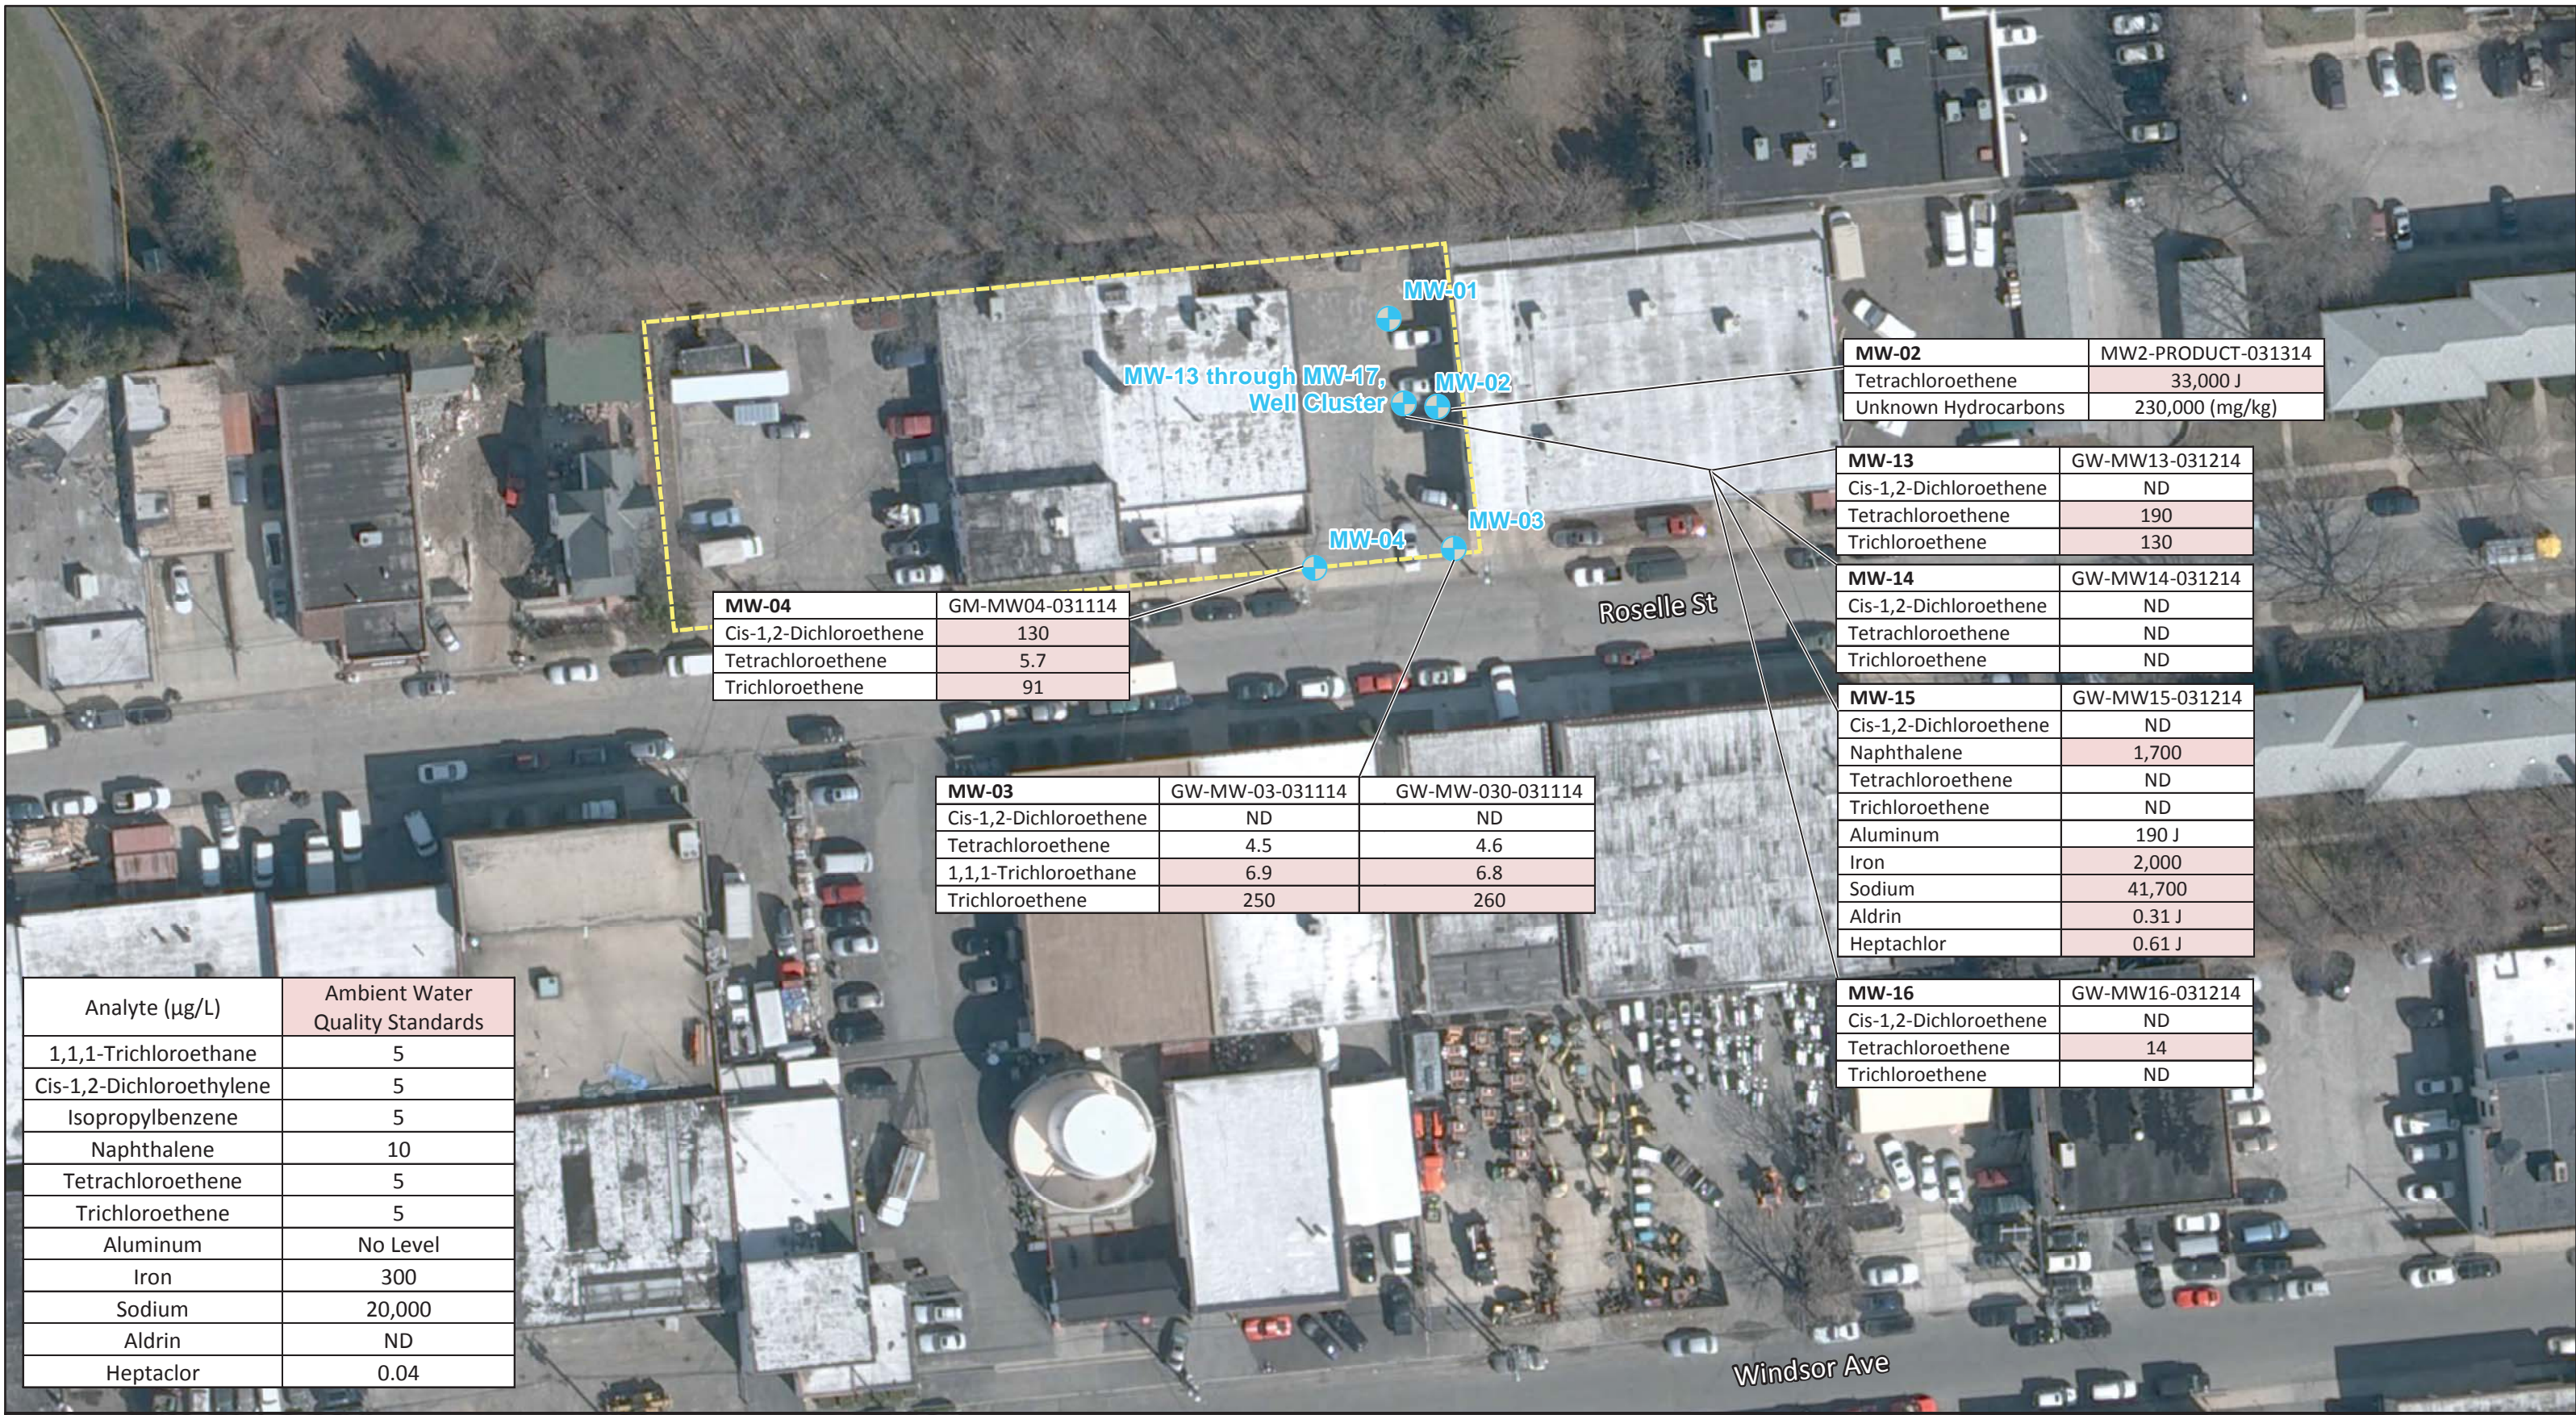
MW-02	MW2-PRODUCT-031314
Tetrachloroethene	33,000 J
Unknown Hydrocarbons	230,000 (mg/kg)

MW-13	GW-MW13-031214
Cis-1,2-Dichloroethene	ND
Tetrachloroethene	190
Trichloroethene	130

- Notes**
1. All results are in ug/L, unless otherwise noted.
 2. Results with light red fill have exceeded AWQS.
 3. ND - Non-Detect
 4. Depths refer to the bottom of the 5' screened interval.

There are no private wells in the vicinity of the site. There are two public supply wells approximately 2,500 ft downgradient of the site. Both wells have detections of similar compounds found at the site. It however, cannot be assumed that these are a result of migration from the site nor can it be ruled out at this point in time. This is being studied in the OU-2 investigation. The data for the first phase of groundwater sampling is show in Figure 2 and the second phase of groundwater sampling on Figure 3.

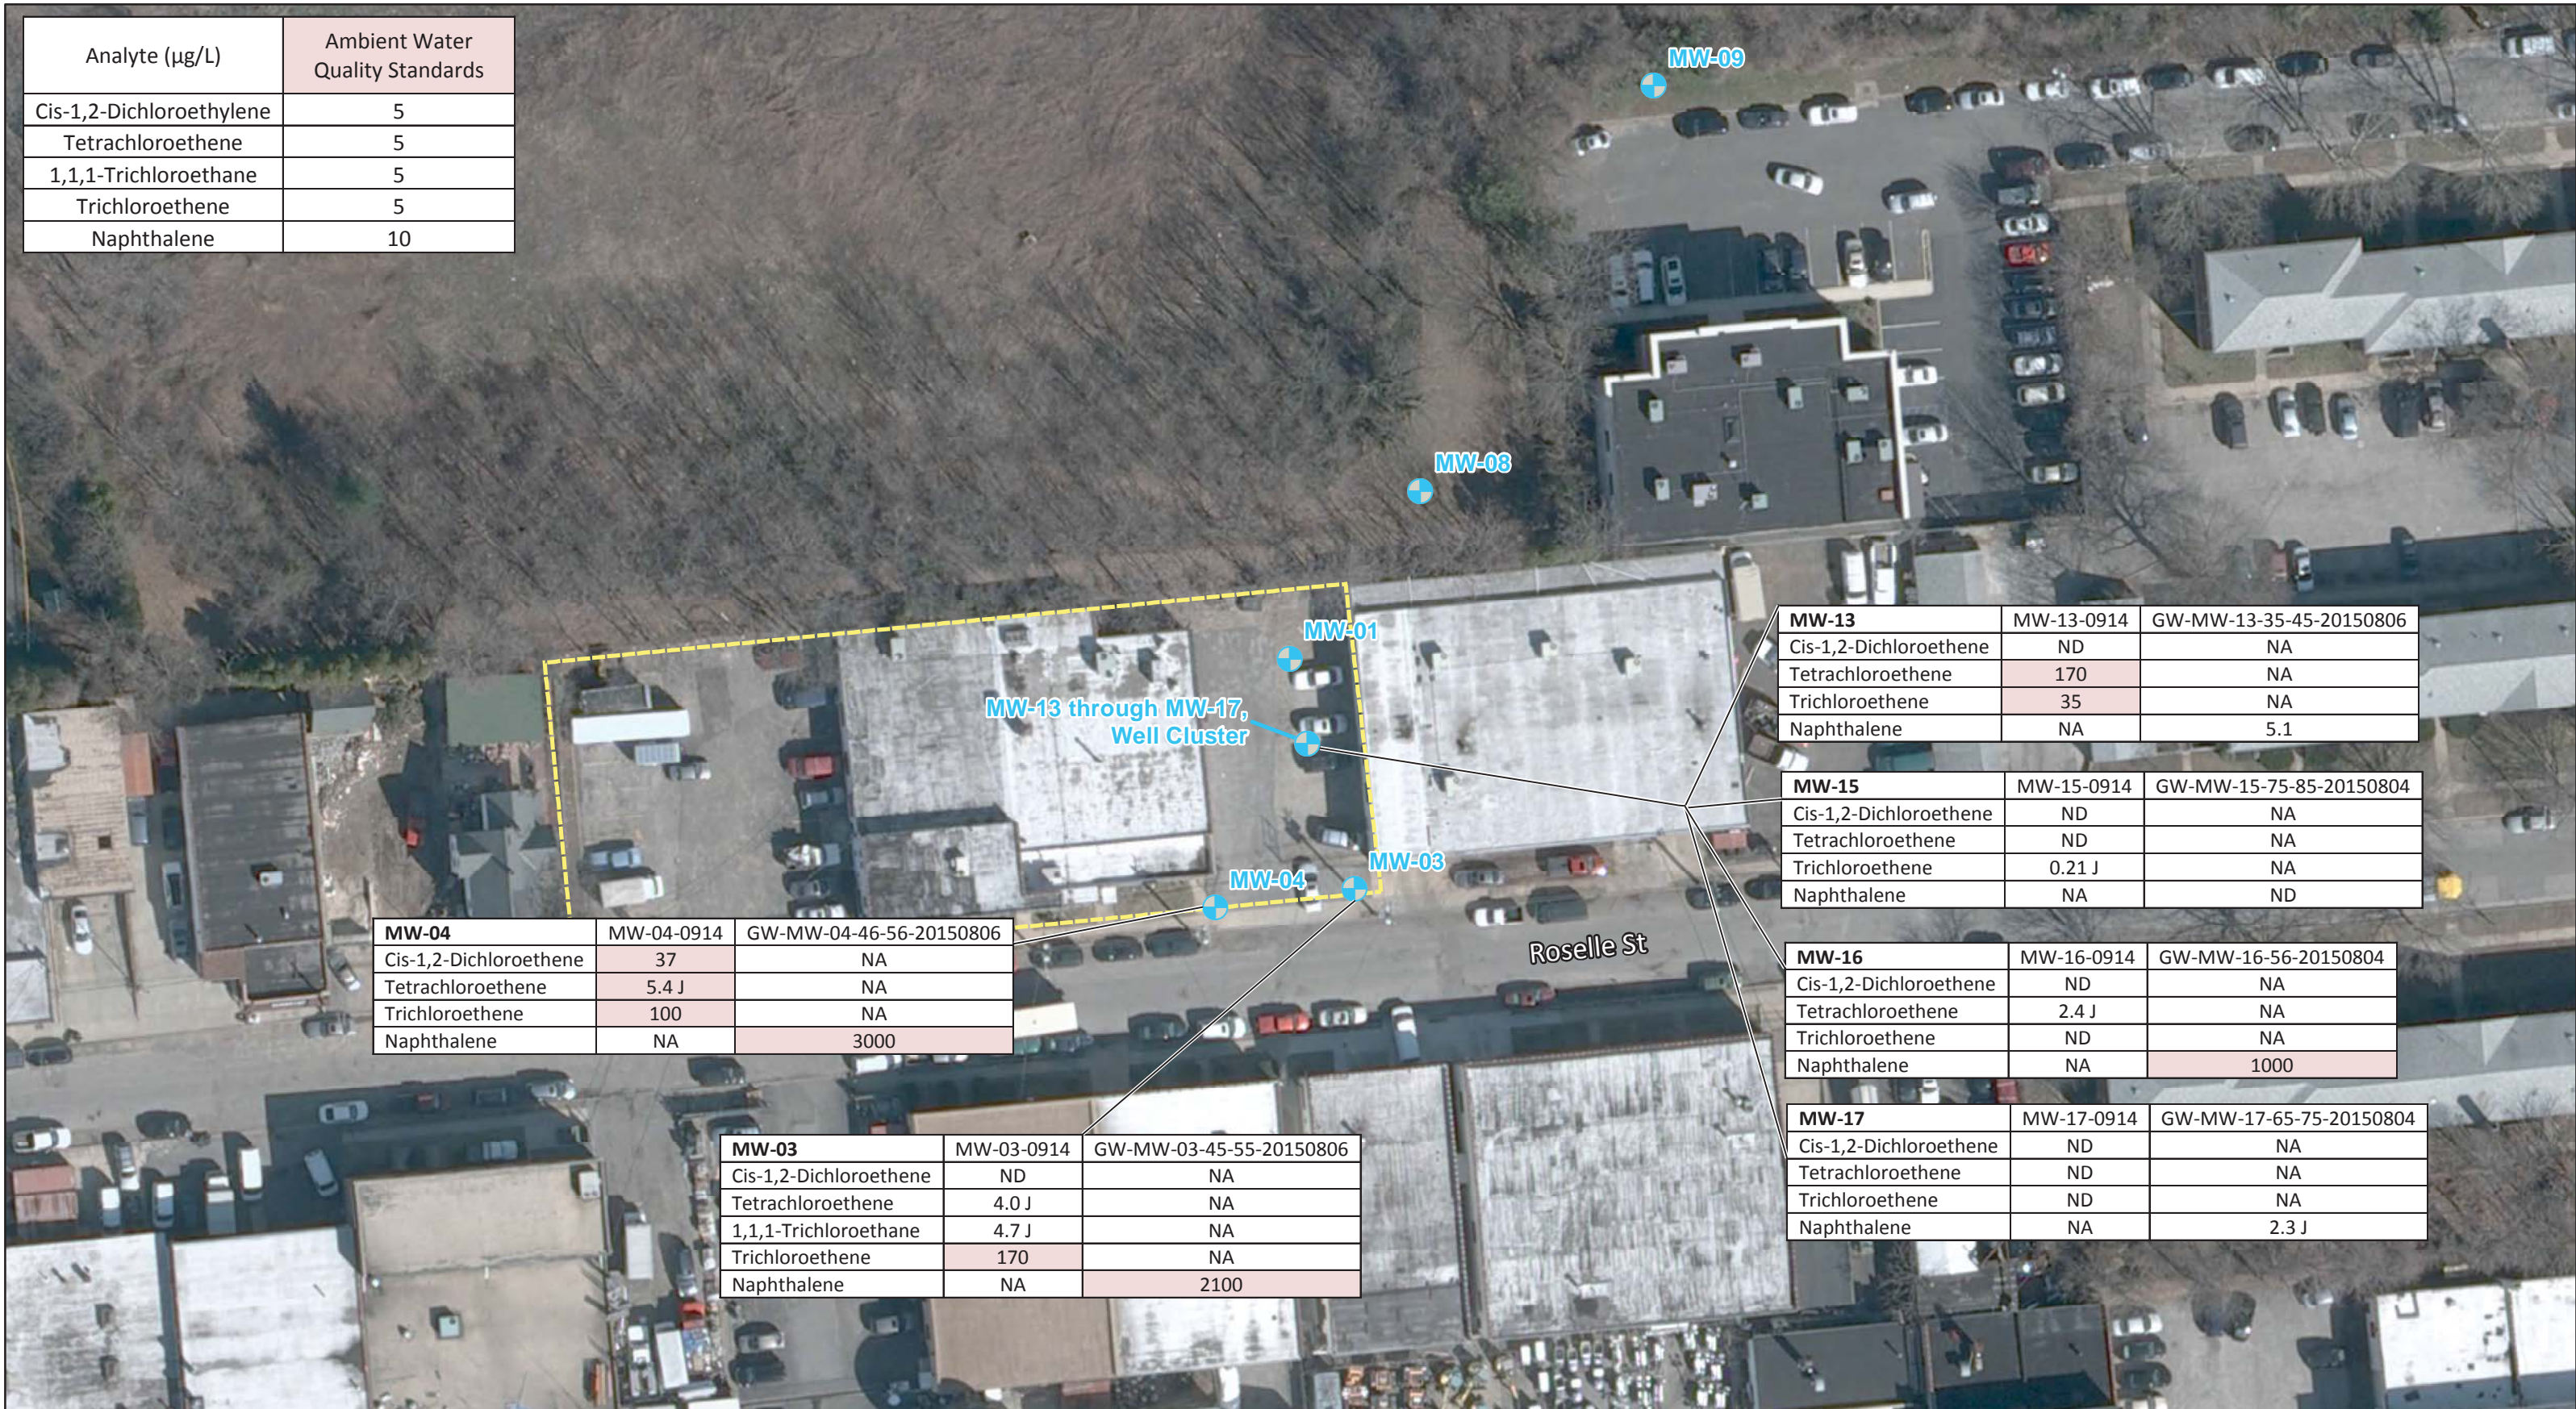
Former Garden Photoengraving
Mineola, NY
Figure 3

MW-04	MW-04-0914	GW-MW-04-46-56-20150806
Cis-1,2-Dichloroethene	37	NA
Tetrachloroethene	5.4 J	NA
Trichloroethene	100	NA
Naphthalene	NA	3000

MW-03	MW-03-0914	GW-MW-03-45-55-20150806
Cis-1,2-Dichloroethene	ND	NA
Tetrachloroethene	4.0 J	NA
1,1,1-Trichloroethane	4.7 J	NA
Trichloroethene	170	NA
Naphthalene	NA	2100

MW-16	MW-16-0914	GW-MW-16-56-20150804
Cis-1,2-Dichloroethene	ND	NA
Tetrachloroethene	2.4 J	NA
Trichloroethene	ND	NA
Naphthalene	NA	1000

MW-17	MW-17-0914	GW-MW-17-65-75-20150804
Cis-1,2-Dichloroethene	ND	NA
Tetrachloroethene	ND	NA
Trichloroethene	ND	NA
Naphthalene	NA	2.3 J

- Notes**
1. All results are in ug/L.
 2. Depths refer to the bottom of the 5' screened interval.
 3. ND - Non-Detect
 4. NA - Not Analyzed
 5. Results with light red fill have exceeded AWQS.
 6. Locations not indicated with an exceedance do not surpass AWQS.

Groundwater Sample Exceedances for VOCs and SVOCs – Phase II

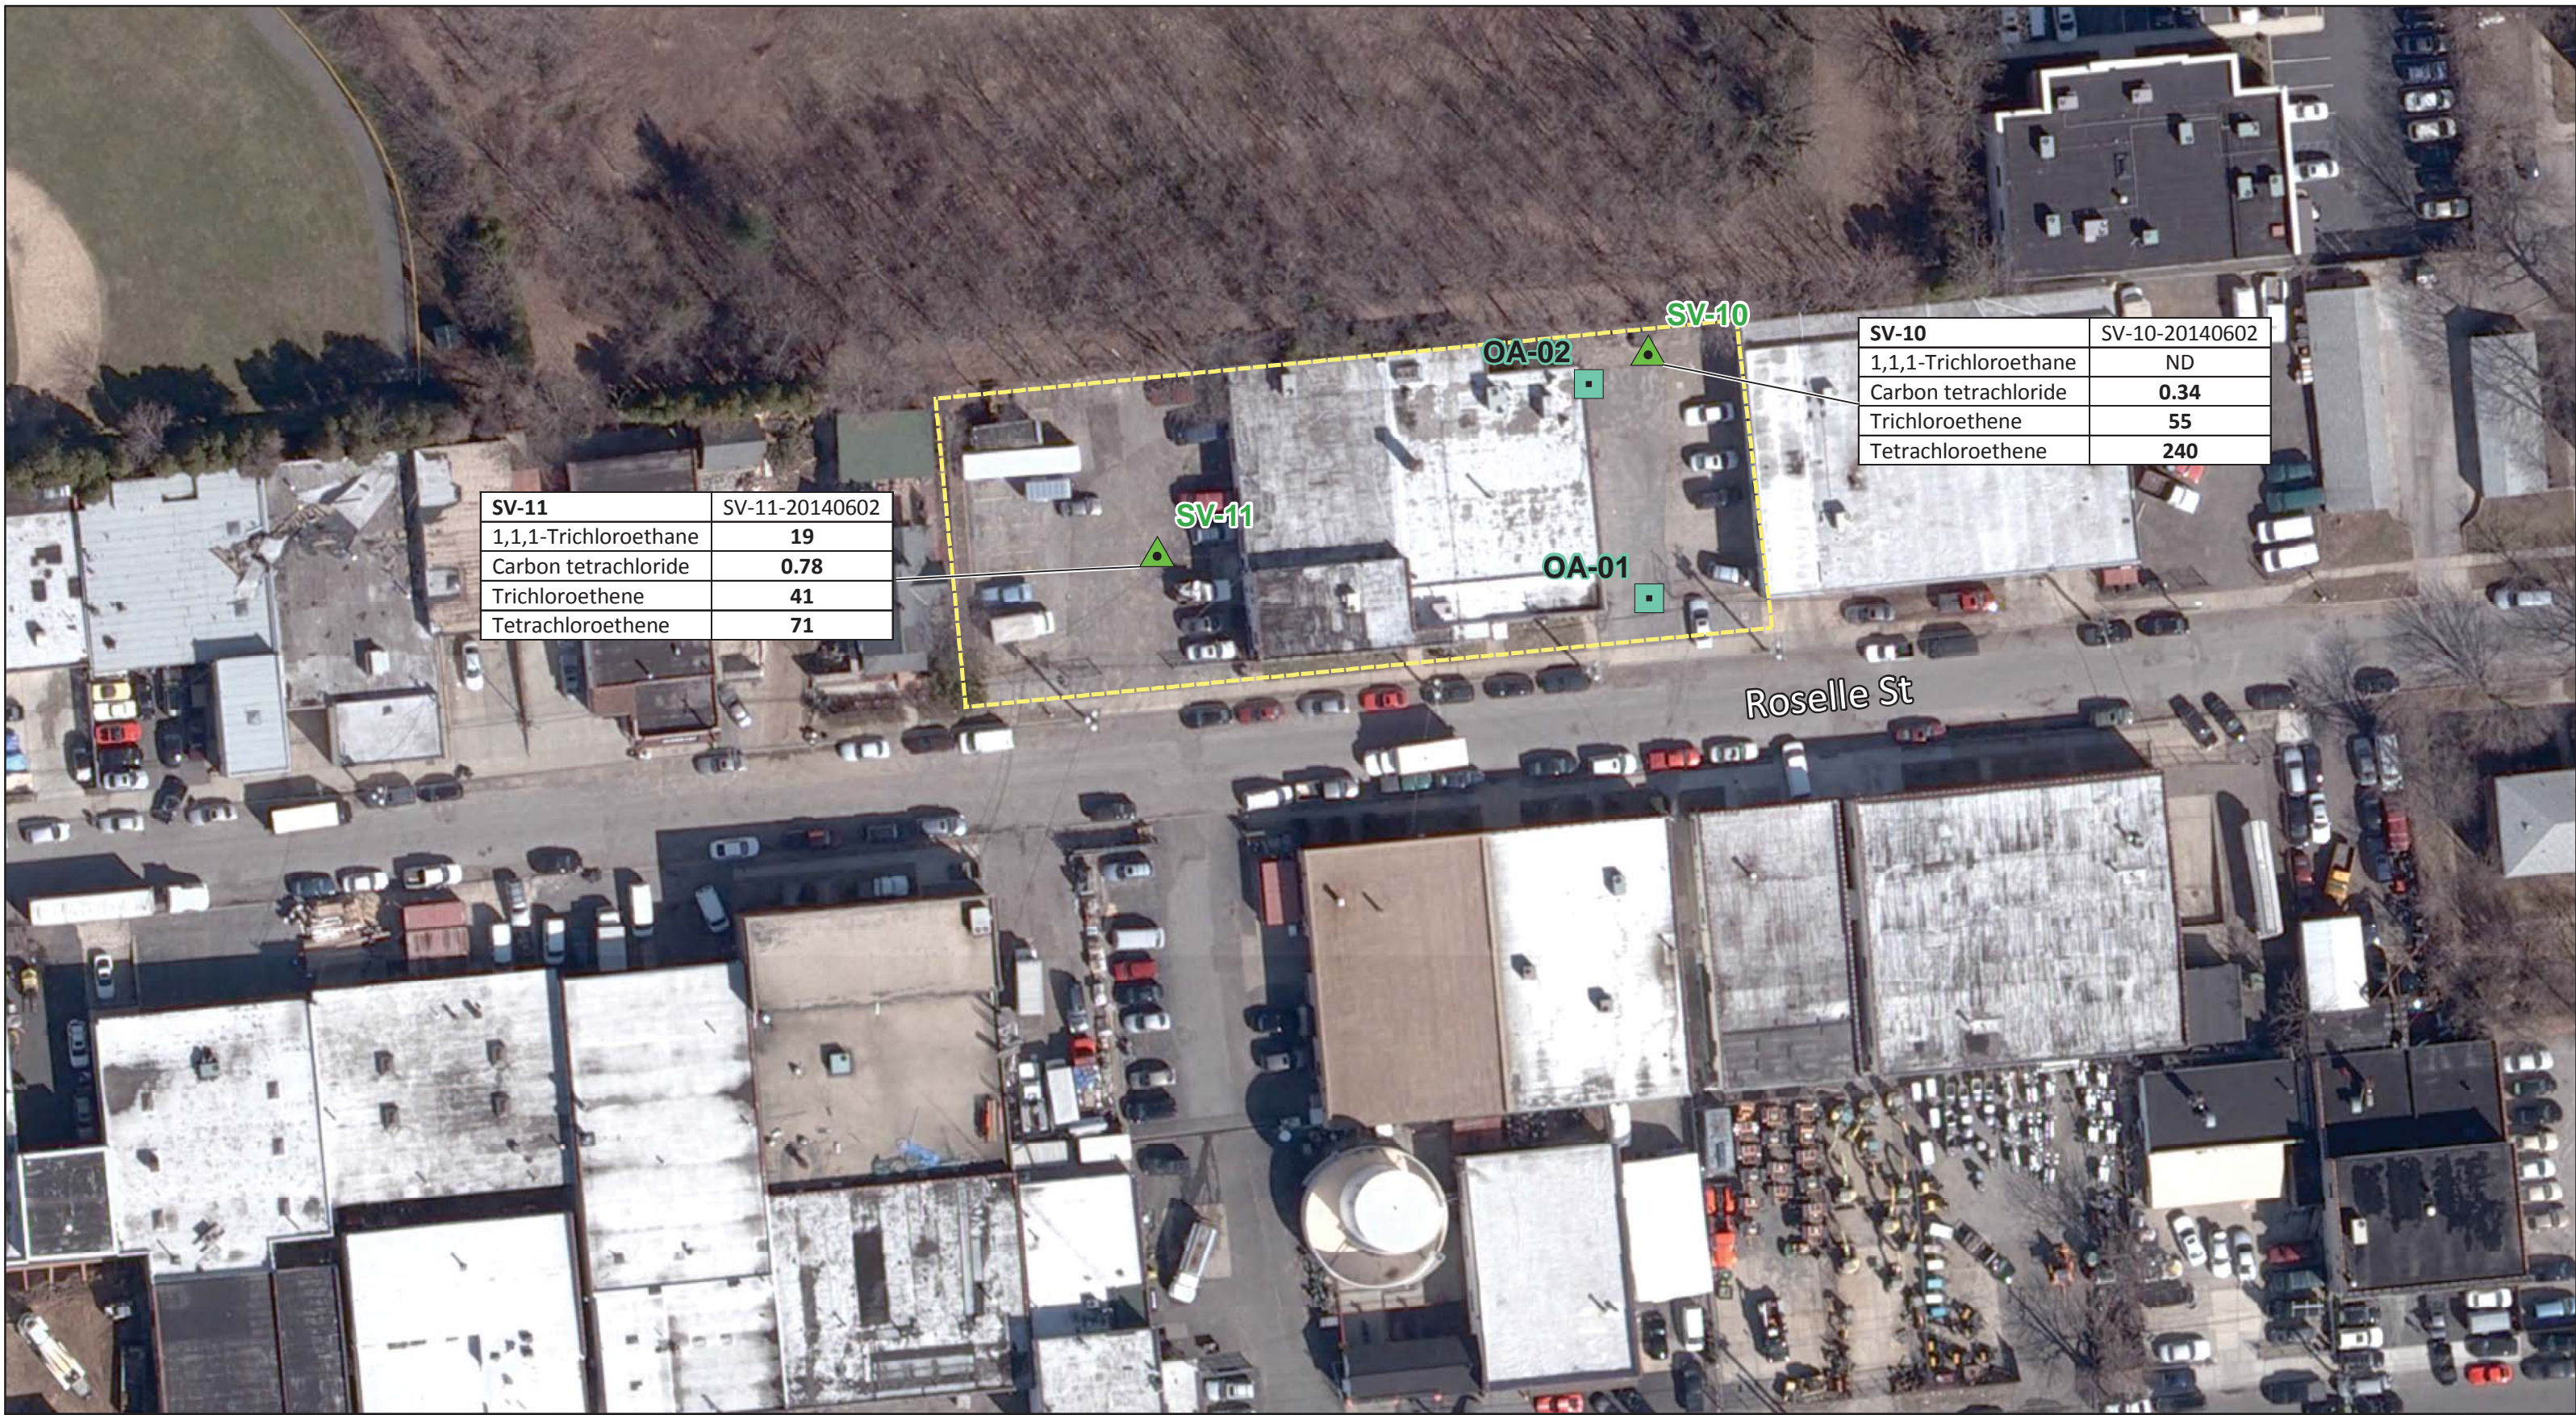
SV-11	SV-11-20140602
1,1,1-Trichloroethane	19
Carbon tetrachloride	0.78
Trichloroethene	41
Tetrachloroethene	71

SV-10	SV-10-20140602
1,1,1-Trichloroethane	ND
Carbon tetrachloride	0.34
Trichloroethene	55
Tetrachloroethene	240

Sub-slab vapor and Indoor Air – PCE and TCE were detected in sub-slab soil vapor and indoor air at 40 and 50 Roselle Streets at elevated concentrations during both samples rounds taken during February 2014 and June 2014. A maximum of 9,600 micrograms per cubic meter (ug/m³) of PCE was found in the sub-slab vapor and in the indoor air up to a maximum of 60 ug/m³. A maximum of 5,900 ug/m³ of TCE was found in the sub-slab vapor and 34 ug/m³ was found in the indoor air. The results of the soil vapor intrusion study indicate actions are recommended to mitigate exposures from soil vapor intrusion at both properties. In addition, the NYSDOH air guideline was exceeded for both PCE and TCE (30 ug/m³ and, currently, 2 ug/m³ respectively) at both the properties.
