PERIODIC REVIEW REPORT

August 29, 2022 to August 29, 2023

1966E Broadhollow Road Farmingdale, NY 11735 Site #152119

Prepared for: Target Rock Corporation

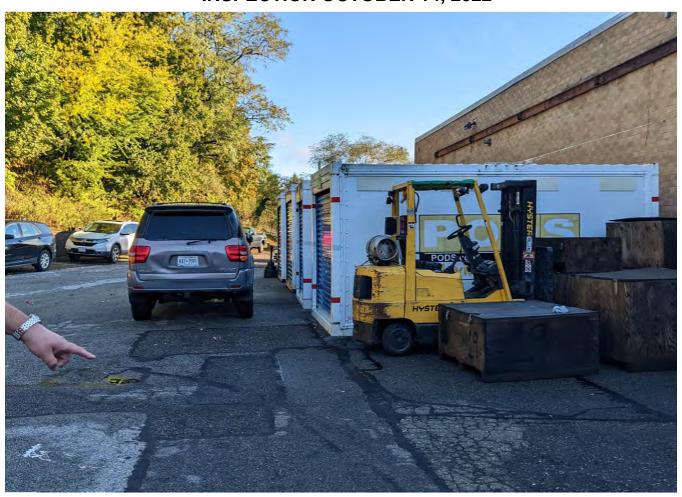
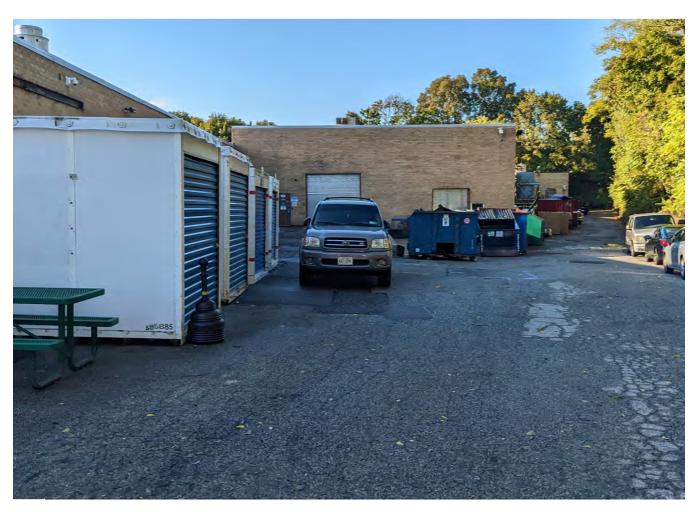
INSPECTION OCTOBER 14, 2022

No cracks were observed in the asphalt UST cap.

Inspection was completed on each date above at the location of the Asphalt UST Cap on the western side of the building. The asphalt cap was inspected for cracks, holes, and gaps. Repairs not required this PRR Period.
