Project: National Heatset Printing Site - Off-Site - Site Management	AECOM
Contractors: AECOM and Preferred Environmental Services	40 British American Boulevard
	Airport Park
AECOM Job No: 60135649	Latham, NY 12110
Site No: 1-52-140	Telephone: 518.7951.2242
AECOM Project Manager: Walt Howard

PHOTOGRAPHIC LOG Date: 2-08-13 AECOM Job No. National Heatset Printing Site - Off-Site

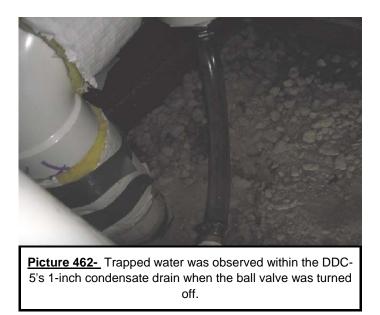
РНОТО	DATE	TIME	DESCRIPTION	COMMENTS
Picture 462	2/8/2013	13:00	Trapped water was observed within the DDC-5's 1-inch condensate drain when the ball valve was turned off.	
Picture 464	2/8/2013	13:30	The shallow and deep piezometer wells were gauged within each DDC well.
