RECORD OF DECISION

C and F Plating
State Superfund Project
Albany, Albany County
Site No. 401057
March 2014

Prepared by
Division of Environmental Remediation
New York State Department of Environmental Conservation

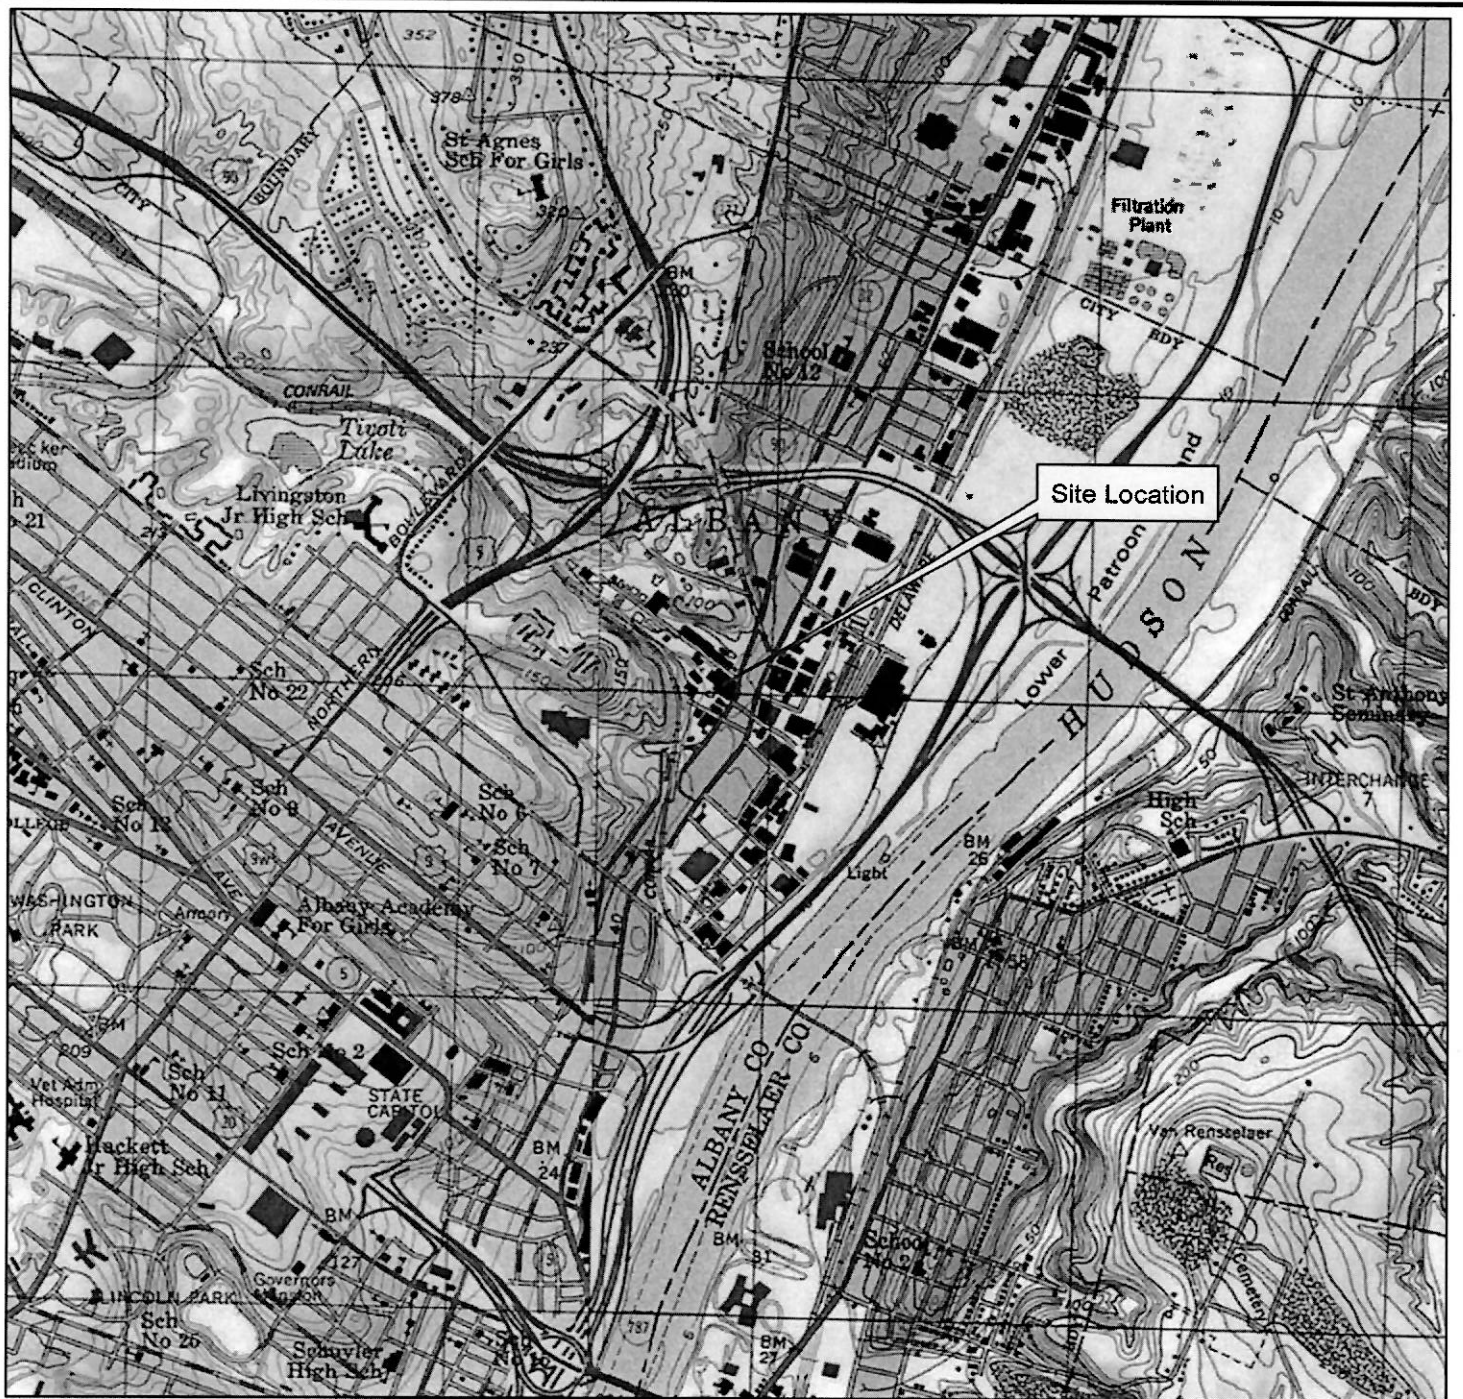
FIGURE 2
SITE PLAN
FORMER C&F PLATING
406 NORTH PEARL STREET
ALBANY, NEW YORK
NOT TO SCALE

The site consists of a generally flat lot with an approximately 6,600-square foot, vacant two-story brick building. The north portion of the building has partially fallen into Patroon Creek. The south side of the building formerly contained office space and the northern section contained warehousing/industrial space. The building is currently filled with debris and municipal waste. The surface of the site is asphalt, concrete, or gravel. The site and surrounding area is located at approximately 30 feet above mean sea level. Access to the site is restricted on three sides by fencing and a locked gate. Access to the site is restricted on the fourth side by Patroon Creek. While operational the site was serviced by municipal water and sewer systems.
