NYSDEC Division of Environmental Remediation

Health & Safety Comments						
Work conducted along grade with potentially unstable material and wet/muddy conditions. Tailgate meeting include discussion about slippery conditions on cap.						
Summary of Work Performed		Arrived at site:	0810	Departed Site:	1600	
<u>Drainage Swale Erosion Emergency Repairs: Oversight of LaBella</u>						
<ul style="list-style-type: none"> • Mobilize to site • Meet with LaBella work Crew – Crew was working upon arrival. <ul style="list-style-type: none"> ○ Items discussed include wet/muddy conditions. ○ 1 Supervisor, 1 Laborer, 1 Operator. • Crew continued to place rip-rap stone on top of the newly-placed geotextile fabric along the entire length of the damaged down-chute/slope to stabilize the landfill cap as a temporary fix until complete repair can be made. <ul style="list-style-type: none"> ○ Used skid-steer to move/place rip-rap. ○ Rip-rap is being sourced from a rip-rap stock pile made by GreenSpark at the top of the landfill from material removed from drainage swales. ○ Estimate between 30-40 bucket loads transported and placed into down-chute swale. ○ LaBella attempting to locate additional mach

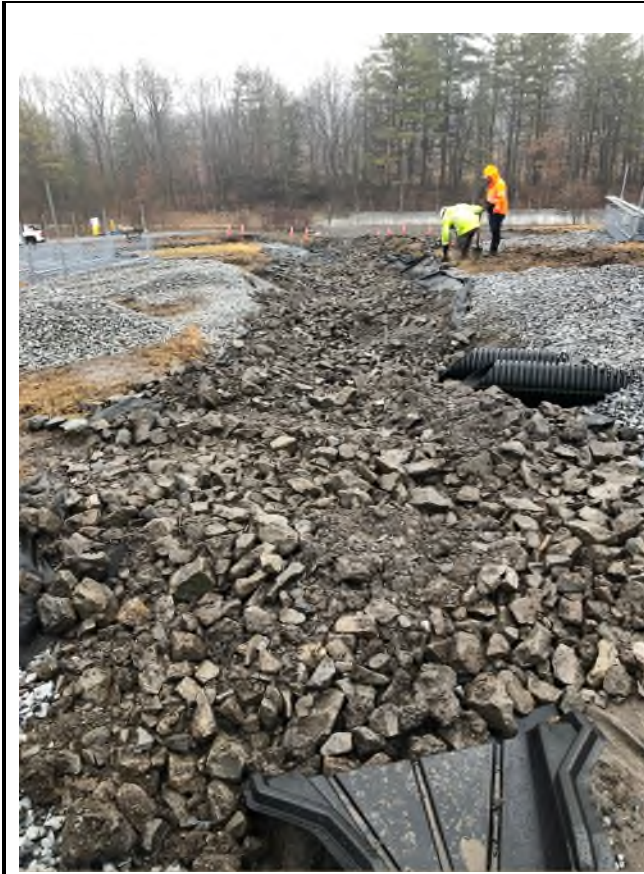
1. Geotextile awaiting rip-rap in down-chute at start of day.	2. Geotextile along erosion bank in down-chute at start of day.

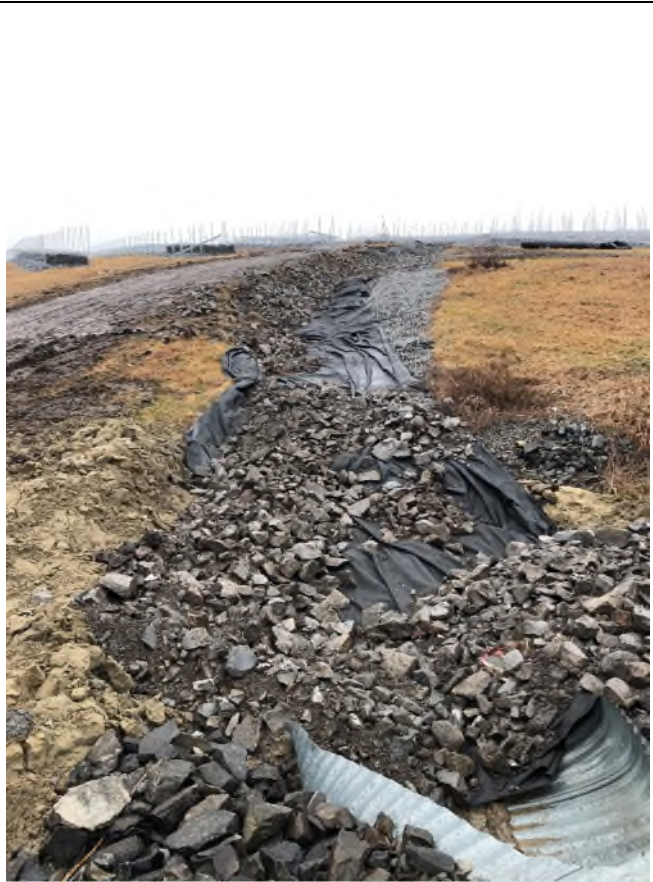
3. Rip-rap placed on geo-textile in down-chute.

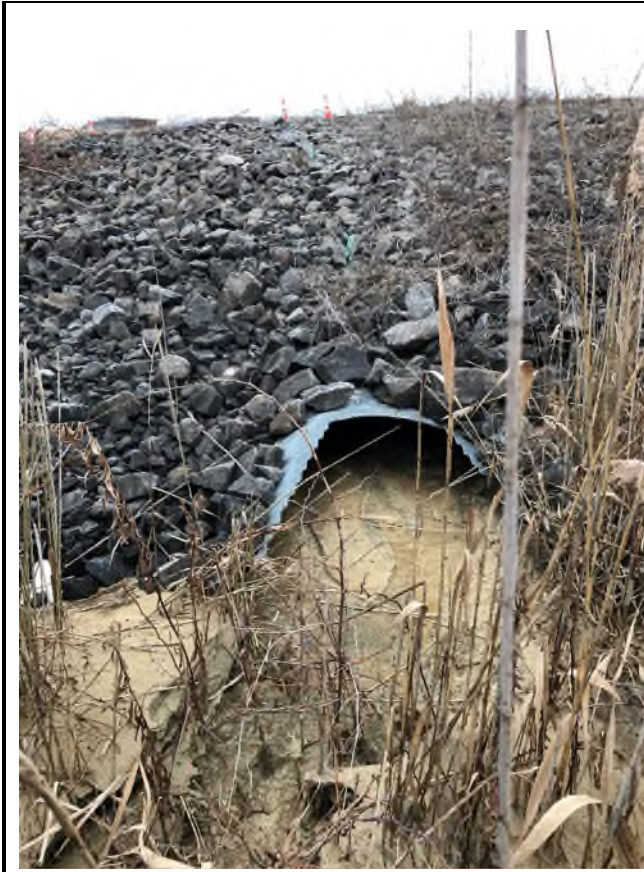
4. View of down-chute from culvert that passes under landfill access driveway.

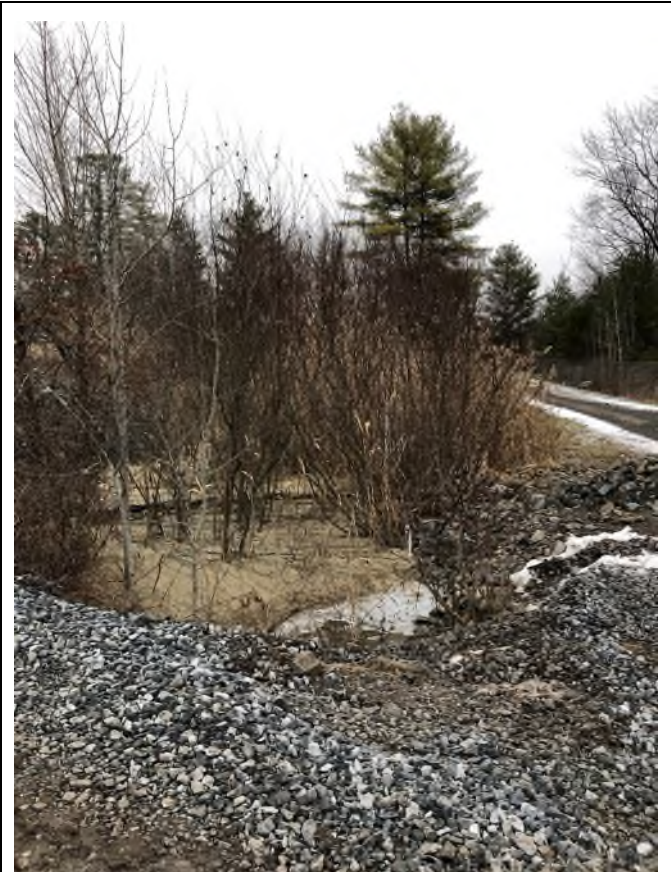
Issues Pending	
Restoration of flow to culvert pipe under landfill access driveway may cause sediment release from initial erosion event to migrate down gradient in landfill perimeter swale.	
Interaction with Public, Property Owners, Media, etc.	
None.	
Site Photographs (Descriptions Below)

5. Sediment accumulation from initial erosion event in culvert that passes under landfill access road.
