# RECORD OF DECISION

Kingsbury Landfill  
Operable Unit Number 01: On-Site Contamination  
State Superfund Project  
Kingsbury, Washington County  
Site No. 558008  
March 2023

Prepared by  
Division of Environmental Remediation  
New York State Department of Environmental Conservation

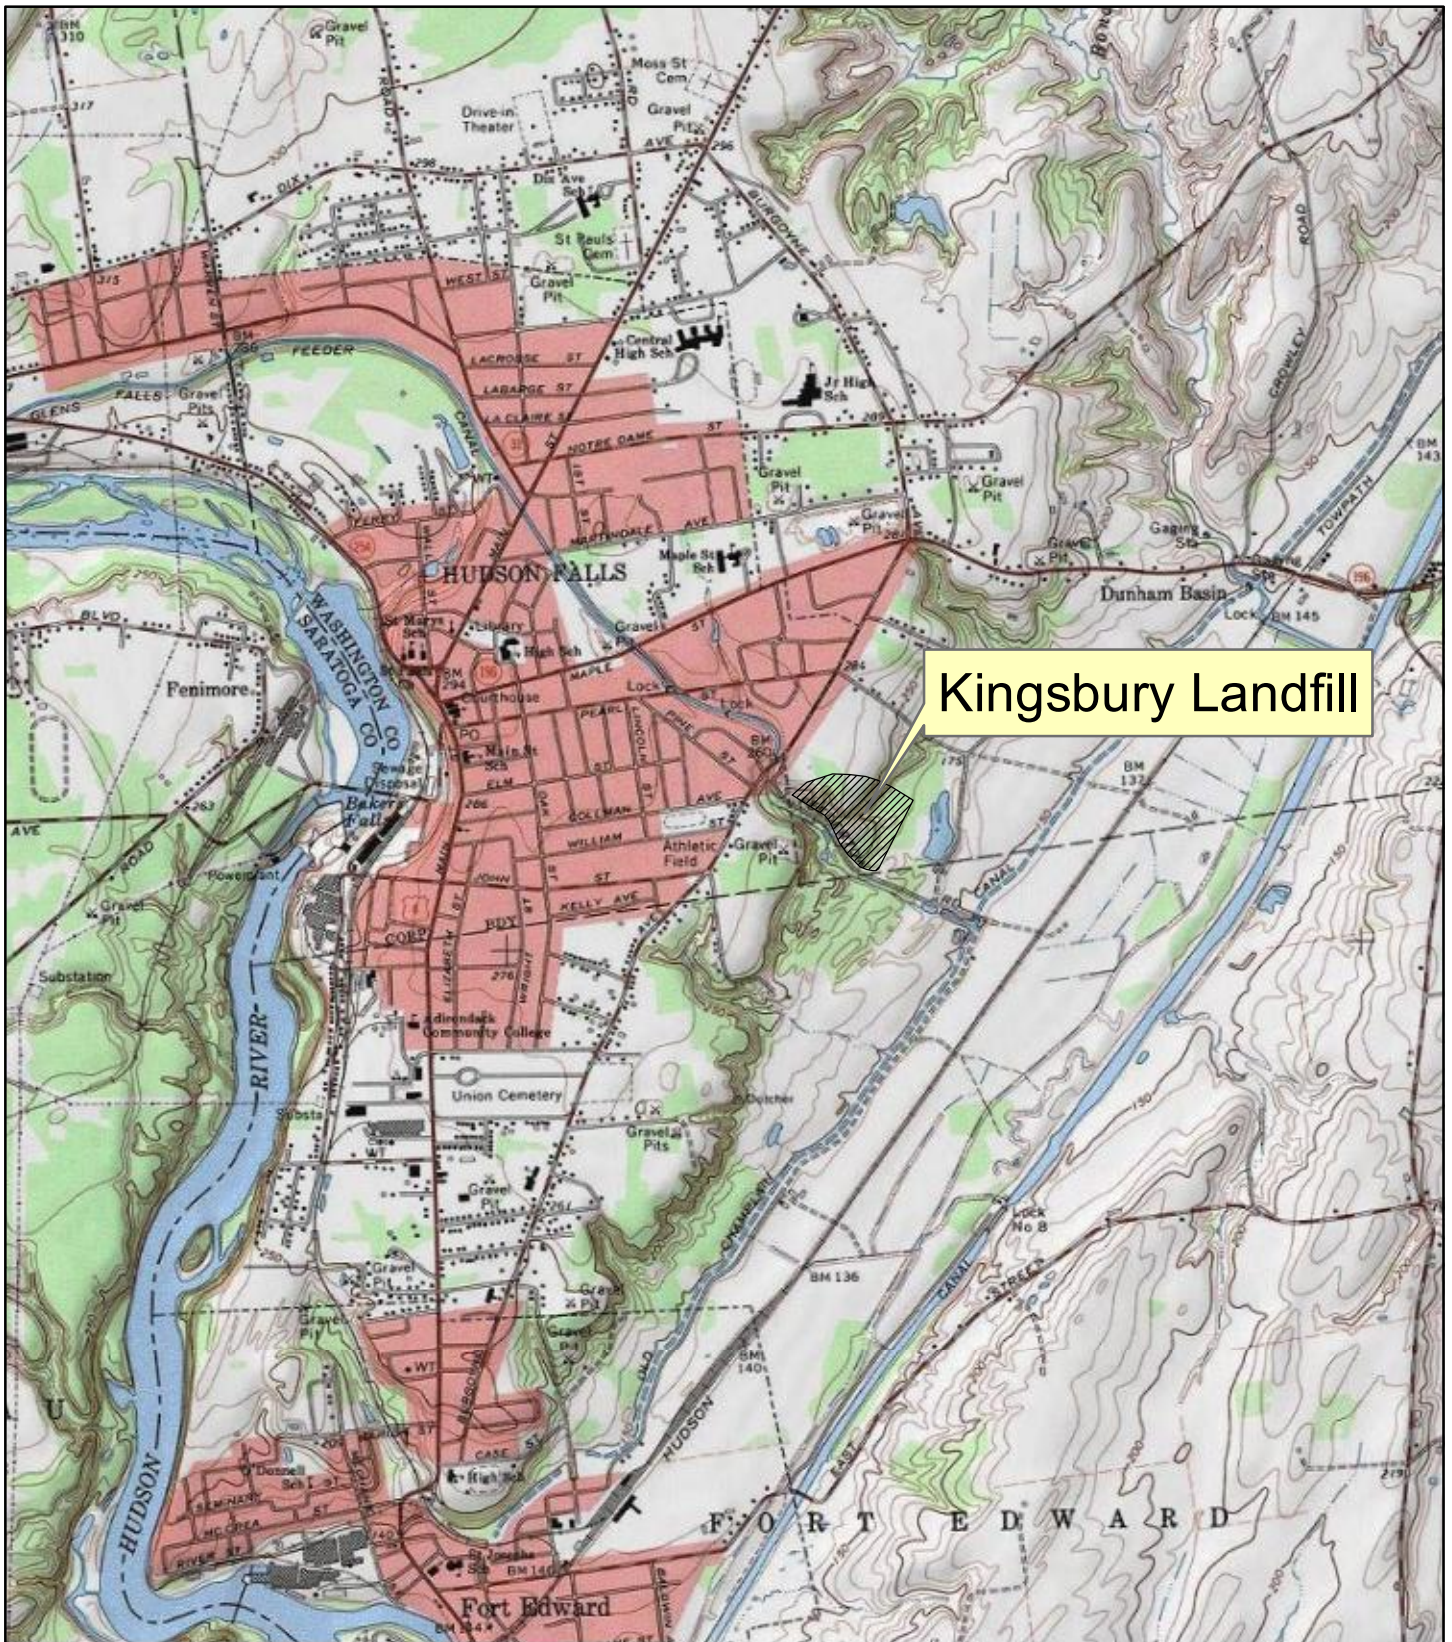
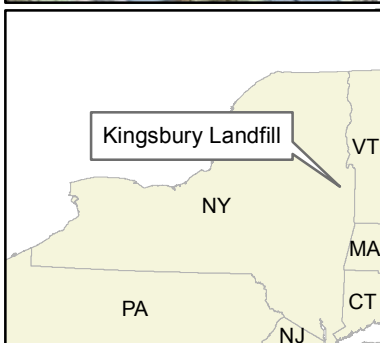
Figure No. :  
1

USGS Hudson Falls  
Quadrangle

U.S.G.S. 1:24 000 SCALE  
TOPOGRAPHIC MAP

A site location map is attached as Figure 1. A site boundary map is shown in Figure 2.

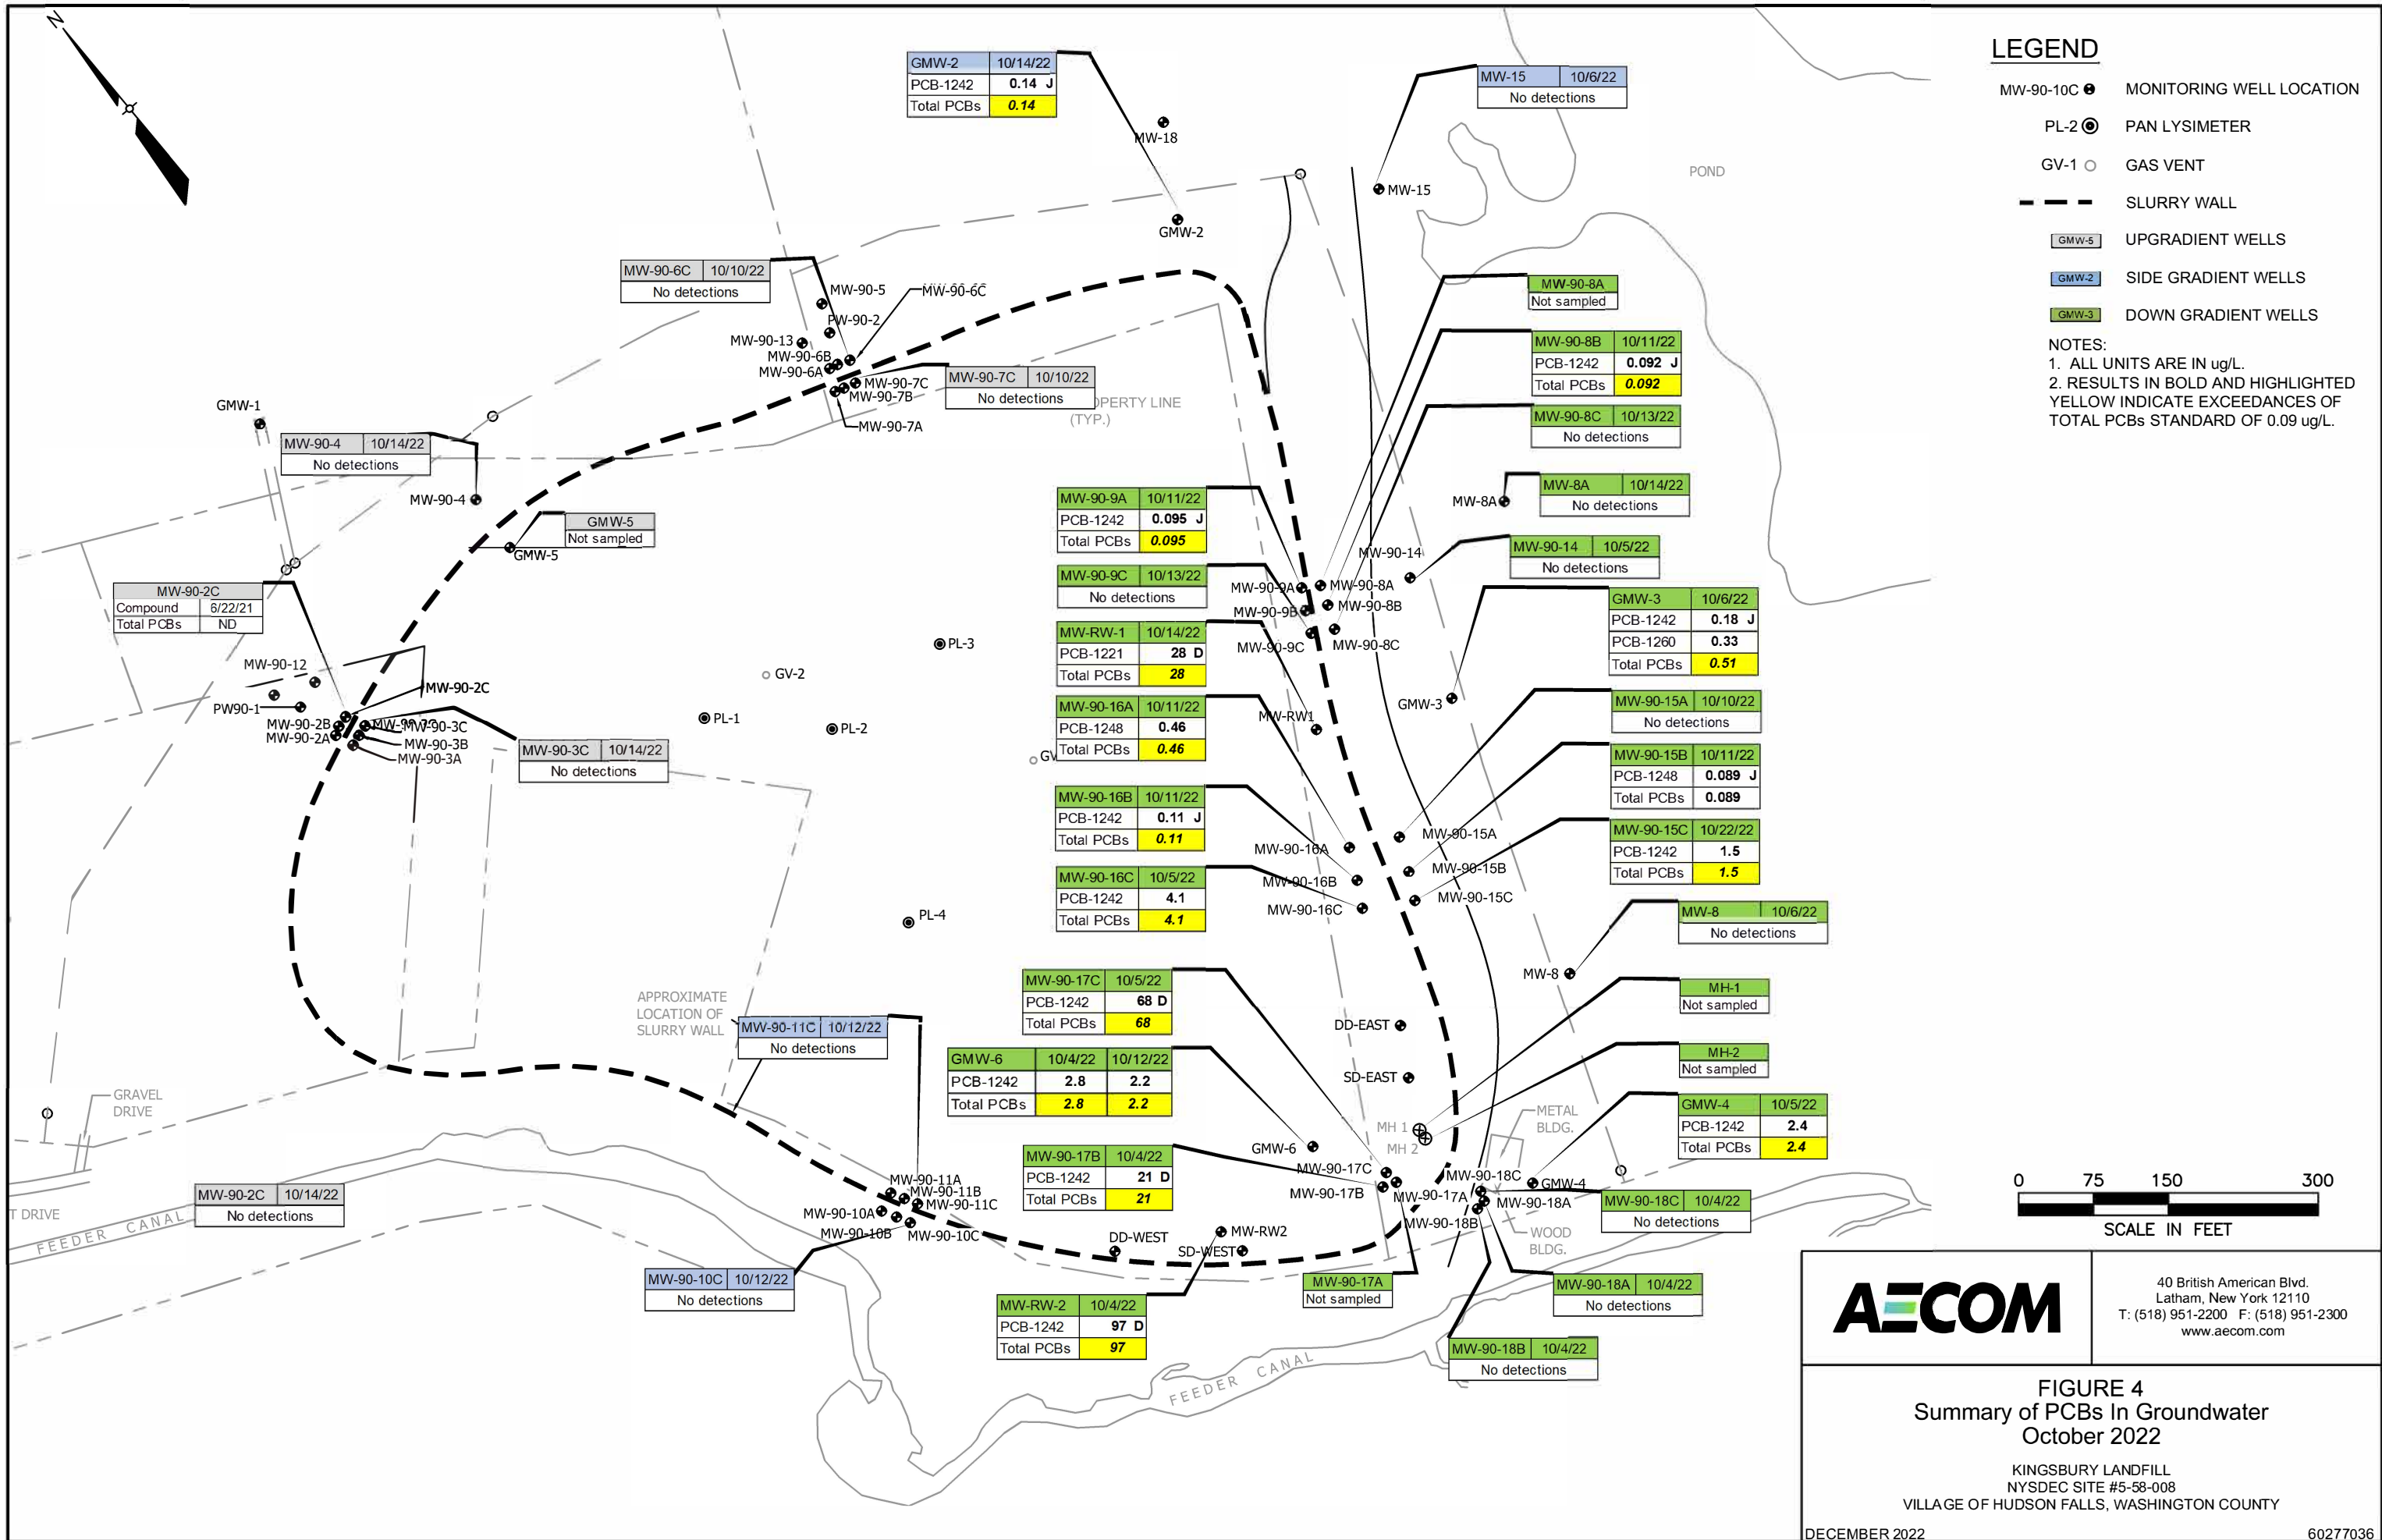
GMW-2	10/14/22
PCB-1242	<b>0.14 J</b>
Total PCBs	<b>0.14</b>

MW-15	10/6/22
No detections

Groundwater samples were collected from monitoring wells upgradient, sidegradient, and downgradient of the landfill that were installed both inside and outside of the current slurry wall. Samples were collected to assess groundwater conditions on-site. The results from the RI indicated that contamination of the groundwater exceeded the SCGs for VOCs, SVOCs, PCBs, and metals. One round of post IRM groundwater samples have been collected to date and are presented in Table 1 and Figures 3 through 5. Groundwater exceeded SCGs for VOCs (Figure 3), SVOCs (Figure 3), PCBs (Figure 4) and metals (Figure 5); the highest concentrations occur within the slurry wall. The focus of the RI and subsequent Feasibility Study (FS) was to evaluate the control of the upgradient groundwater. Controlling groundwater entering the site will limit, or eliminate, the migration of contaminants from the site. Since the installation of the upgradient drain, the upgradient groundwater elevation has been significantly reduced, demonstrating the drain is functioning as designed. Contaminant levels of VOCs, SVOCs, PCBs, and

Currently, VOC and SVOC exceedances occur mainly within the slurry wall. Minor exceedances are also present outside of the slurry wall in select locations sidegradient (both east and west) and downgradient of the landfill. The highest PCB exceedances in groundwater are located within the slurry wall in the southern portion of the landfill. Four locations outside of the slurry wall on the eastern side of the landfill exceed the SCG for PCBs. Various metals exceed their corresponding SCGs both within and outside of the slurry wall. Although antimony, selenium, and sodium occur upgradient of the landfill, these metals are also present in groundwater within the slurry wall. Antimony, iron, manganese, magnesium, and sodium are the most frequent metals to exceed their respective SCGs within the slurry wall. The highest emerging contaminant concentrations occur within the slurry wall.

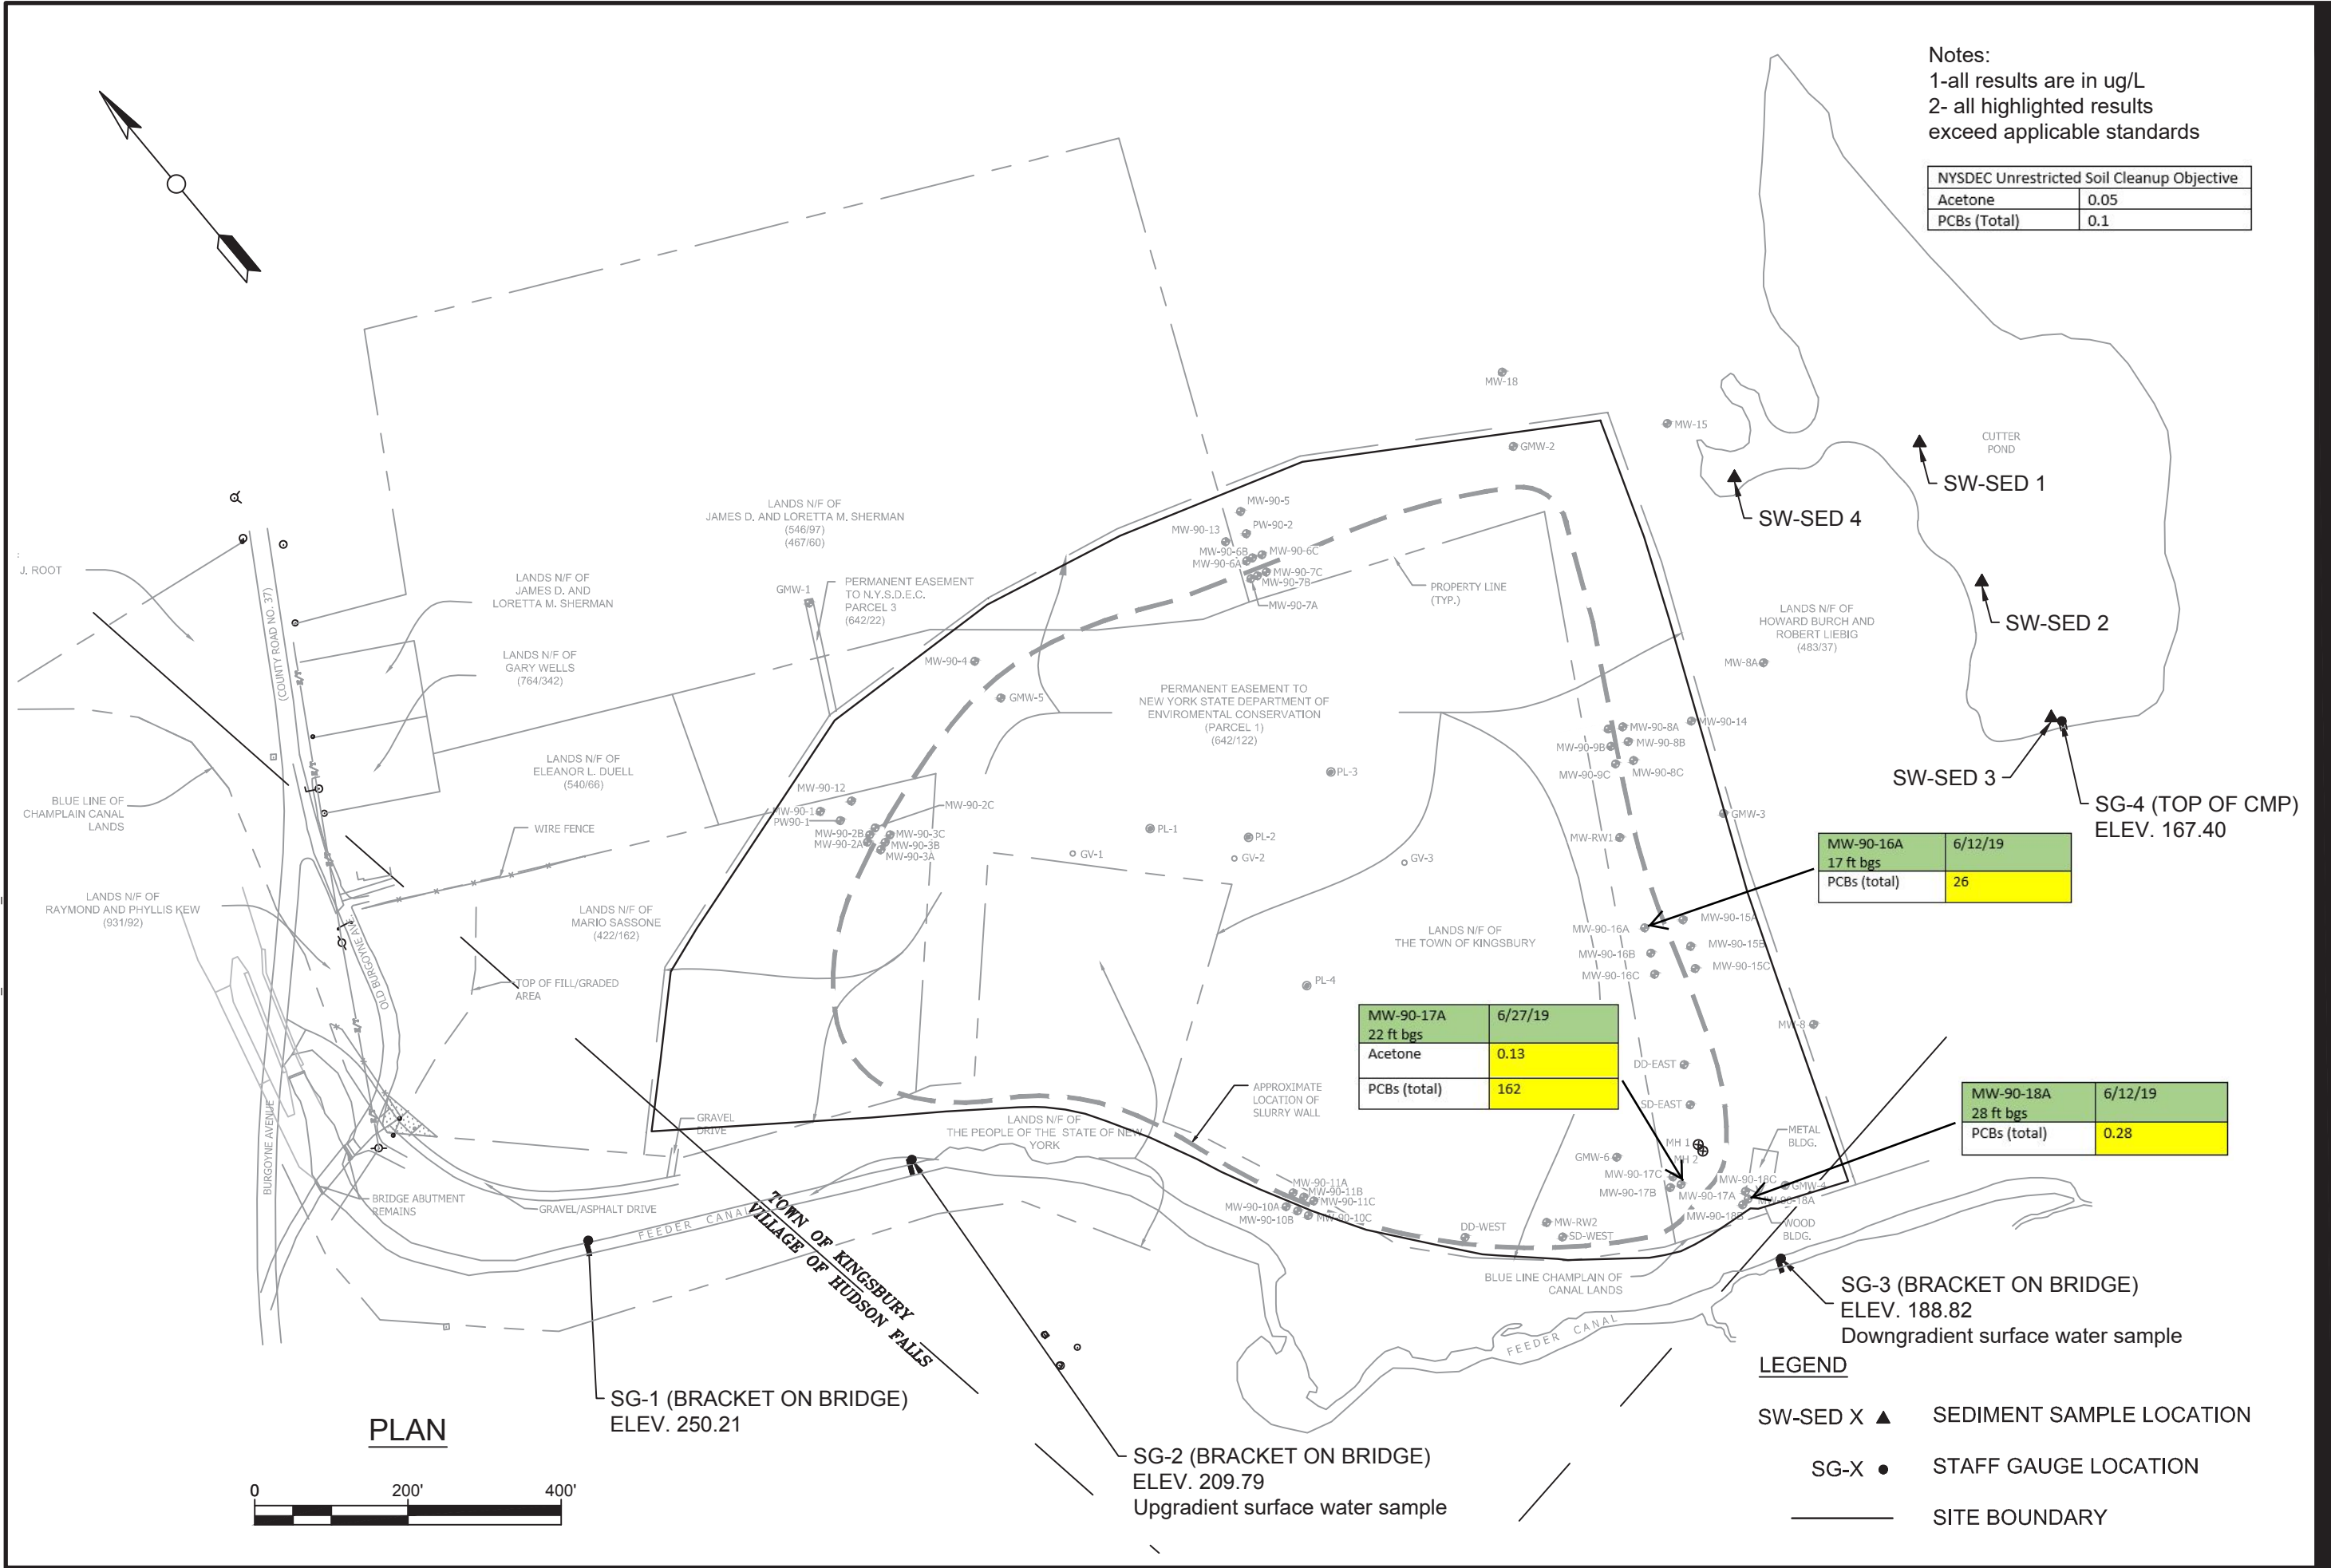
NYSDEC Unrestricted Soil Cleanup Objective	
Acetone	0.05
PCBs (Total)	0.1

MW-90-16A	6/12/19
17 ft bgs	
PCBs (total)	26

MW-90-17A	6/27/19
22 ft bgs	
Acetone	0.13
PCBs (total)	162

Soil: During an additional investigation in 2019, PCBs and VOCs were detected in site soils that have been sequestered under the landfill cover system. Total PCBs were detected in site soils up to 162 parts per million (ppm) compared to the unrestricted use soil cleanup objective (UUSCO) of 0.1 ppm. Acetone was detected at 0.13 ppm (UUSCO – 0.05 ppm). Acetone and PCB soil exceedances above the commercial use SCO were found within the slurry wall.
