**Perfluorinated Compounds
Preliminary Assessment**

Former Griffiss Air Force Base, NY

**Perfluorinated Compounds (PFCs) Release
Determination at Multiple BRAC Bases**

**FORMER GRIFFISS AIR FORCE BASE
ROME, NEW YORK**

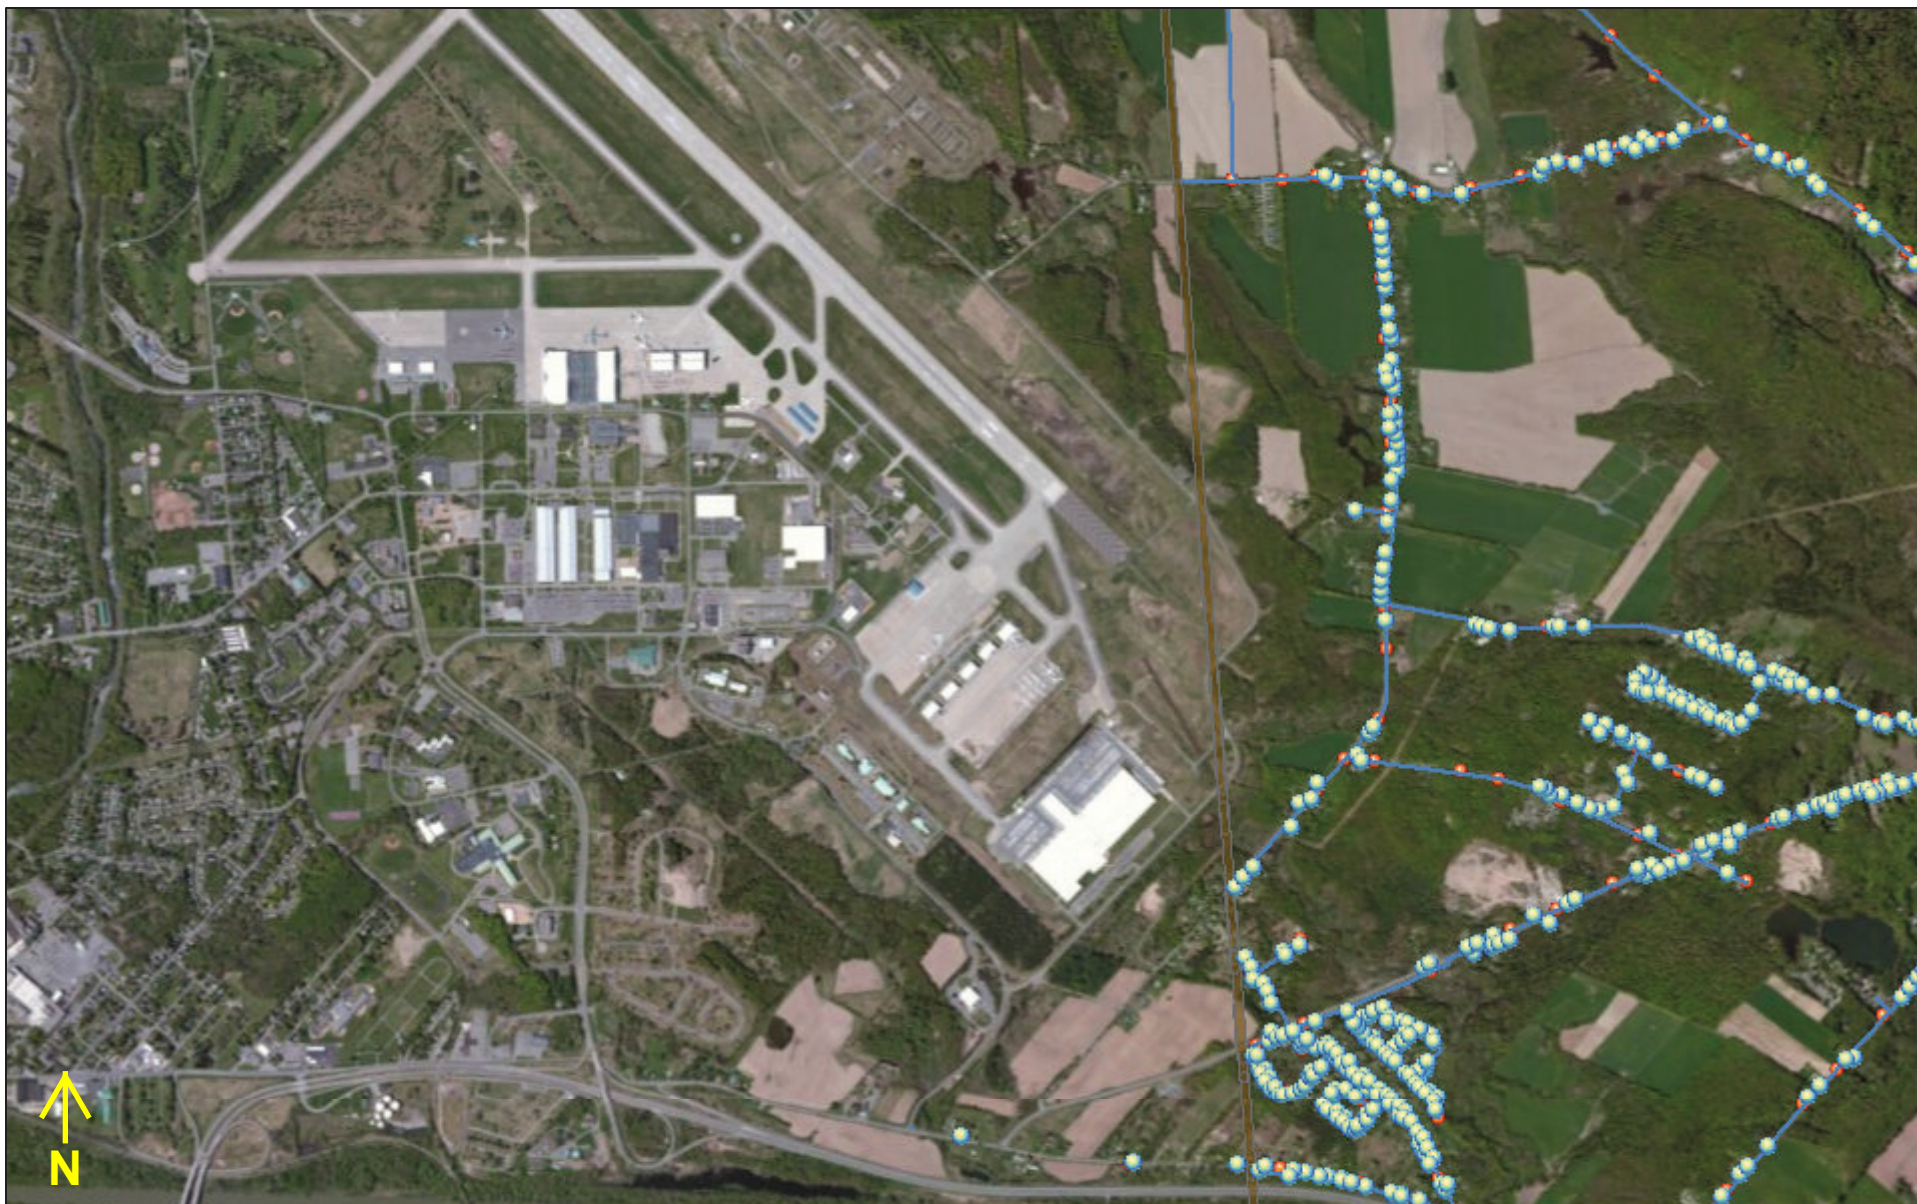
Map showing Town of Floyd water lines (blue), water connections (blue circles), and fire hydrants (red circles):
<http://www.arcgis.com/apps/OnePane/basicviewer/index.html?appid=9a523a65b9ff4abd8b1d46cb52c9ec89>

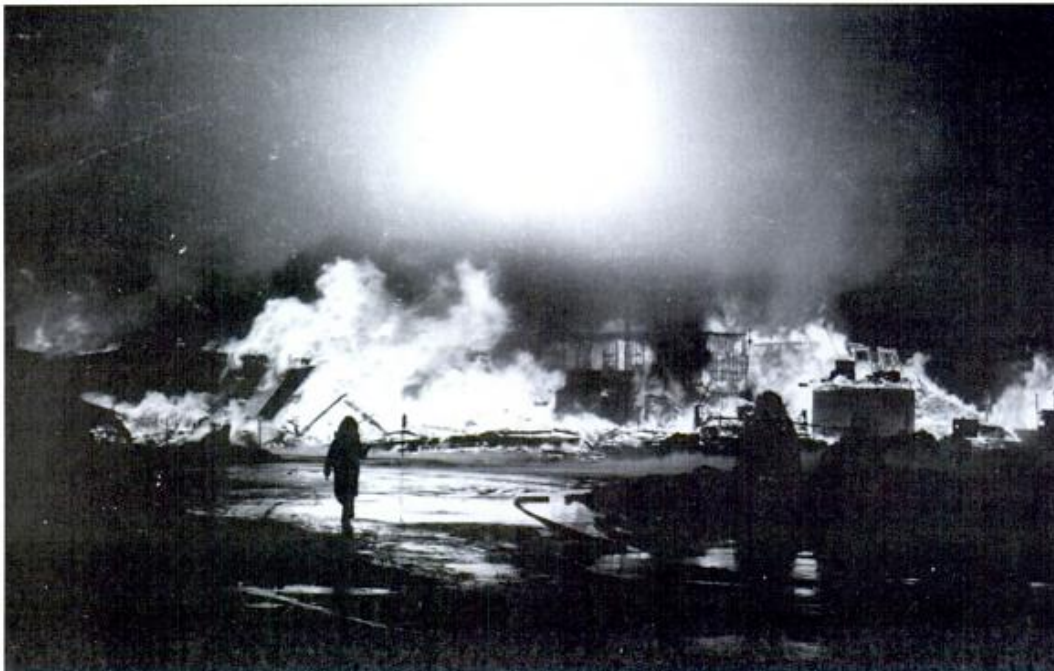
Fire quickly spread through the two-story wood-framed ROAMA headquarters building in the early morning hours of January 28, 1961. **Fire** crews battled the cold weather and intense flames throughout the night; however, the structure was completely lost by daybreak. The only other major structure **fire** at **Griffiss** was on March 12, 1952, when the officers mess hall burned, resulting in the death of the officer in charge. (RHS.)

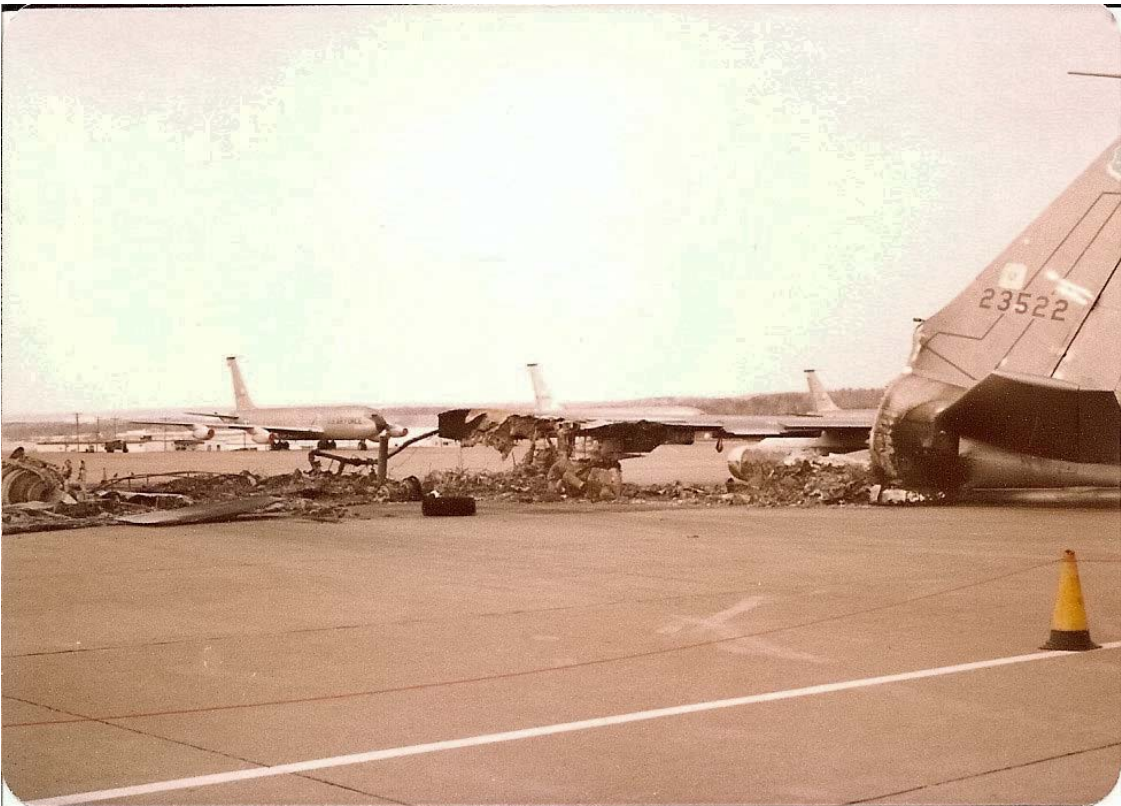
KC 135 Burned during engine trim operation on tanker ramp 1978 (noted as 1977 in comments)

- 12) Apron 1: In 1977, an airplane fire occurred on Apron 1 in which AFFF was reportedly used.
- 13) Nose Docks 1 and 2 and Apron 1 - trench (part of SD-41): Soil caught on fire near Nose Docks 1 and 2 and Apron 1 due to fuel contaminated soil. It is not known whether AFFF was used for fire suppression (this area is adjacent to the 1977 aircraft fire that occurred on Apron 1).

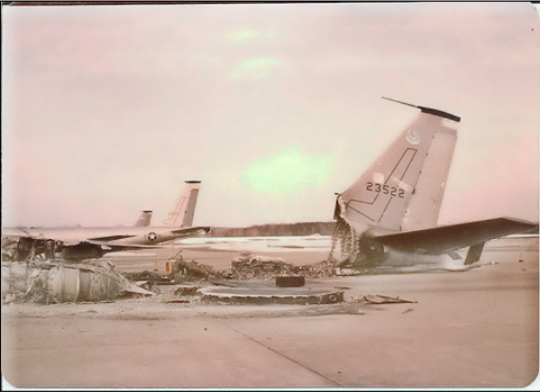
KC 135 Burned during engine trim operation on tanker ramp 1978

From: **David Schuster** (Sat 03 Sep 2011 17:25:14 EDT)
believe the fire was 1976 or 1977 I was there and left Griffiss in April 1977

From: **Dan Yock** (Sun 26 Aug 2012 14:17:28 EDT)
Dave is right it was in 1977, he was my roommate and I watched it burn and recovered other nearby aircraft to the bomber side.

From: **Ron Rogers SRA 416th Bomb Wing** (Sat 09 Mar 2013 18:10:09 EST)
I was stationed at Griffiss and remember hearing the engine run up and then pop, pop, boom. Drove to the parking lot on perimeter rd and watched it burn to the ground.
