**SITE MANAGEMENT PLAN  
TOWNLEY HILL ROAD DUMP SITE  
NEW YORK STATE  
DEPARTMENT OF ENVIRONMENTAL CONSERVATION  
SITE REGISTRY NO. 8-08-006  
CATLIN, CHEMUNG COUNTY, NEW YORK**

**PREPARED FOR:  
CBS CORPORATION  
20 STANWIX STREET, 10<sup>TH</sup> FLOOR  
PITTSBURGH, PA 15222**

**PREPARED BY:  
CUMMINGS/RITER CONSULTANTS, INC.  
A WOODARD & CURRAN COMPANY  
300 PENN CENTER BLVD., SUITE 800  
PITTSBURGH, PA 15235**

**PROJECT NO. 01304.30/05  
SEPTEMBER 2014**

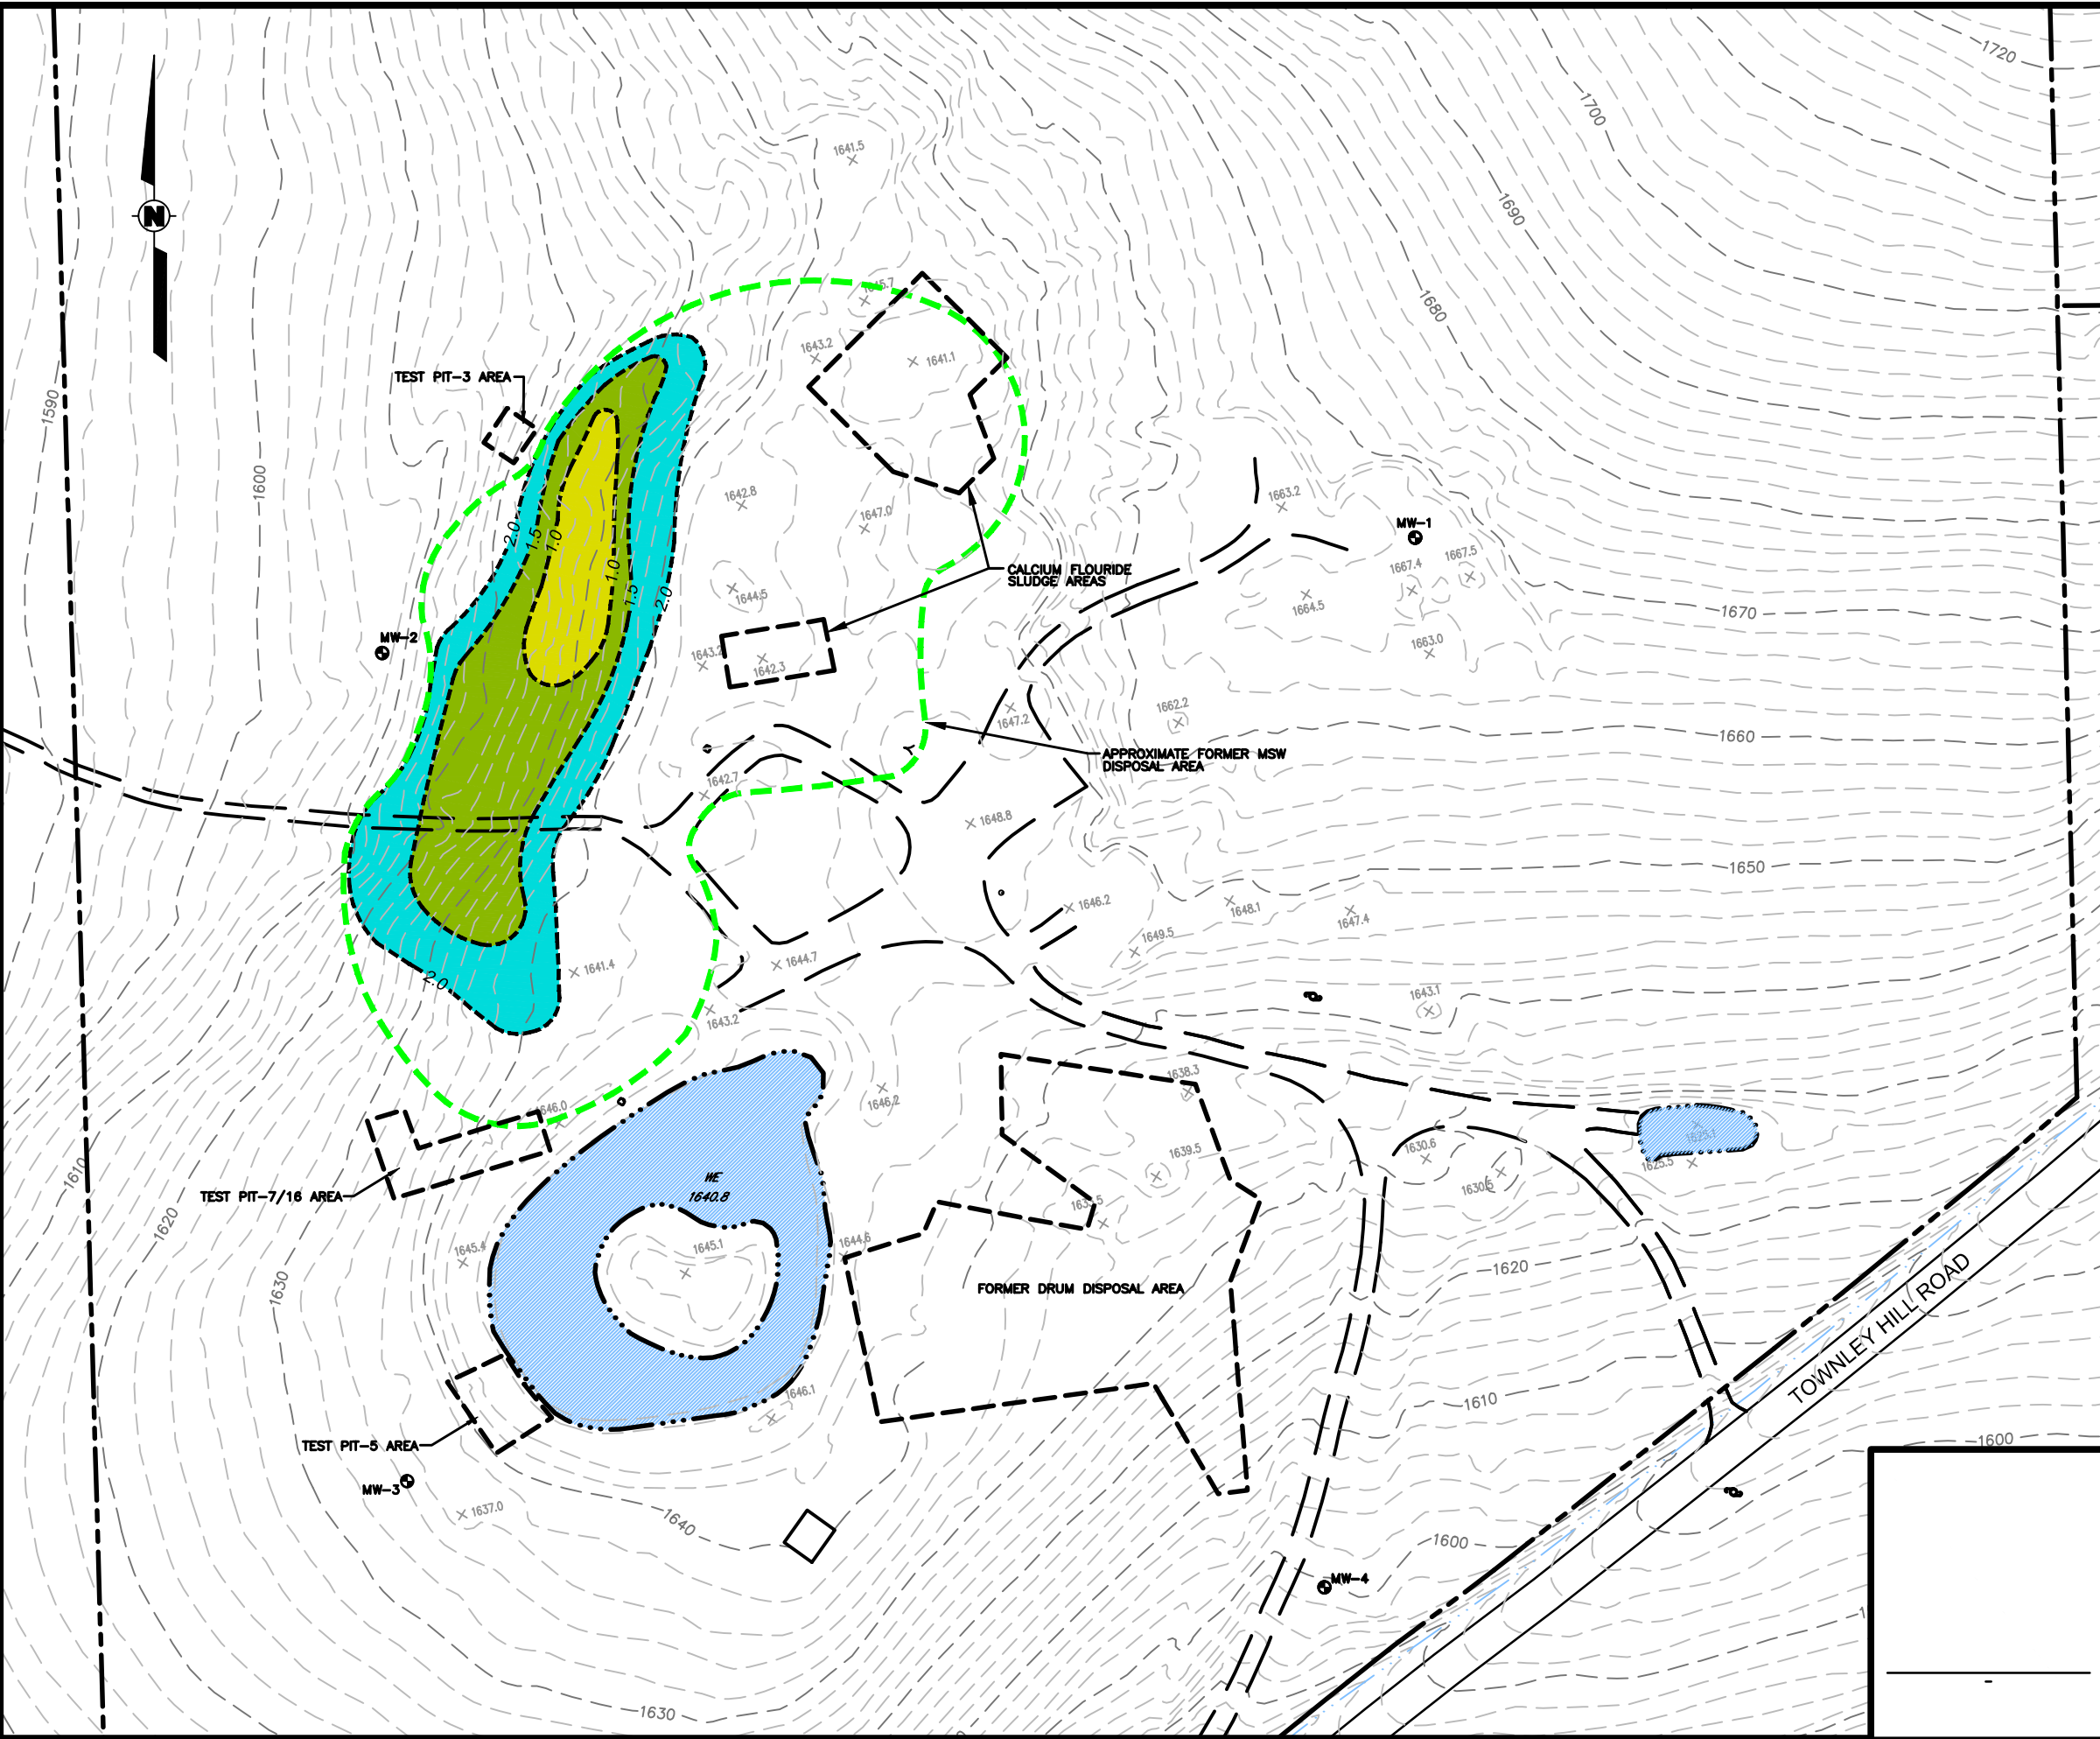
AUTOCAD FILE NUMBER: <b>01304E58</b>		FIGURE NUMBER
DRAWN BY: <b>T.N. Fitzroy</b>	DATE: <b>2-4-14</b>	<b>2</b>
CHECKED BY: <b>R.P. HRENKO</b>	DATE: <b>8-6-14</b>	
APPROVED BY: <b>A.E. PROCTOR</b>	DATE: <b>8-6-14</b>

- LEGEND:**
- ~0.5' TO ~1.0' EXISTING SOIL COVER THICKNESS (3,680 SF)
  - ~1.0' TO ~1.5' EXISTING SOIL COVER THICKNESS (11,140 SF)
  - ~1.5' TO ~2.0' EXISTING SOIL COVER THICKNESS (12,660 SF)
  - APPROXIMATE PROPERTY LINE
  - APPROXIMATE LIMITS OF FORMER MSW DISPOSAL AREA
  - POND

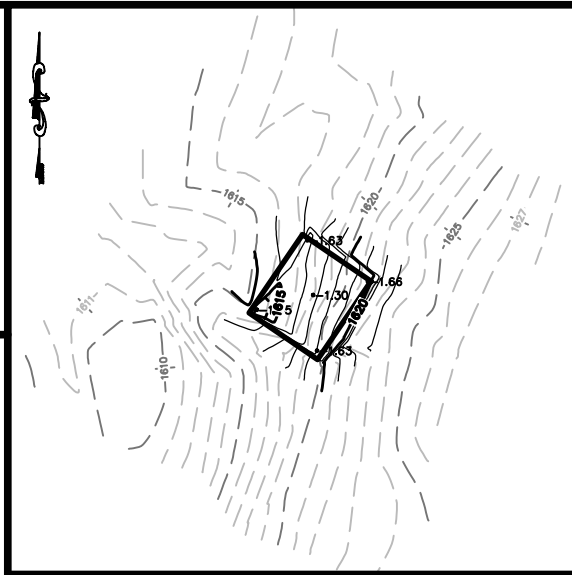
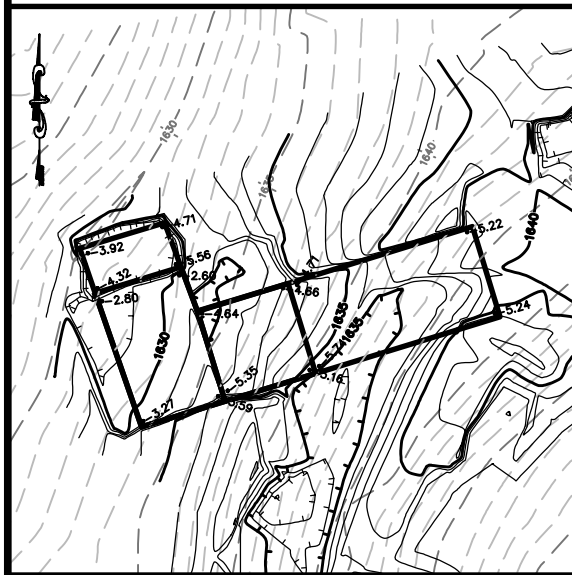
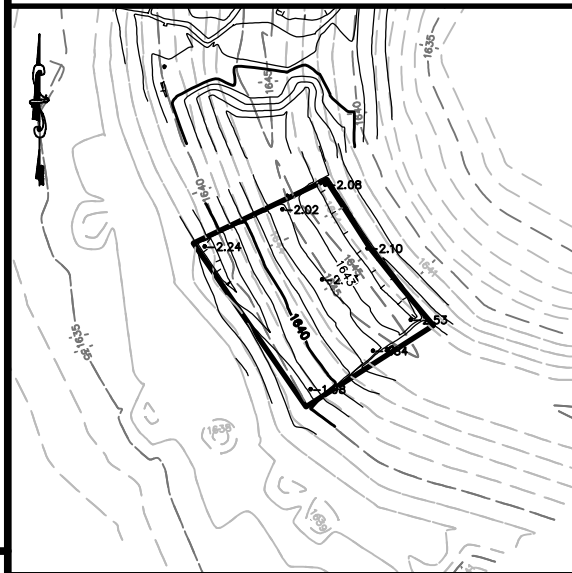
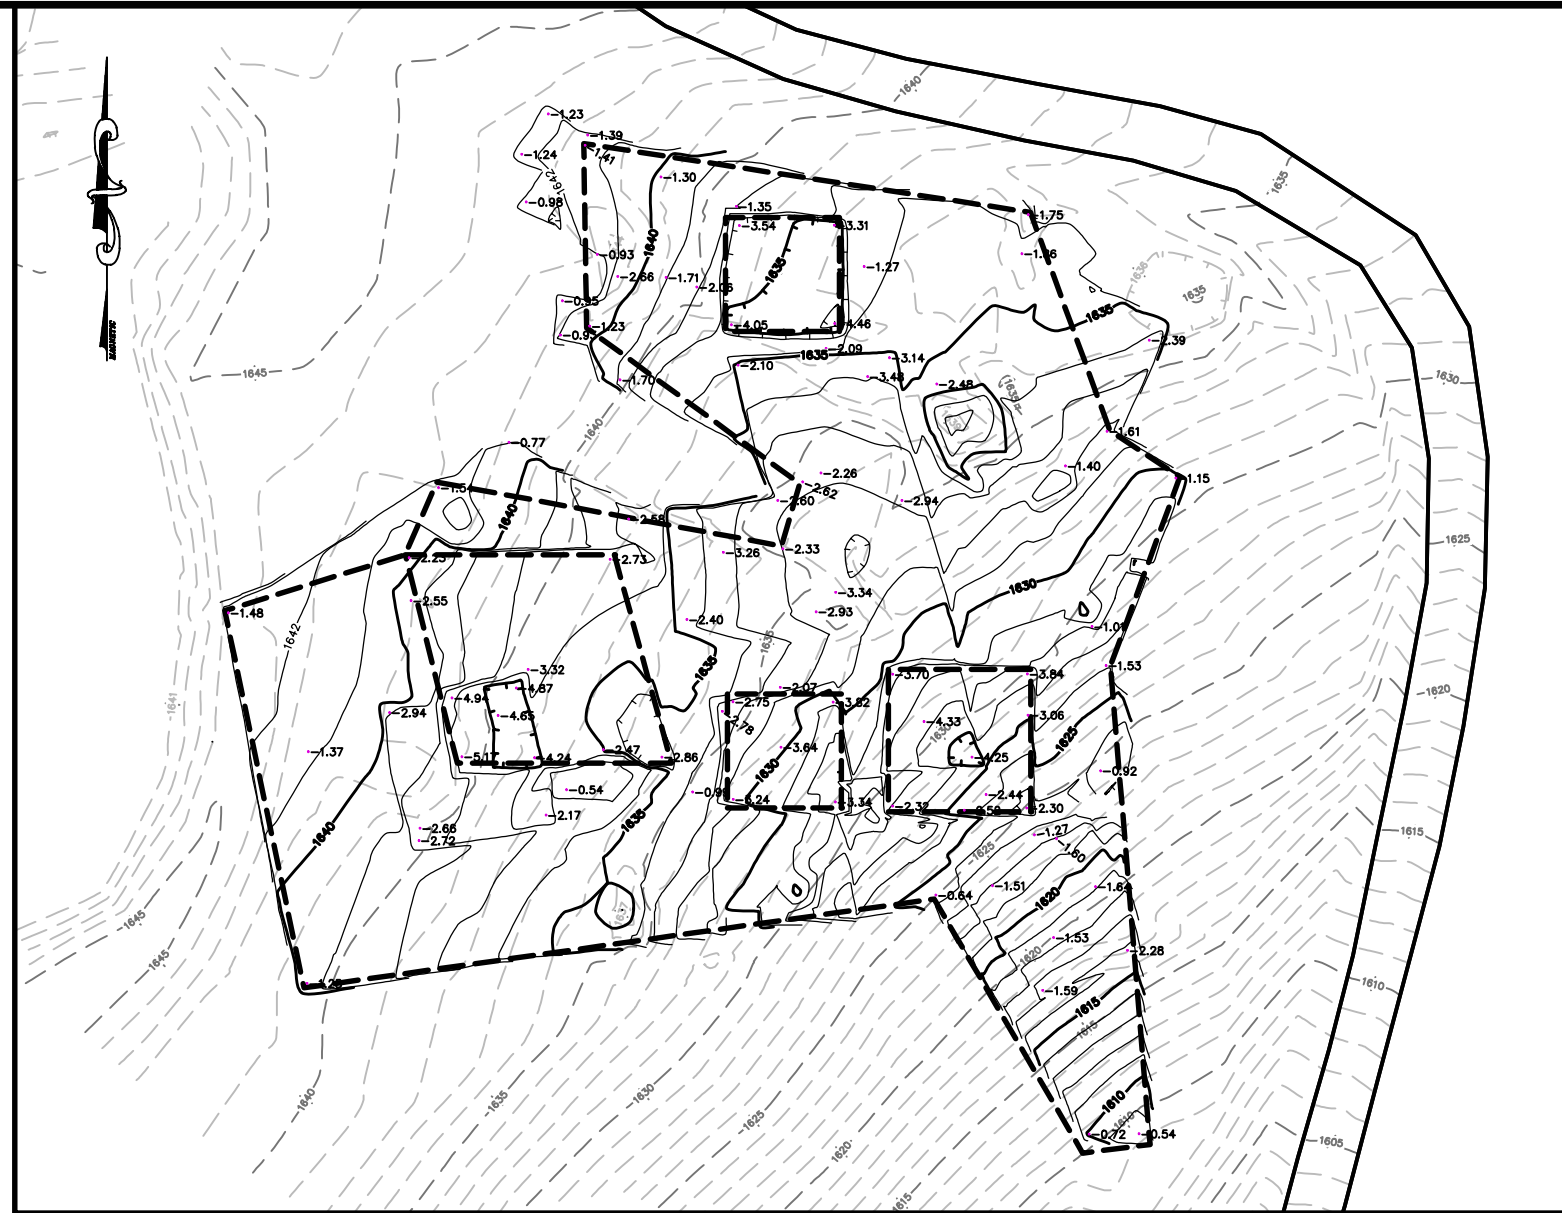
**TEST PIT TP-3**

**TEST PIT TP-7/16**

**TEST PIT TP-5**

**FORMER DRUM DISPOSAL AREA**

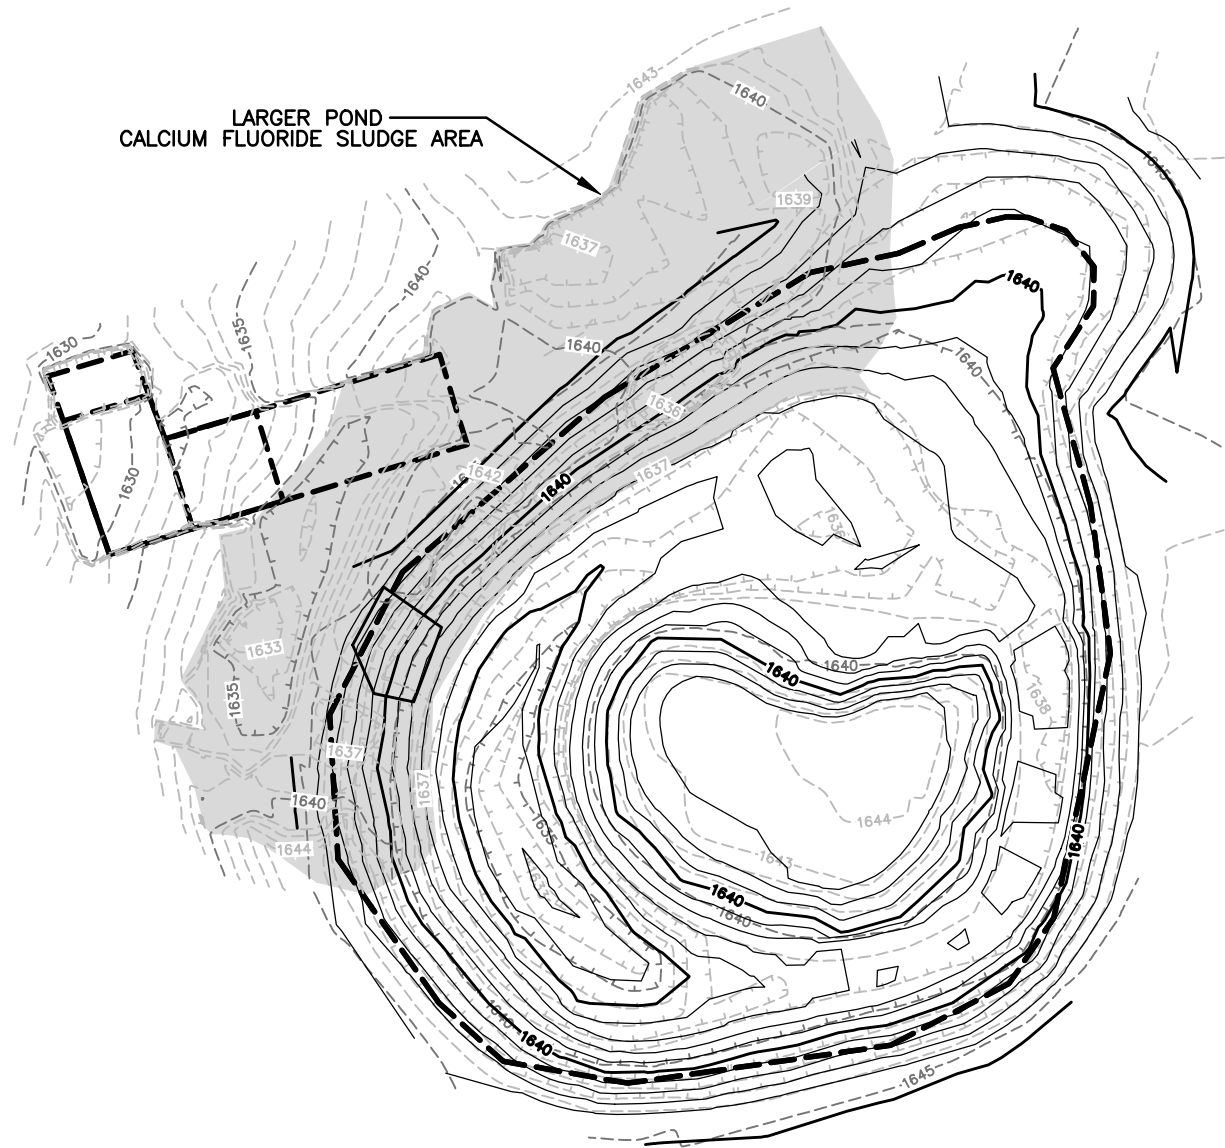
**LARGER POND**  
1" = 20'

**SMALLER POND**  
1" = 10'

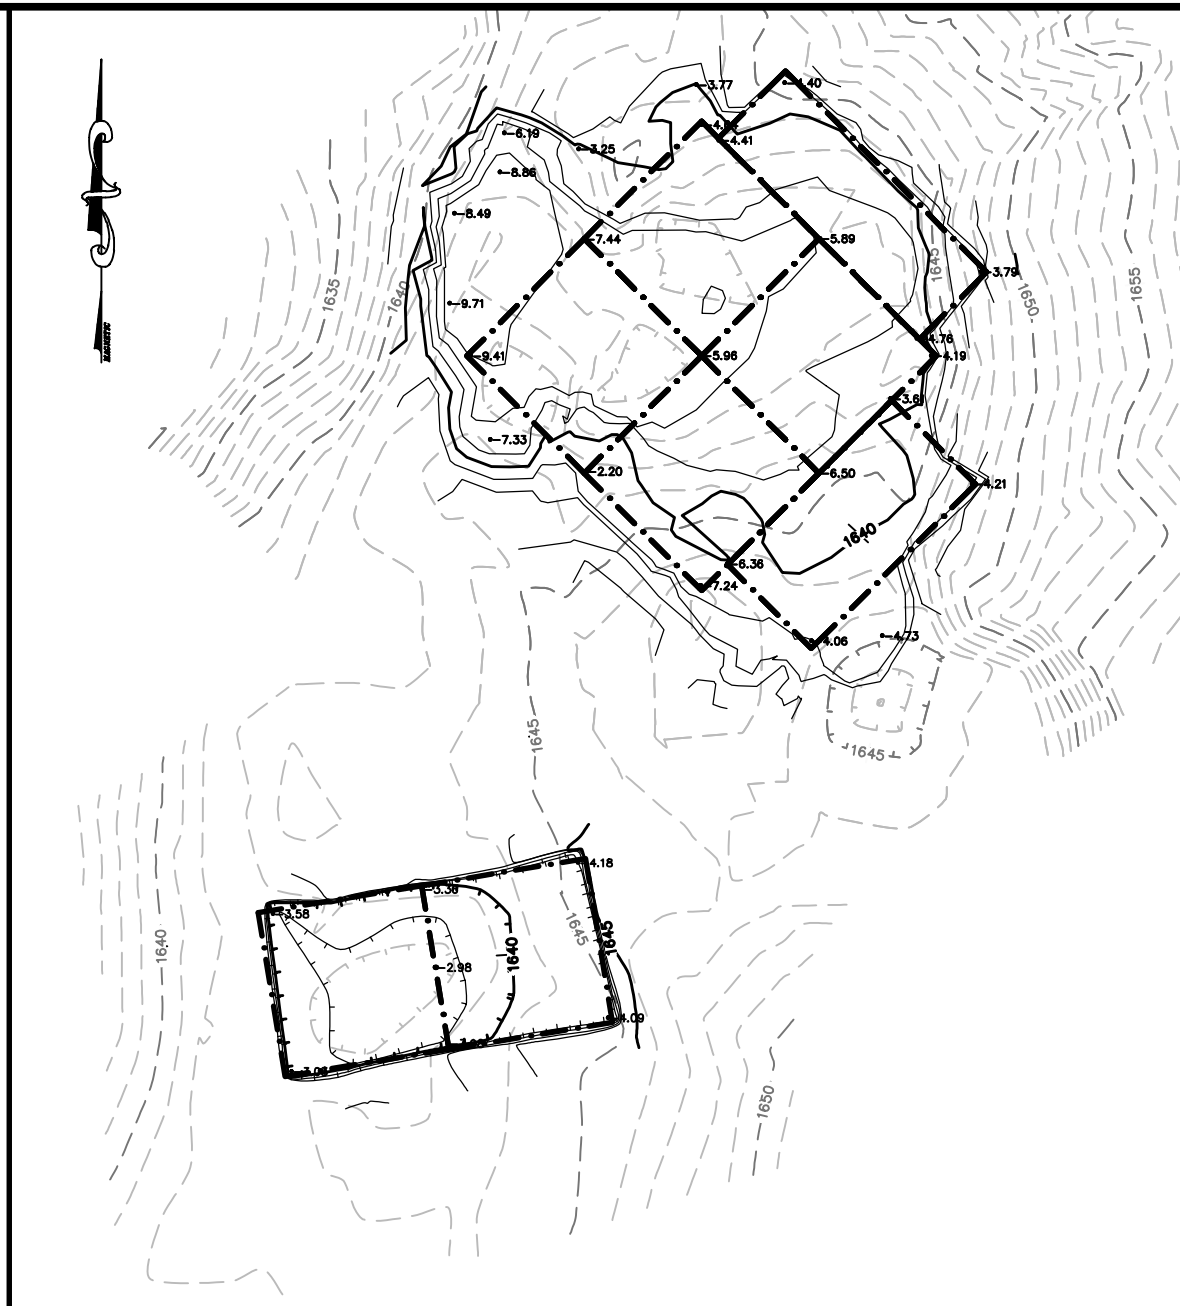
- - - - - LIMITS OF IN SITU SOIL TREATMENT
- EXISTING GRADE CONTOUR
- - - - - EXISTING GRADE CONTOUR DEPRESSION
- 1640— EXCAVATED SOIL CONTOUR
- - - - - EXCAVATED SOIL CONTOUR DEPRESSION
- -6.36 EXCAVATED DEPTH

The 1997 NYSDEC focused RI identified a 0.2-acre “suspected calcium fluoride sludge disposal area” within the MSW disposal area at the Site, although details regarding the basis of this delineation were not provided and its location was not consistent with the descriptions provided in earlier Site evaluations (Engineering-Science, Inc., 1988). In the RI, CFS was not observed in test pits excavated in the “suspected calcium fluoride sludge disposal area.” In addition, none of the RI soil samples collected at these test pits exhibited cadmium concentrations above the Commercial SCO. In the RI, a buried lens of CFS, approximately four feet thick, was visibly identified in a test pit (TP-19) excavated within the MSW disposal area at a location approximately 100 feet north of the NYSDEC “suspected calcium fluoride sludge disposal area.” Testing of this visibly distinctive material showed it to exhibit the characteristic of a Resource Conservation and Recovery Act (RCRA) hazardous waste due to the cadmium concentration by the Toxicity Characteristic Leaching Procedure (i.e., 2.1 milligrams per liter [mg/l]) versus the regulatory threshold of 1.0 mg/l. Total cadmium concentrations were not elevated in soil samples collected above or below the CFS. Sludge was not observed in any of the other 18 test pits excavated in the MSW disposal area during the 2011 RI. The RI data were used to refine the limits of CFS; however, during implementation of remedial actions, CFS was additionally encountered to the west of the Large Pond, and CFS material was found to extend beyond the defined areas. The actual quantity of CFS remediated was approximately 3,750 cy (Figure 5).

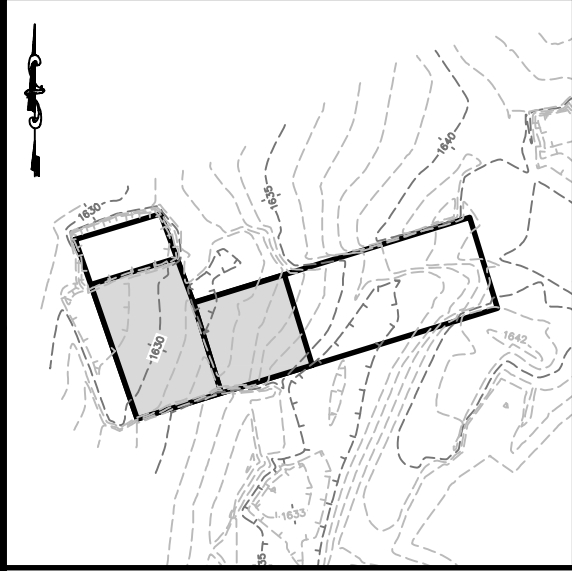
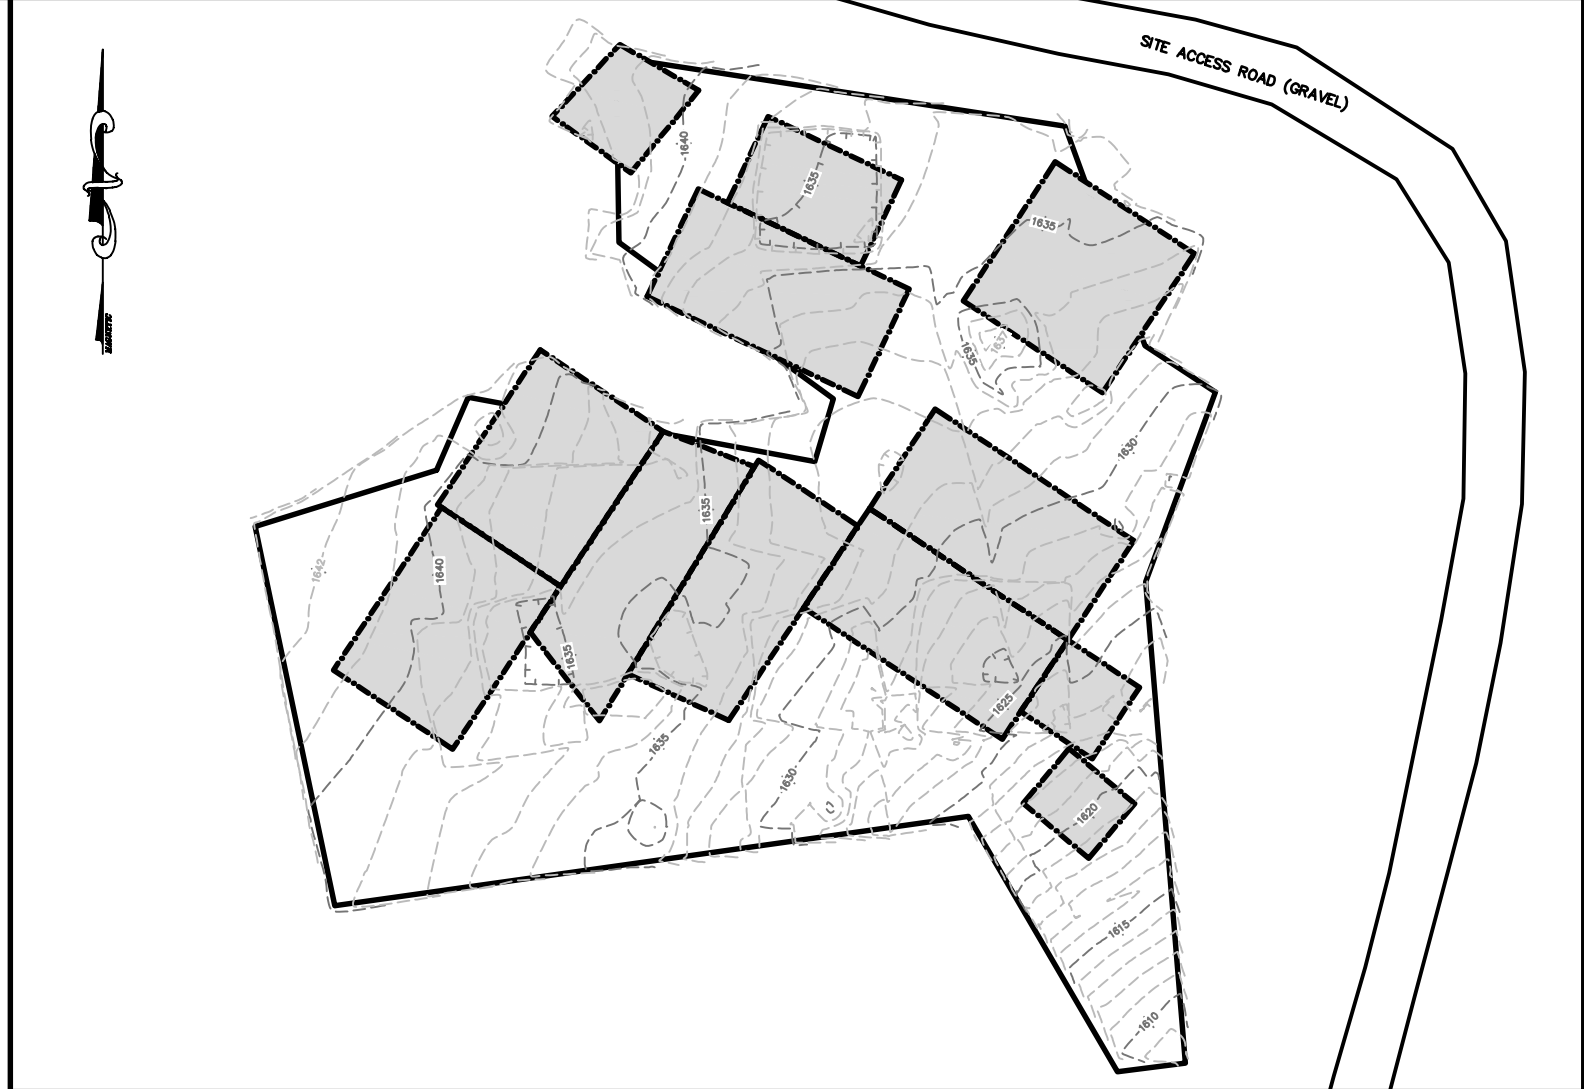
DRAWN BY: <i>D.J. Martino</i>	DATE: <i>1-22-14</i>	FIGURE NUMBER
CHECKED BY: <i>R.P. HRENKO</i>	DATE: <i>8-6-14</i>	<b>6</b>
APPROVED BY: <i>A.E. PROCTOR</i>	DATE: <i>8-6-14</i>

**TEST PIT TP-7/16**  
1" = 20'

**FORMER DRUM DISPOSAL AREA**  
1" = 20'

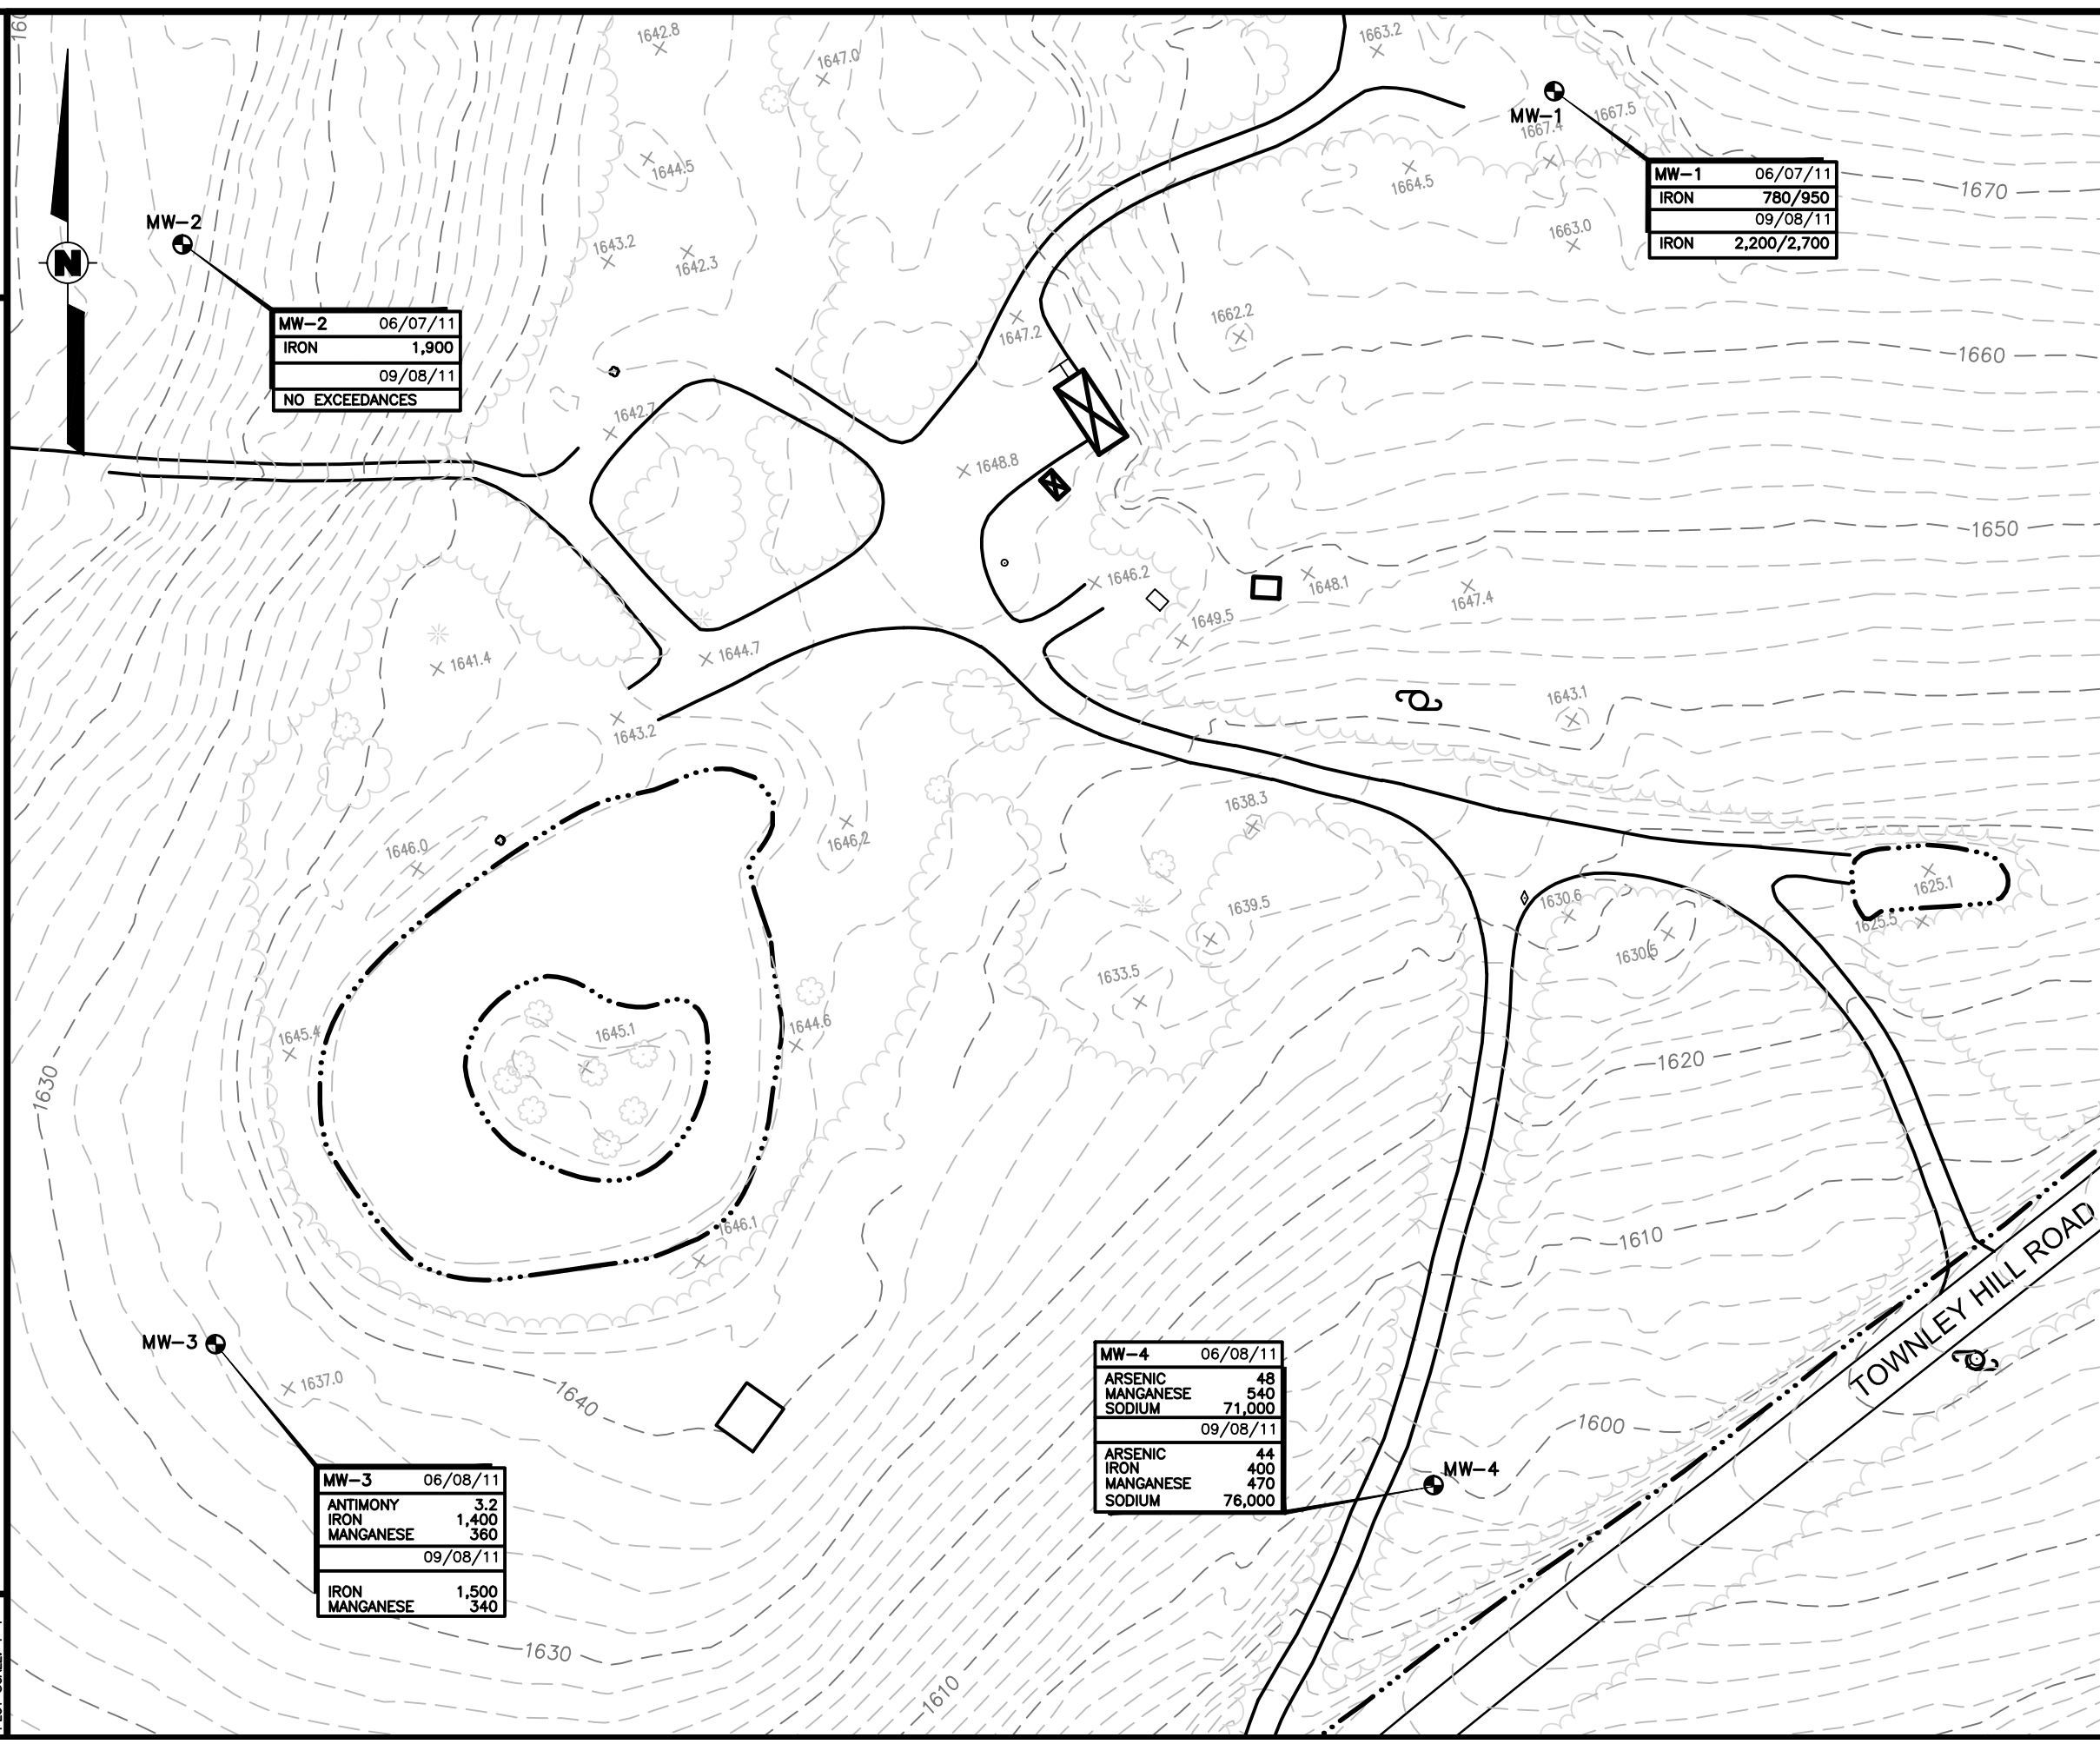
8

MW-2	06/07/11
IRON	1,900
	09/08/11
NO EXCEEDANCES

MW-1	06/07/11
IRON	780/950
	09/08/11
IRON	2,200/2,700
