**SITE MANAGEMENT PLAN  
TOWNLEY HILL ROAD DUMP SITE  
NEW YORK STATE  
DEPARTMENT OF ENVIRONMENTAL CONSERVATION  
SITE REGISTRY NO. 8-08-006  
CATLIN, CHEMUNG COUNTY, NEW YORK**

**PREPARED FOR:  
CBS CORPORATION  
20 STANWIX STREET, 10<sup>TH</sup> FLOOR  
PITTSBURGH, PA 15222**

**PREPARED BY:  
CUMMINGS/RITER CONSULTANTS, INC.  
A WOODARD & CURRAN COMPANY  
300 PENN CENTER BLVD., SUITE 800  
PITTSBURGH, PA 15235**

**PROJECT NO. 01304.30/05  
SEPTEMBER 2014**

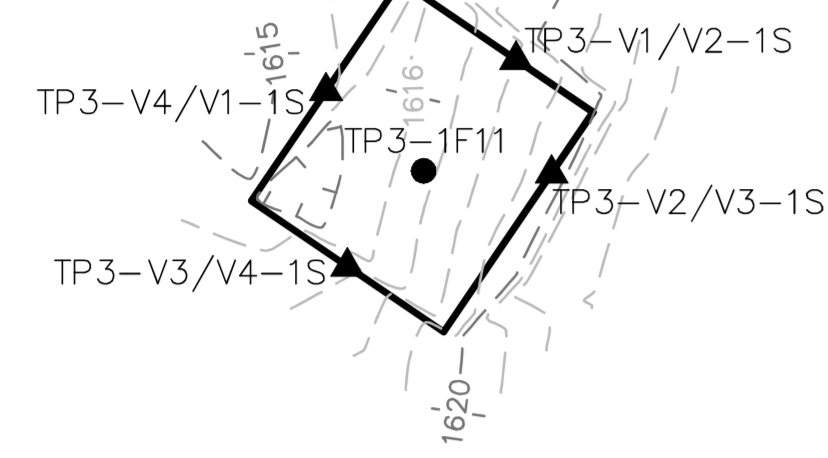
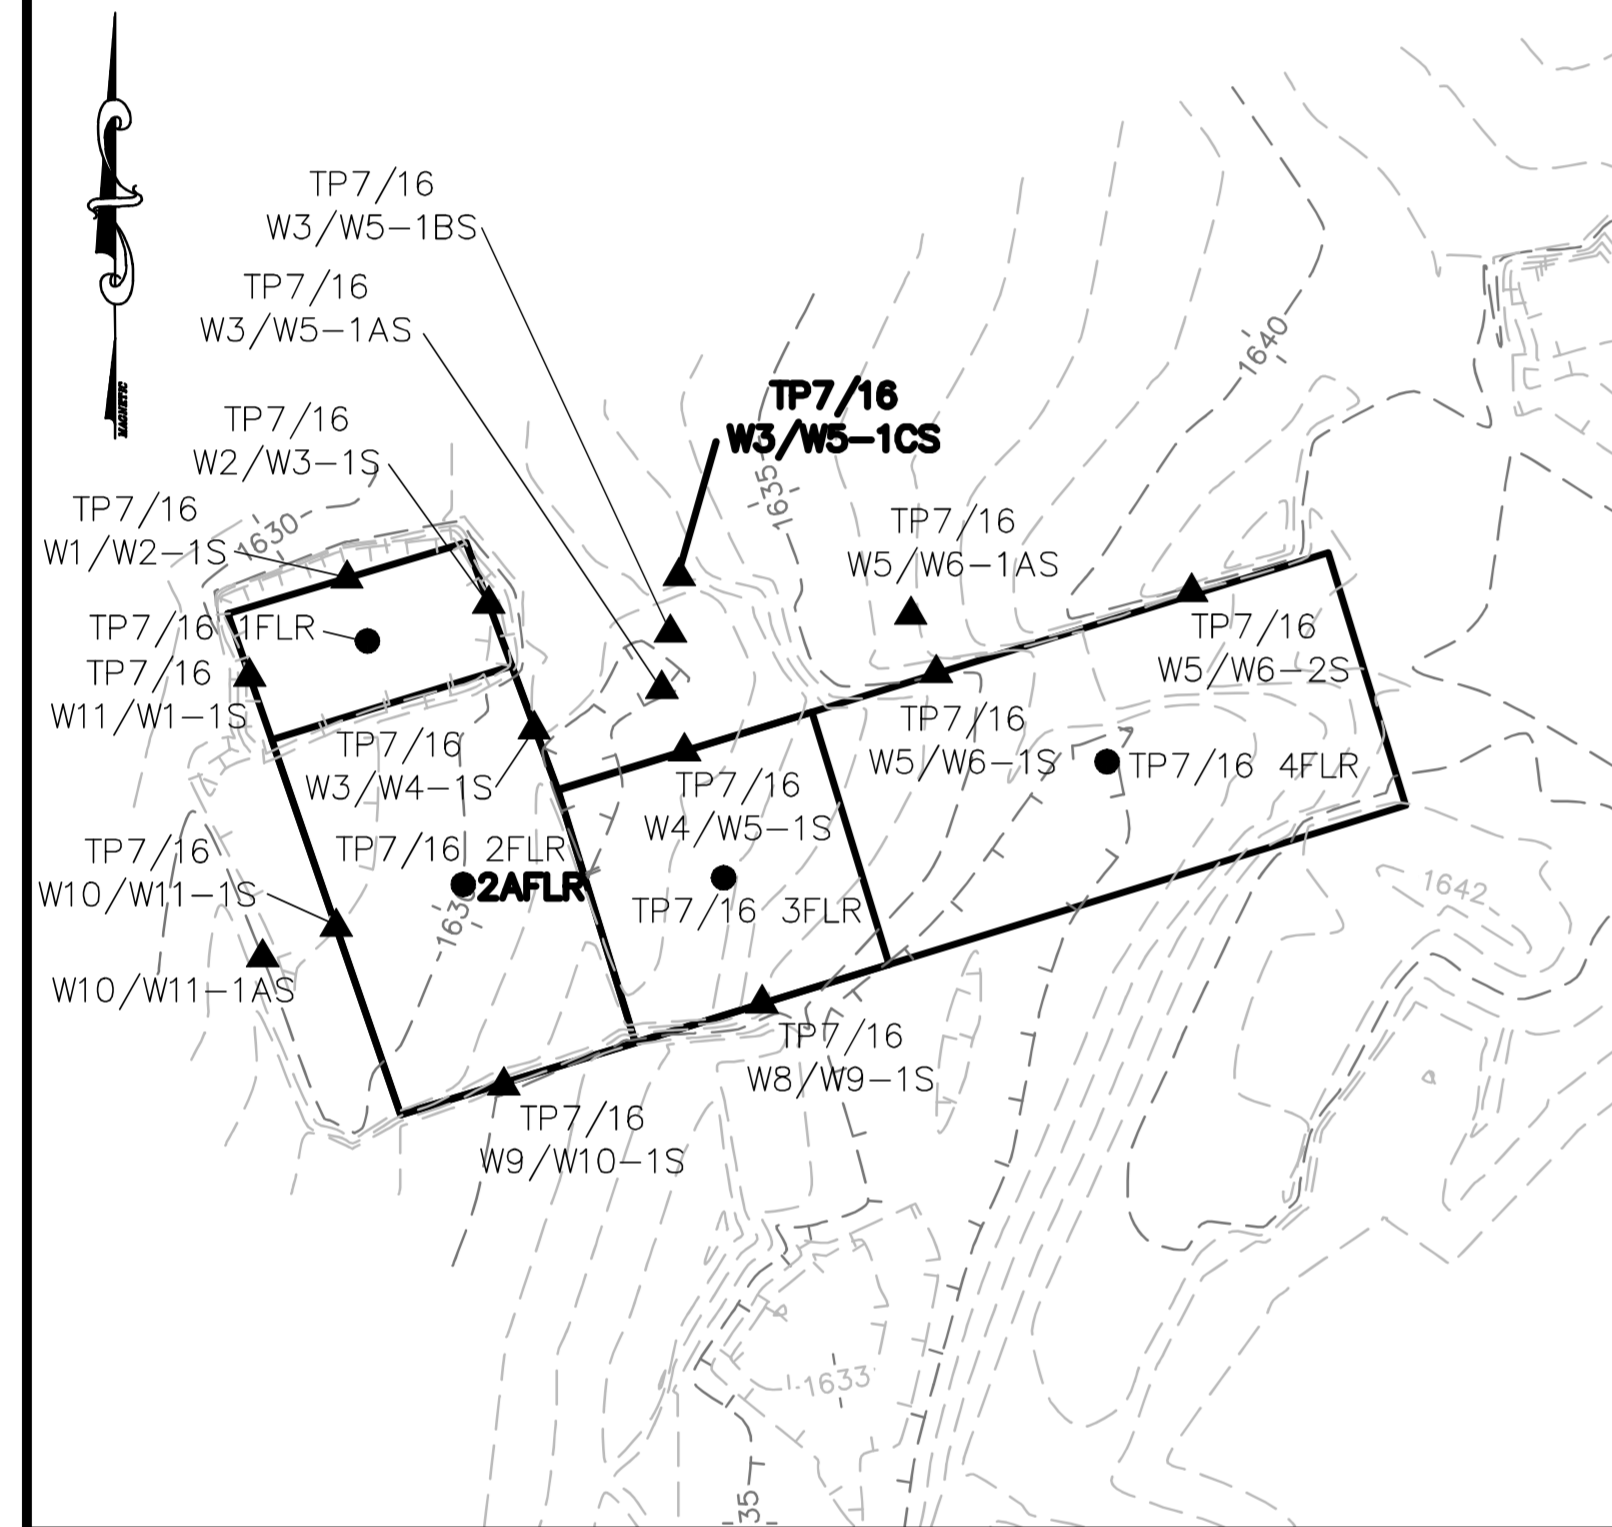
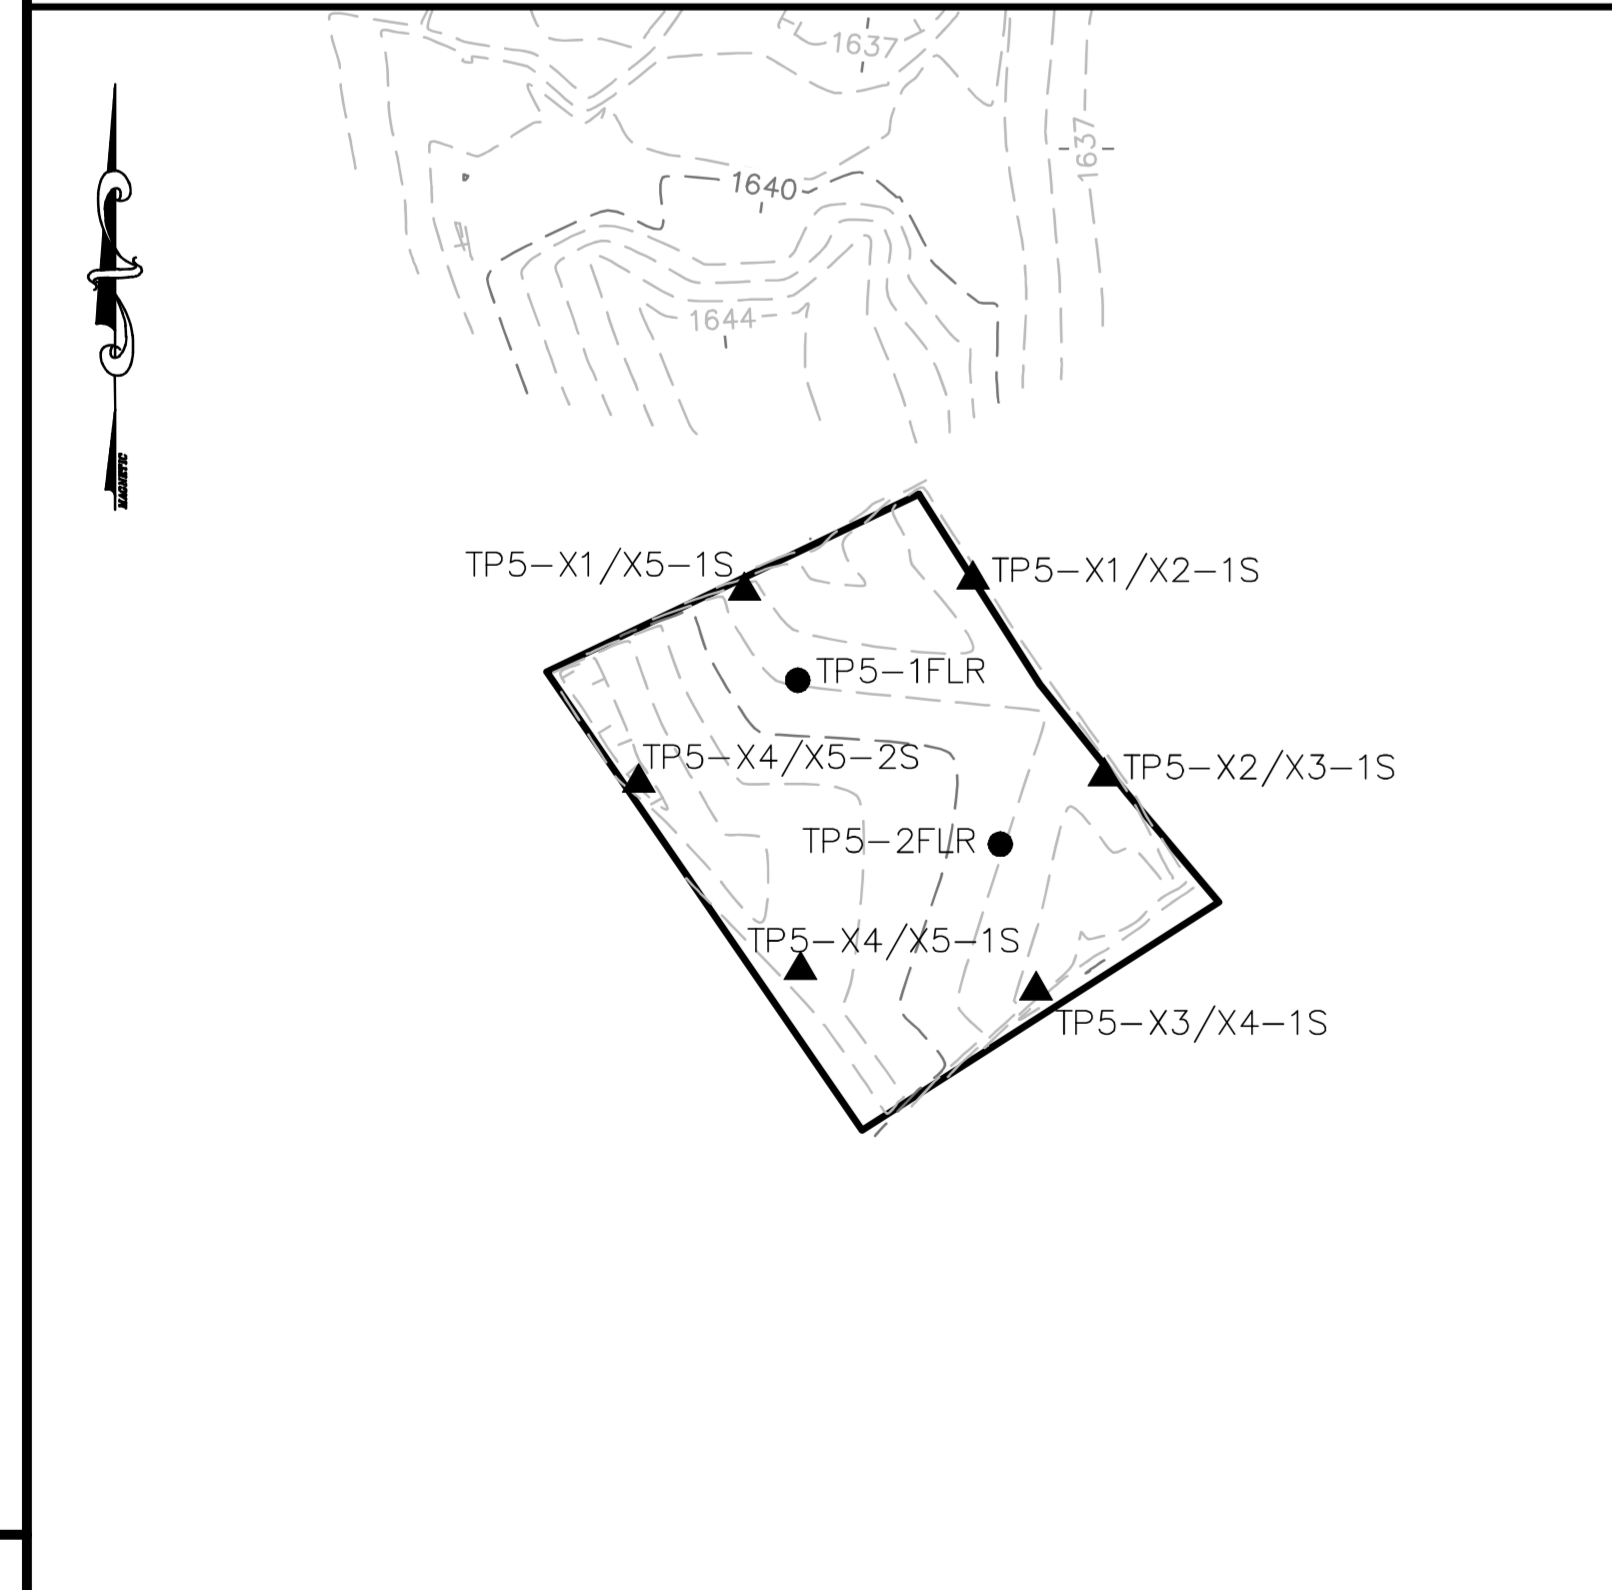
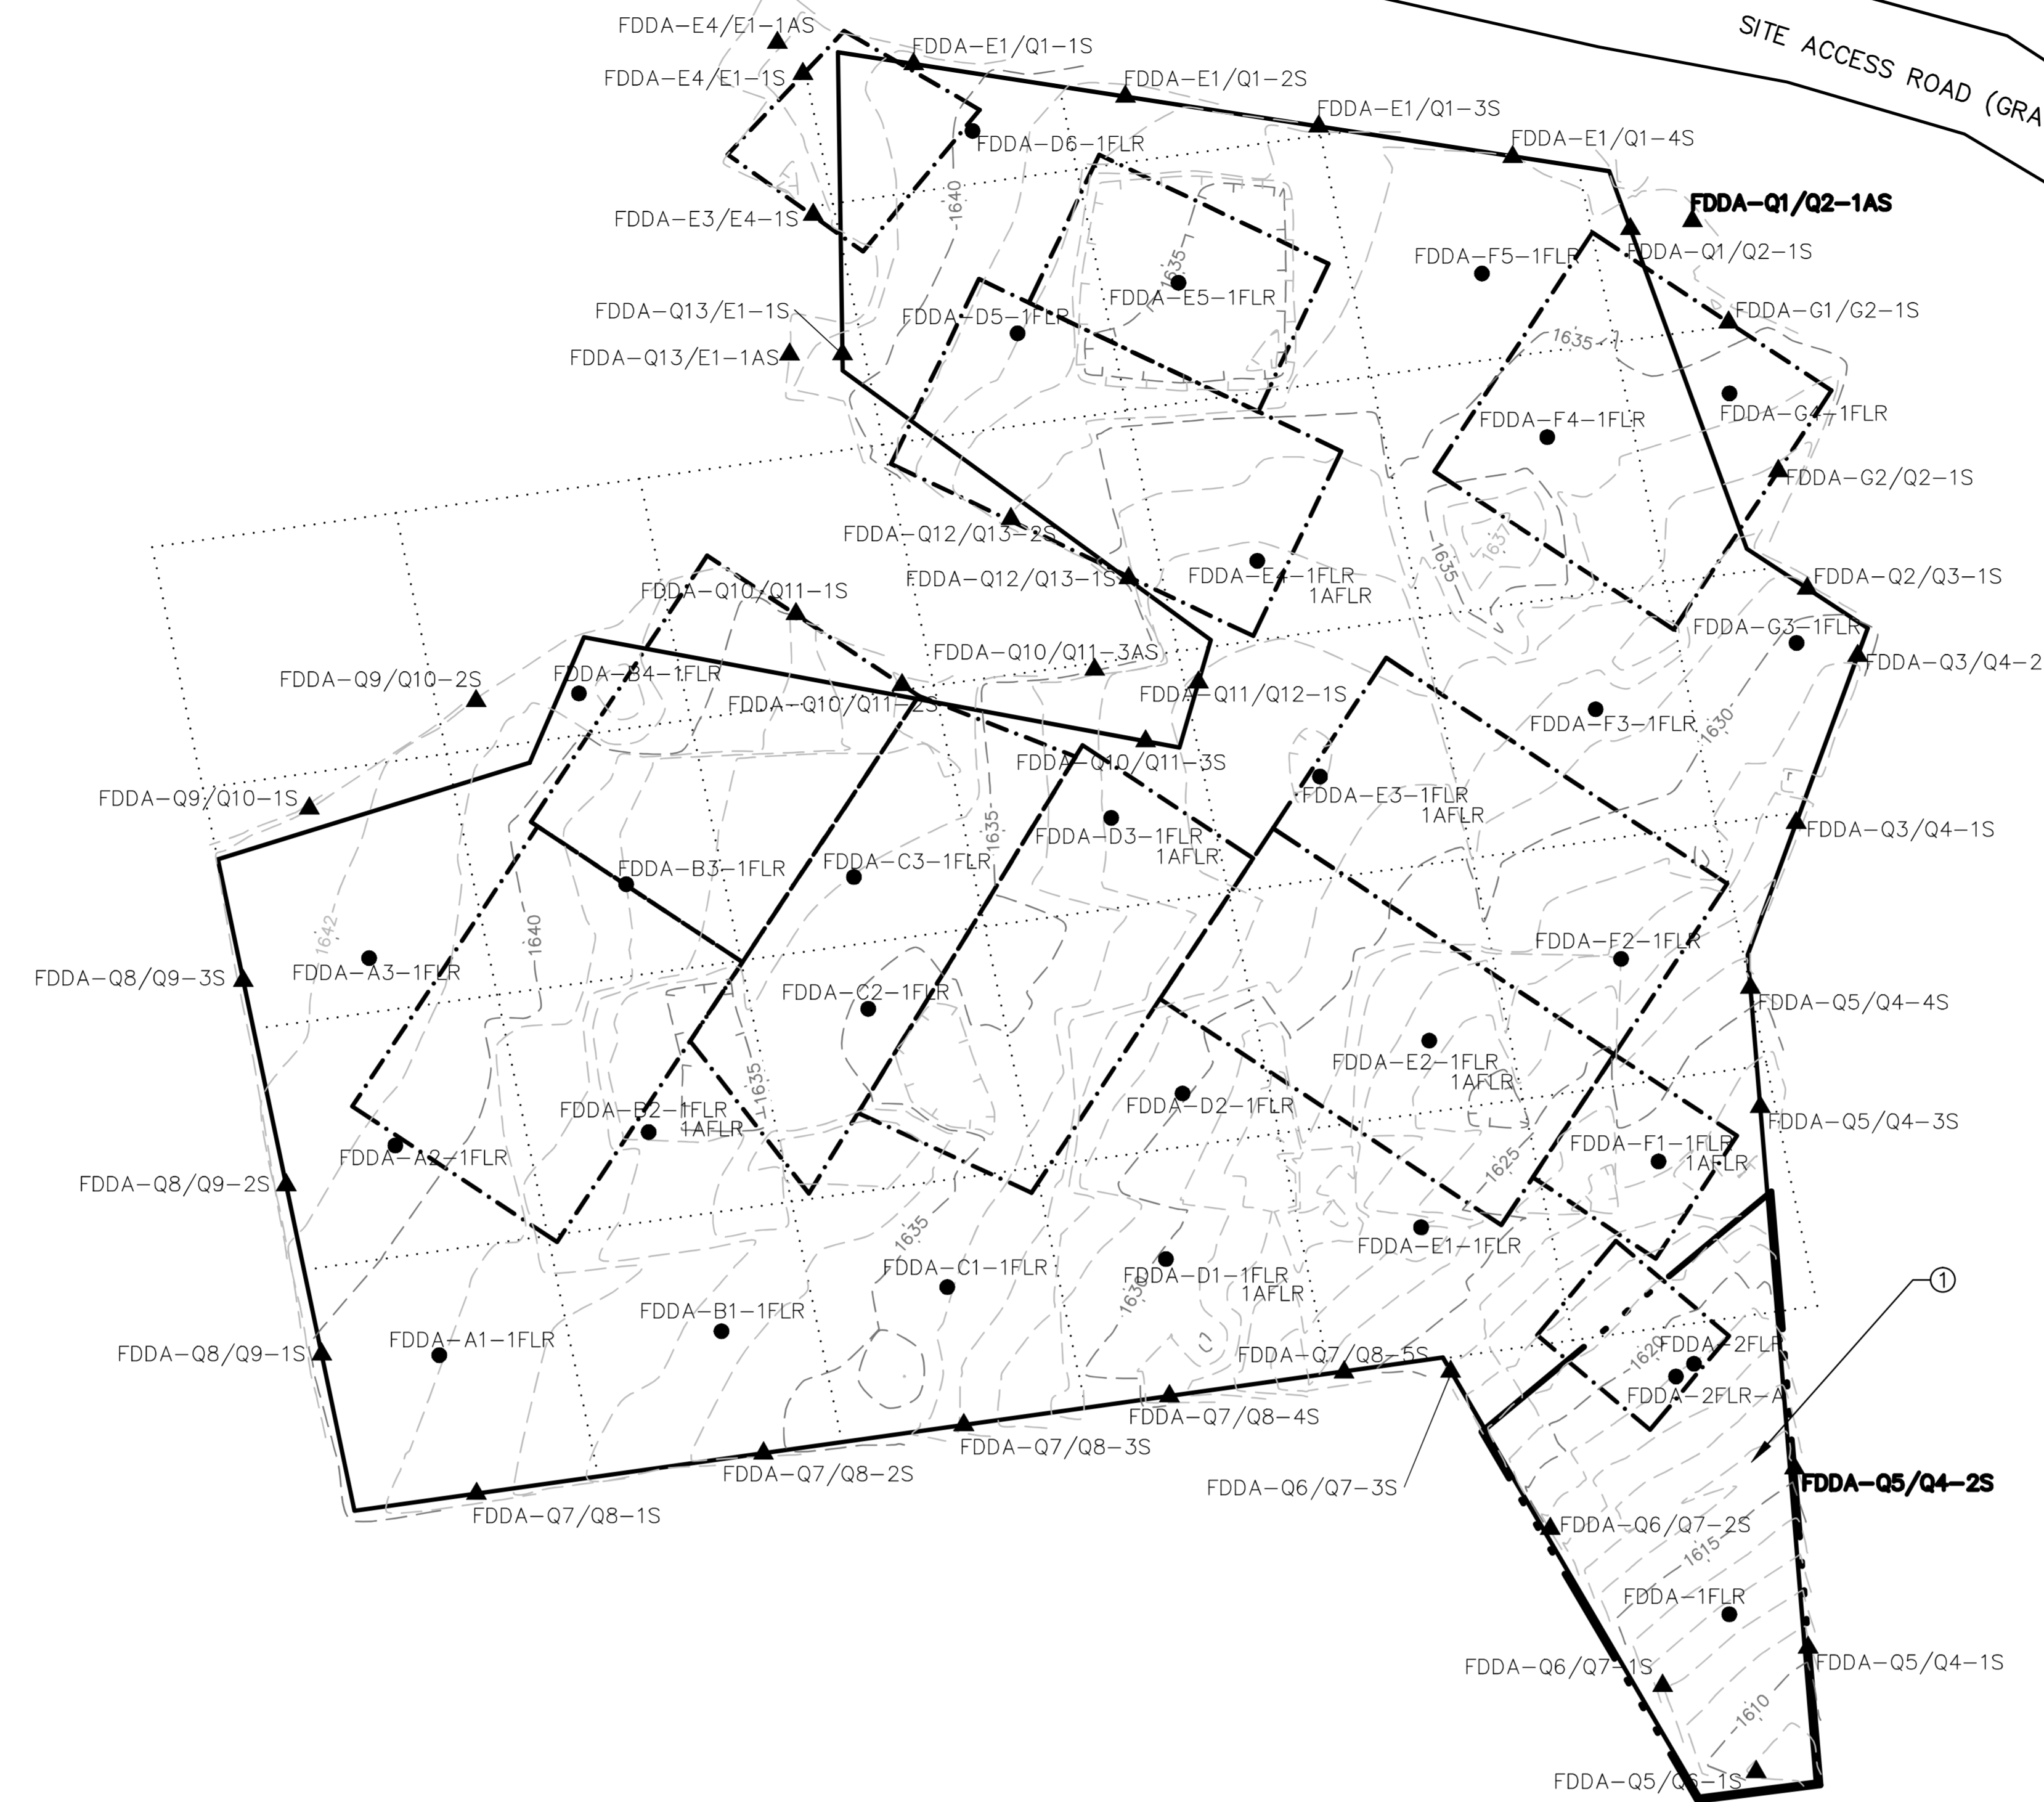
DRAWN BY: <i>D.J. Martino</i>	DATE: 1-22-14	FIGURE NUMBER
CHECKED BY: <i>R.P. HRENKO</i>	DATE: 8-6-14	<b>9</b>
APPROVED BY: <i>A.E. PROCTOR</i>	DATE: 8-6-14

**TEST PIT TP-3**  
1" = 20'

**TEST PIT TP-7/16**  
1" = 20'

**TEST PIT TP-5**  
1" = 20'

**FORMER DRUM DISPOSAL AREA**  
1" = 20'

- (e) Indicates that a duplicate sample was collected.
- (f) Bold results indicate an exceedance of the Restricted Use Soil Cleanup Objective - Commercial which was subsequently excavated.

- (g) Bold and Shaded result indicates an exceedance of the Restricted Use Soil Cleanup Objective - Commercial which was left in place.

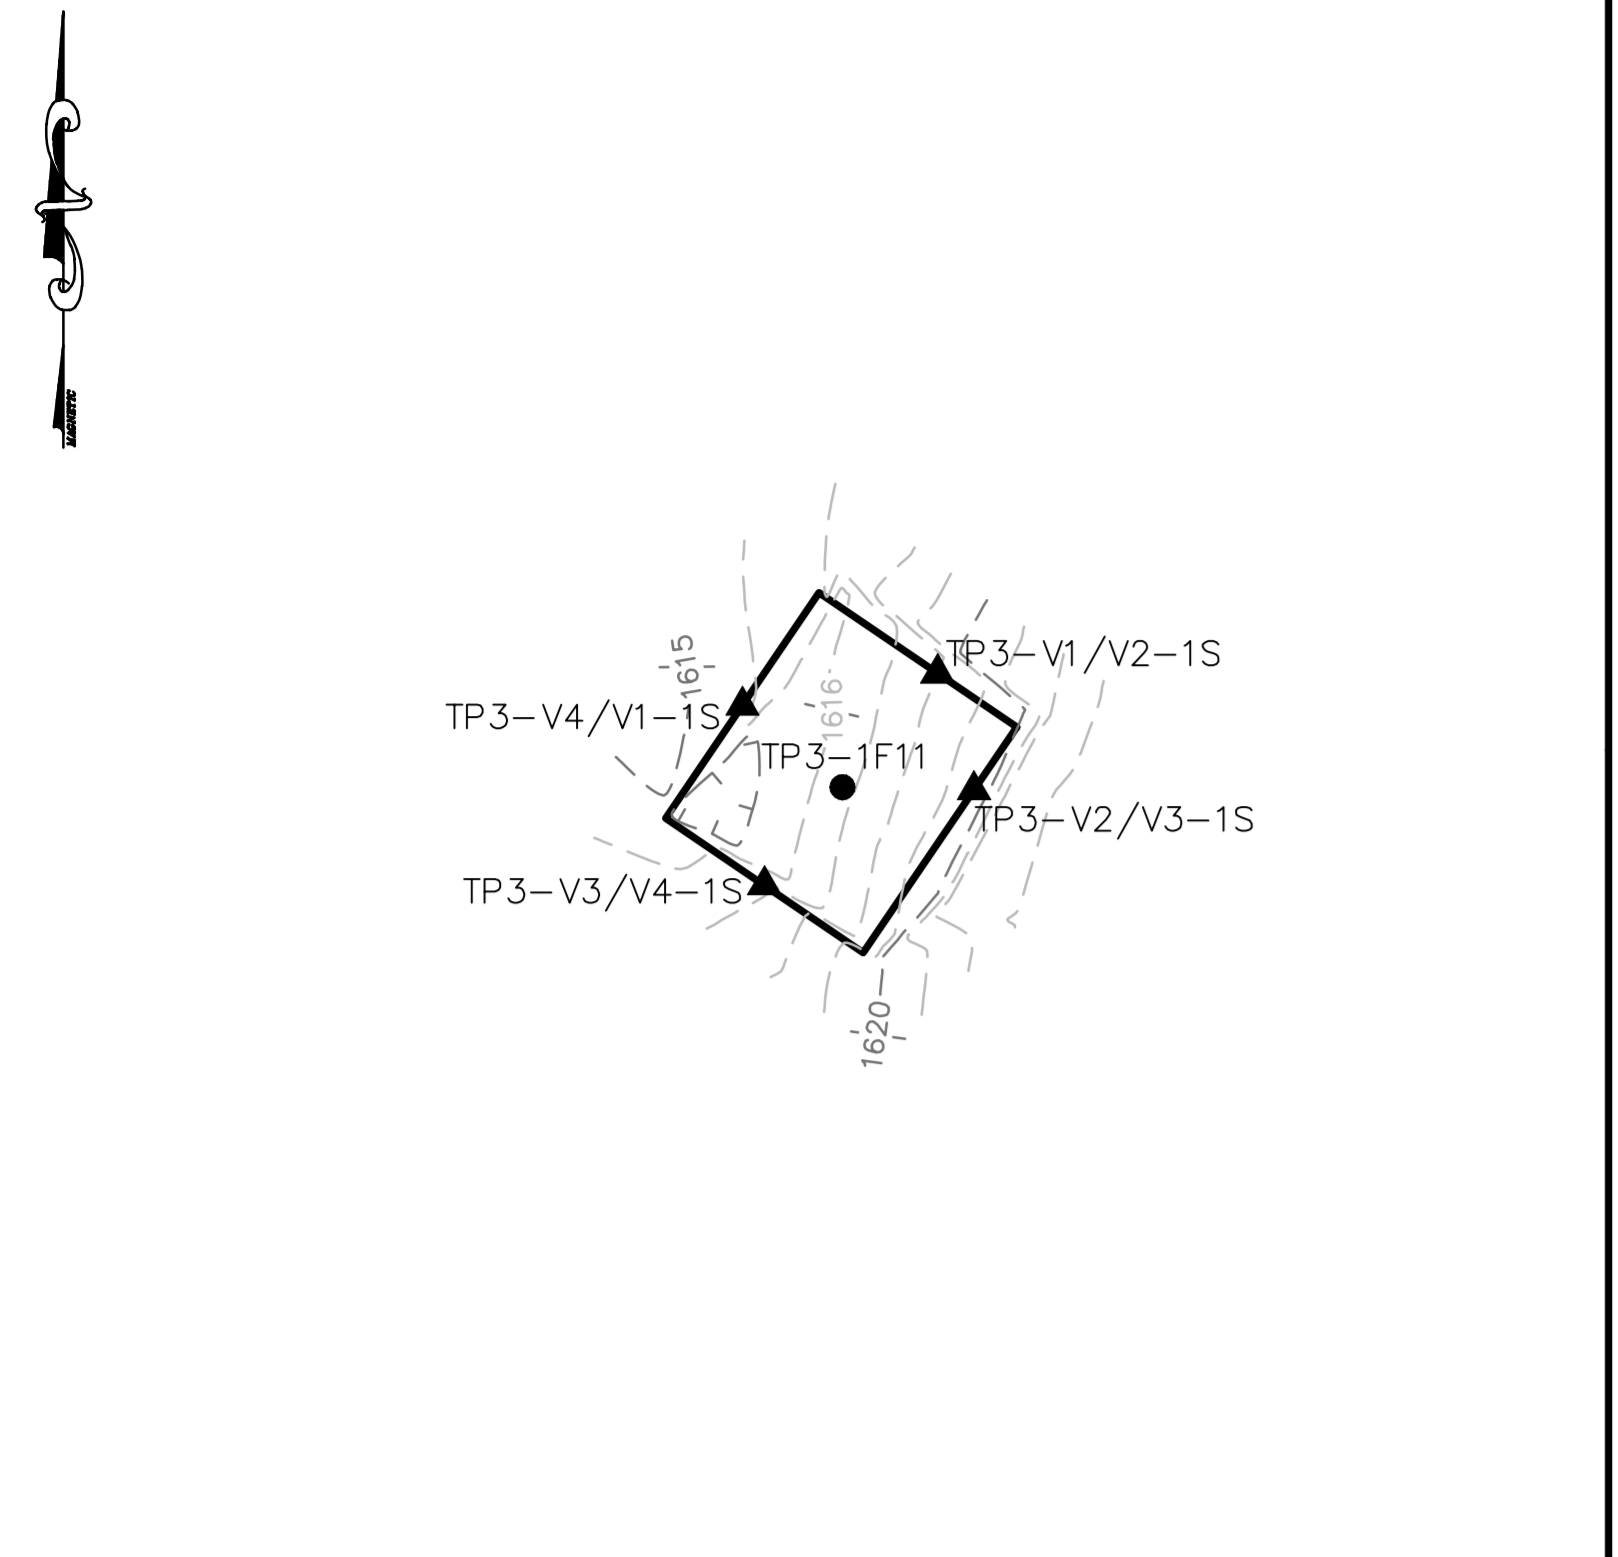
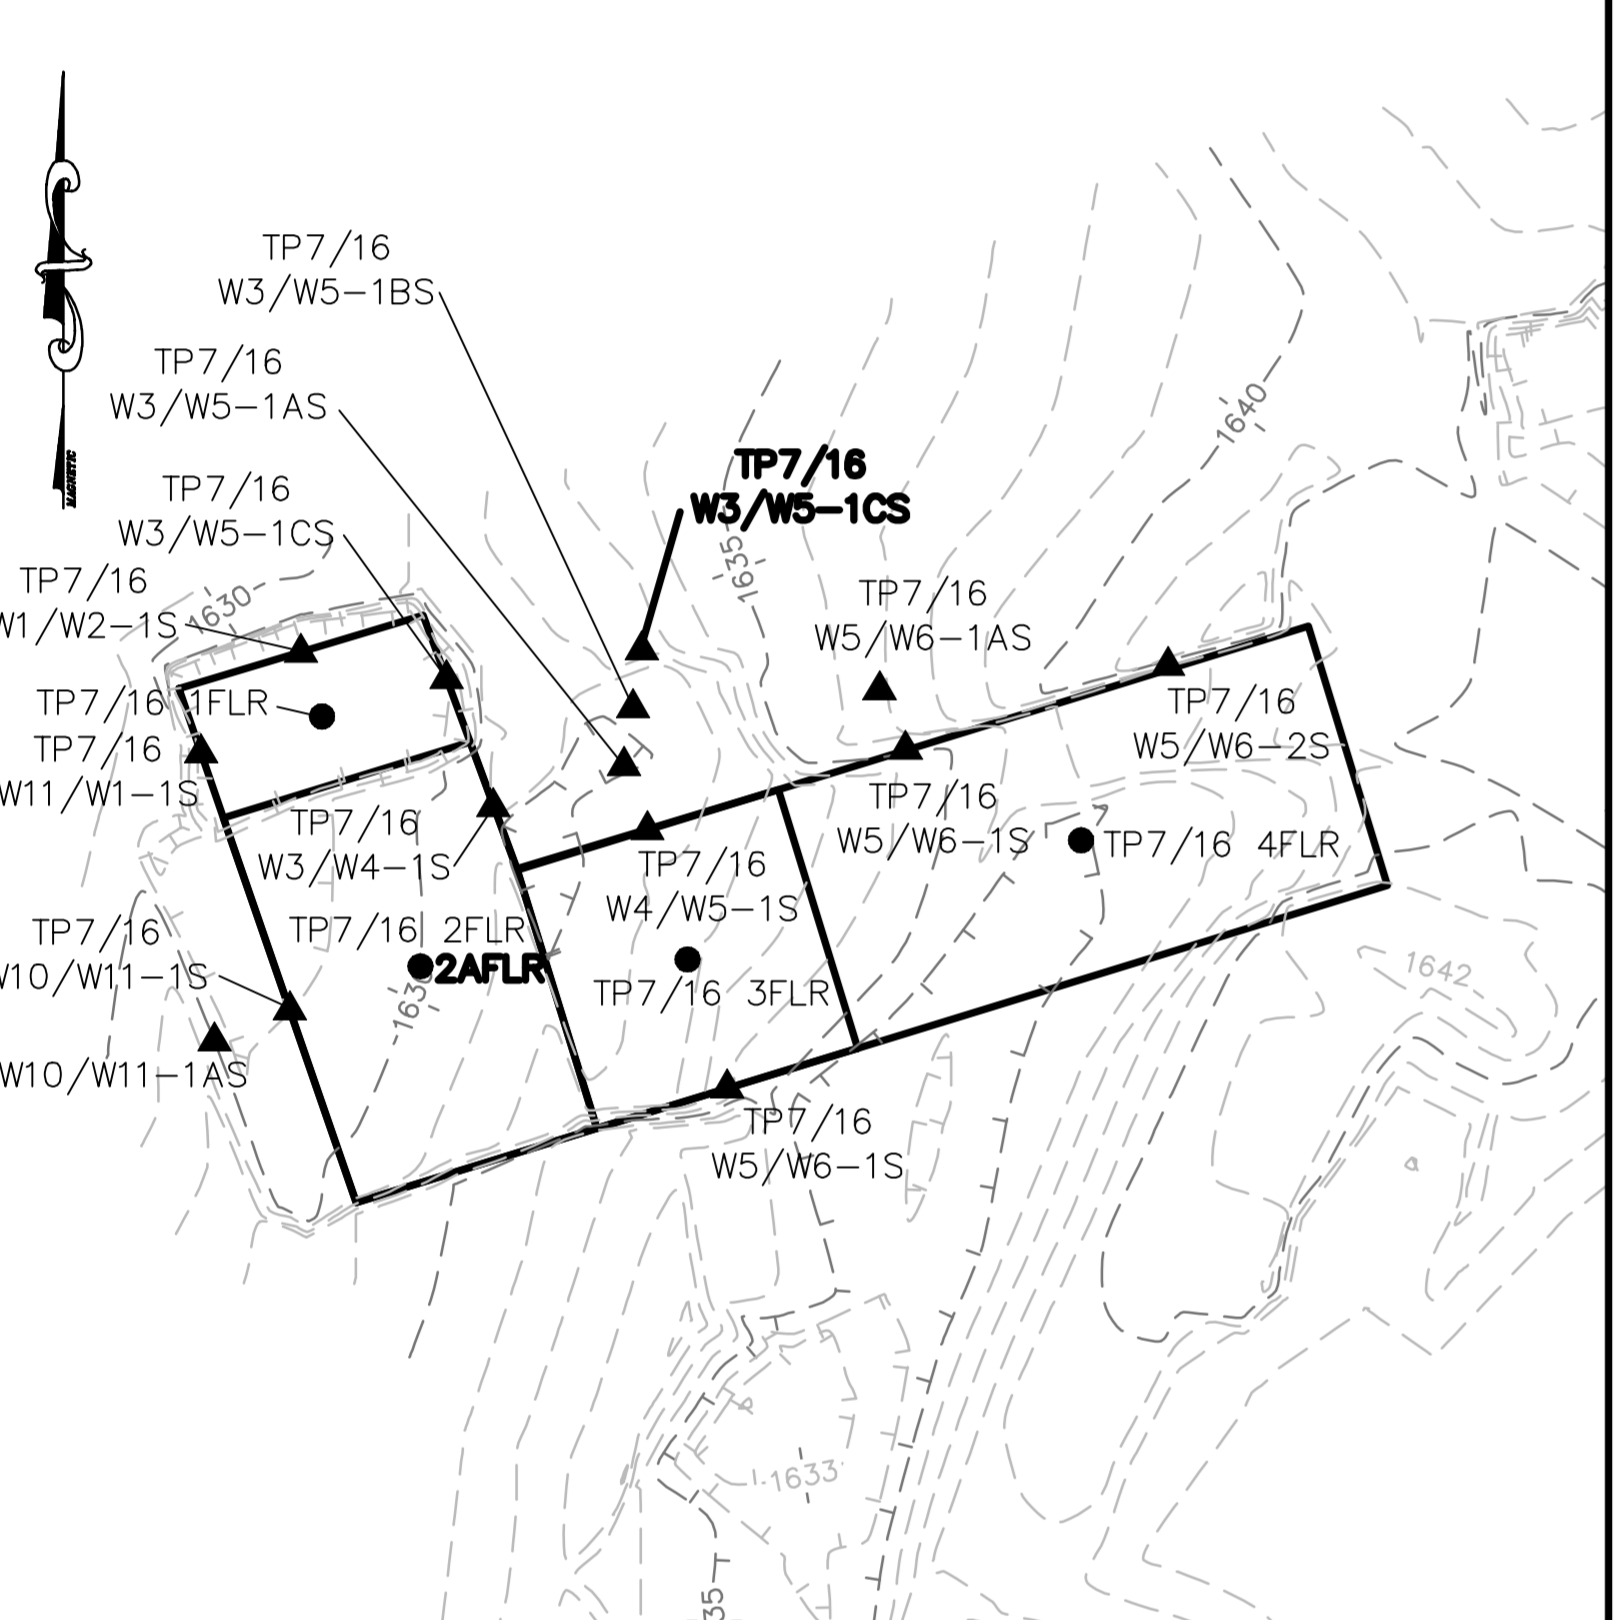
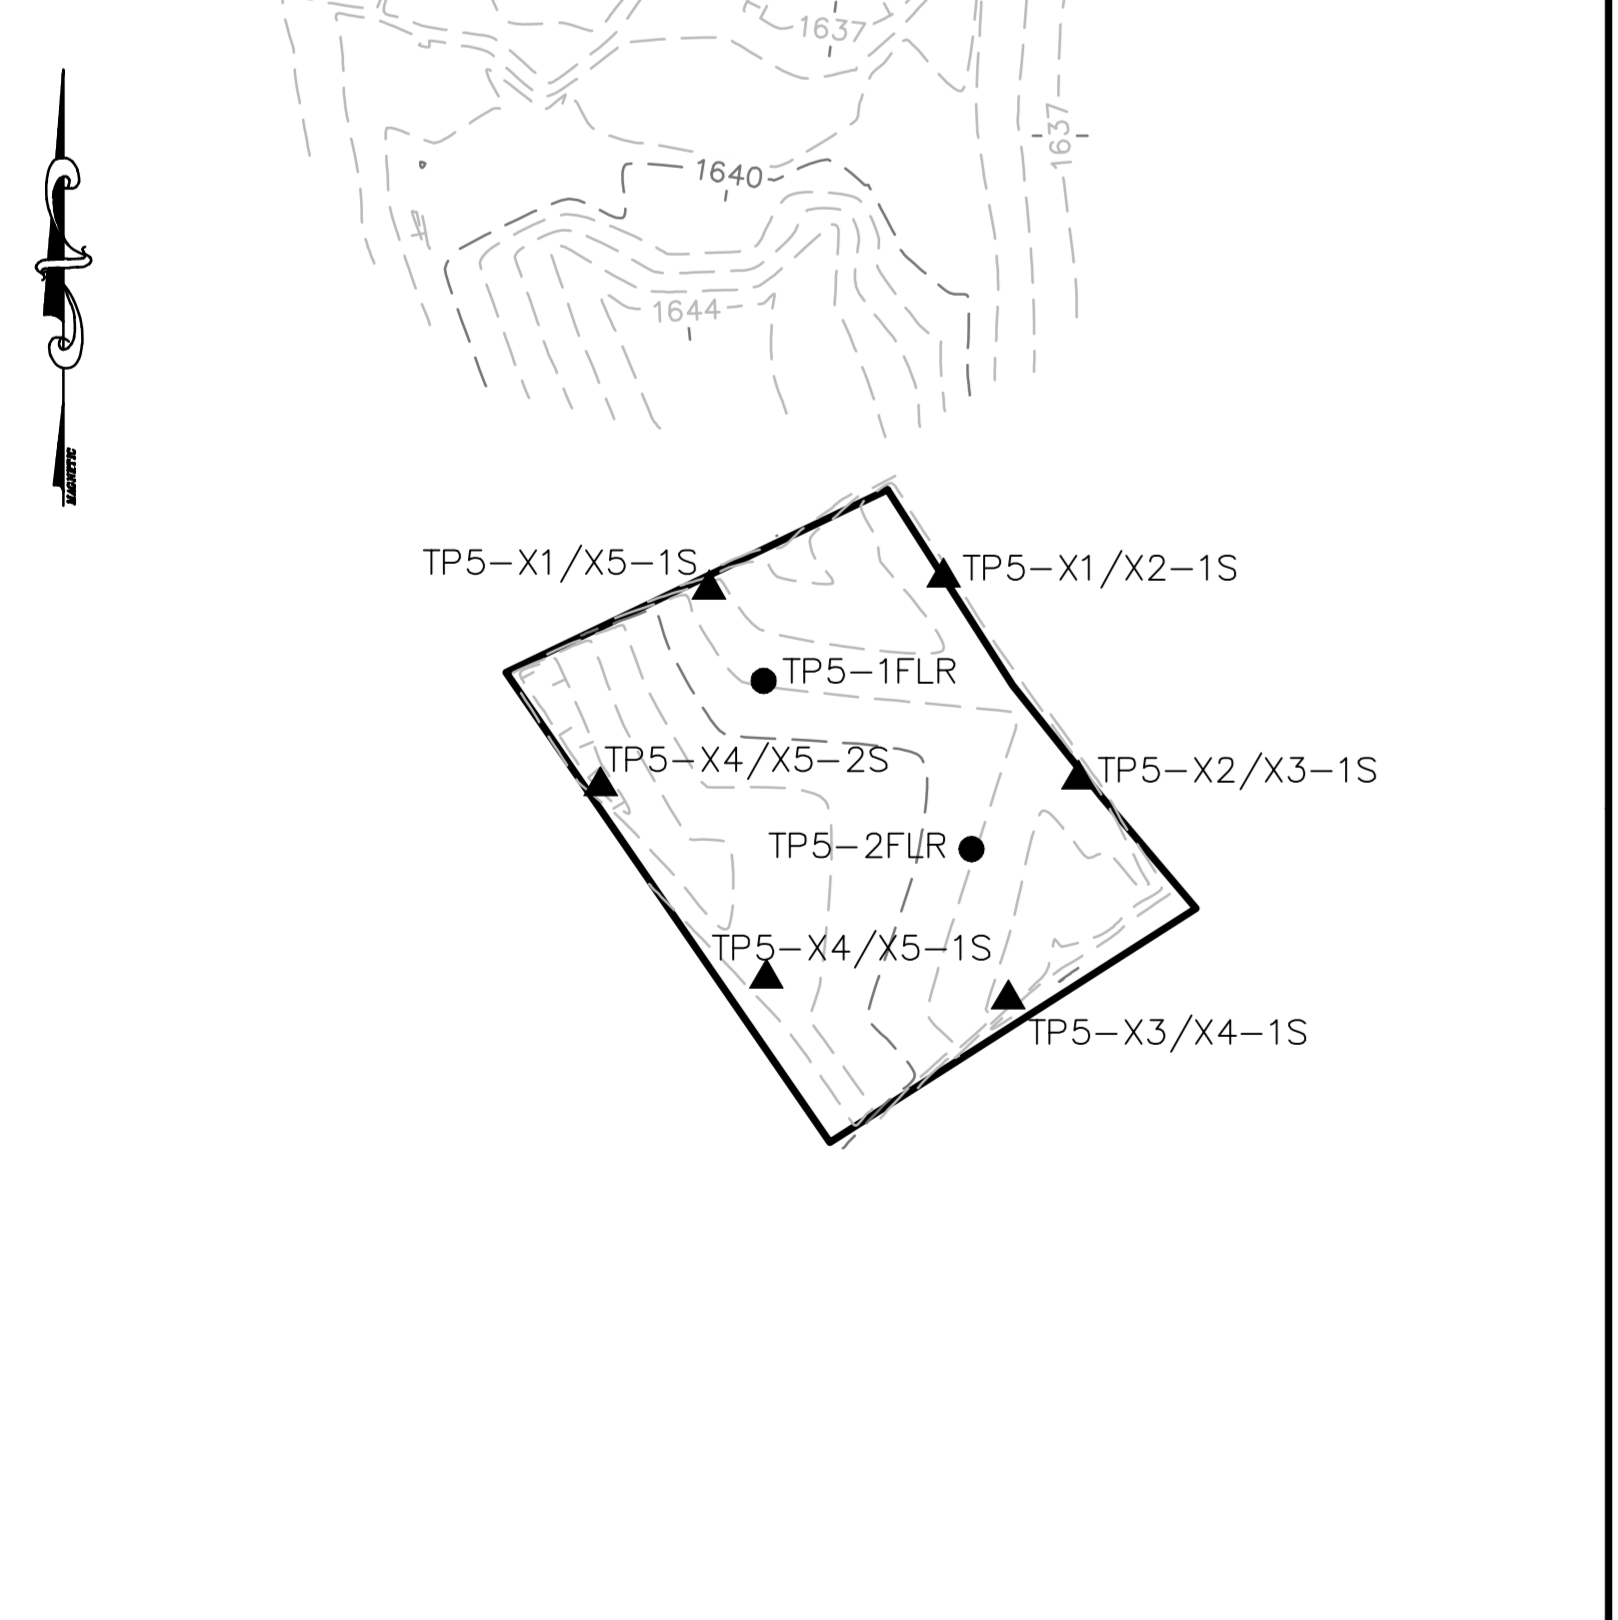
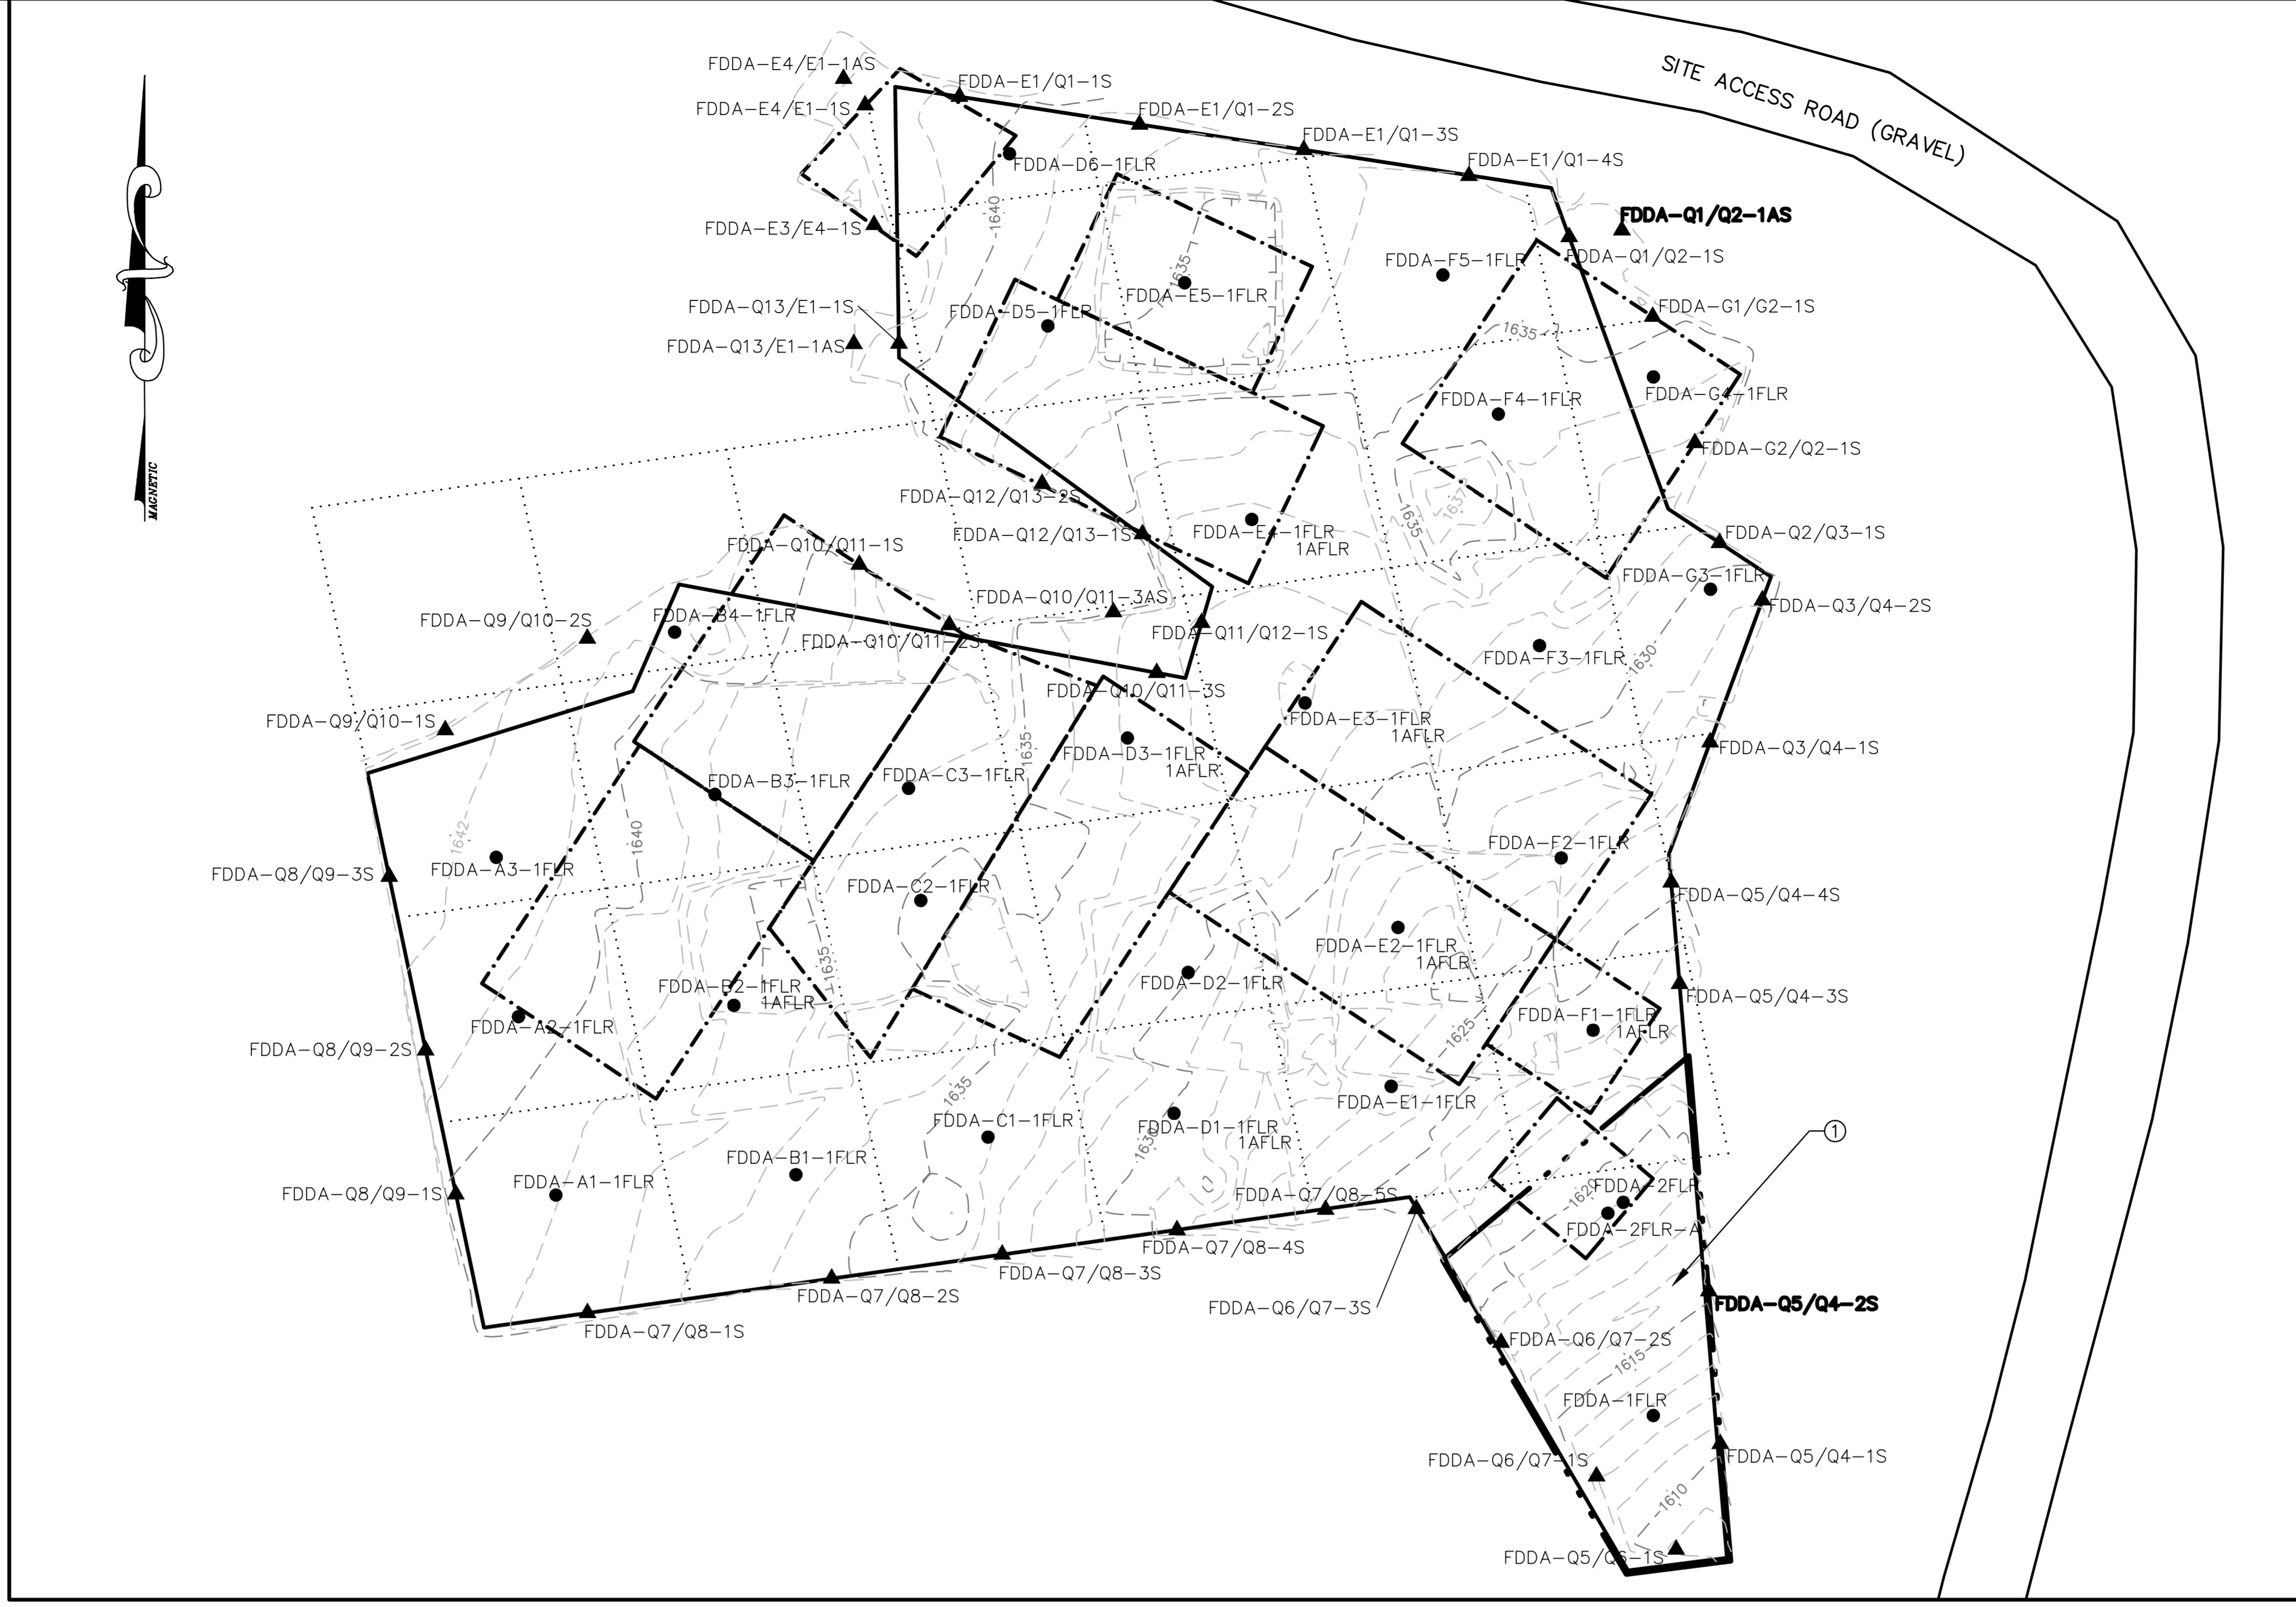
DRAWN BY: <i>D.J. Martino</i>	DATE: 1-22-14	FIGURE NUMBER
CHECKED BY:	DATE:	<b>10</b>
APPROVED BY:	DATE:

**TEST PIT TP-3**  
1" = 20'

**TEST PIT TP-7/16**  
1" = 20'

**TEST PIT TP-5**  
1" = 20'

**FORMER DRUM DISPOSAL AREA**  
1" = 20'

- LEGEND:**
- LIMITS OF IN SITU SOIL TREATMENT
  - ..... SAMPLE GRID
  - 1640- EXISTING / EXCAVATED GRADE CONTOUR
  - - - EXISTING / EXCAVATED GRADE CONTOUR DEPRESSION
  - PROPOSED LIMITS OF SOIL EXCAVATION
  - FDDA-F4-1FLR FLOOR SOIL SAMPLE LOCATION
  - FDDA-Q1/Q2-1S SIDEWALL SOIL SAMPLE LOCATION
  - FDDA-Q1/Q2-1AS** SCO SOIL SAMPLE EXCEEDANCE LOCATION

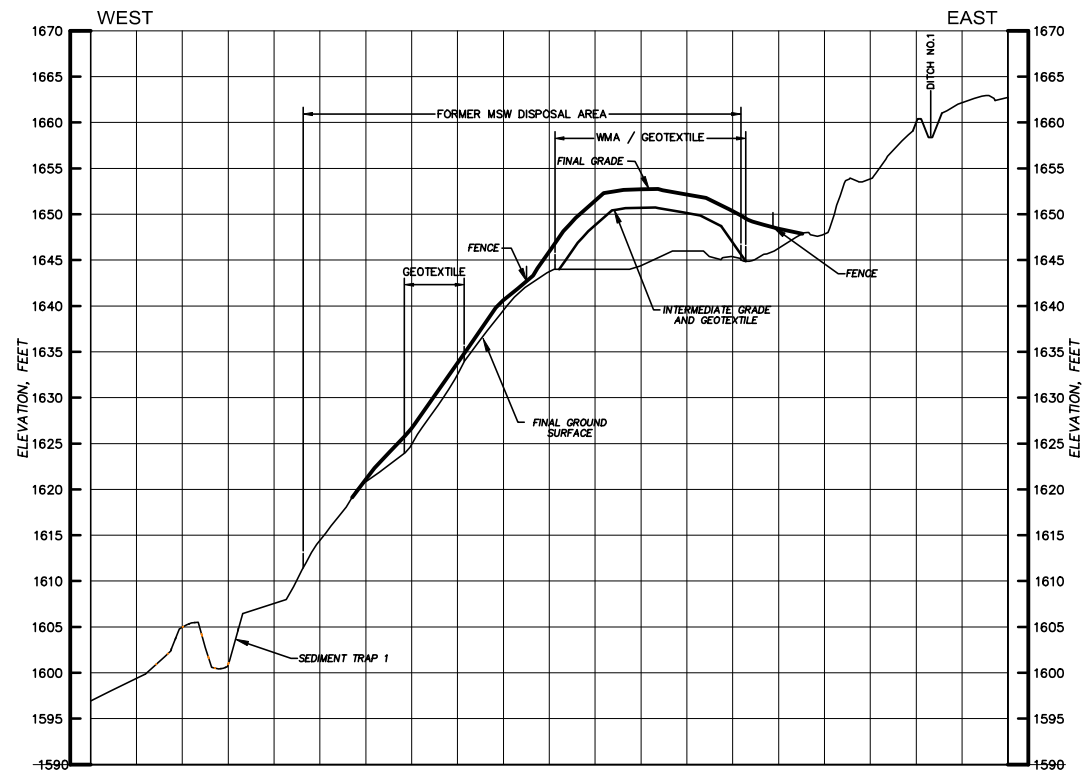
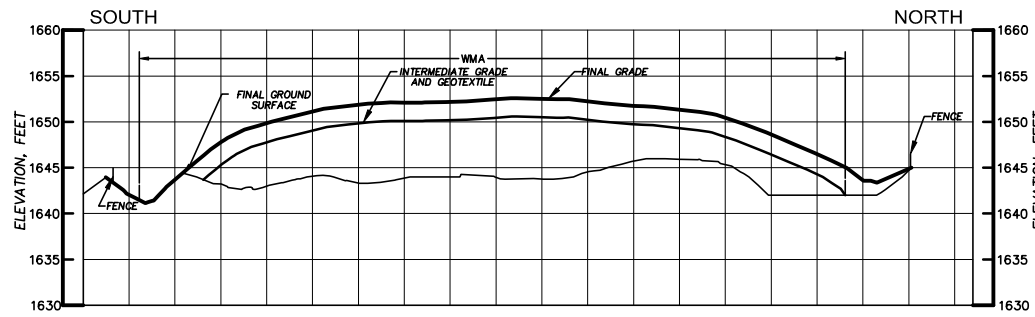
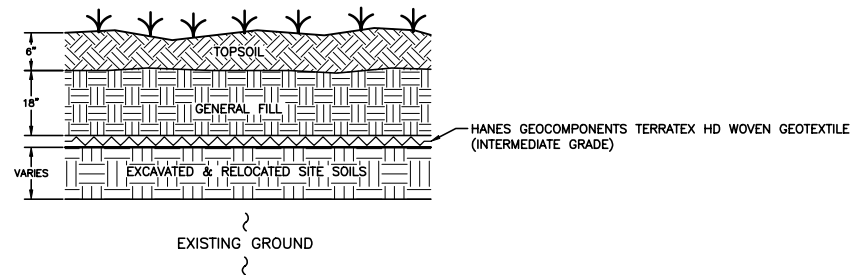
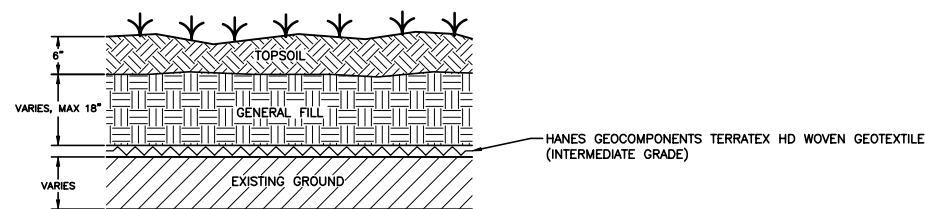
**SECTION A**  
12/14  
**WEST AND EAST**

**SECTION B**  
12/14  
**SOUTH AND NORTH**

**DETAIL 1**  
**WASTE MANAGEMENT AREA**  
(NTS)

**DETAIL 3**  
**FORMER MSW DISPOSAL AREA PLACEMENT OF <6" GENERAL FILL AND 6" TOPSOIL**  
(NTS)

**DETAIL 2**  
**FORMER MSW AREA DISPOSAL PLACEMENT OF >6" GENERAL FILL PLUS 6" TOPSOIL**  
(NTS)

- Repair and enhancement of the existing soil cover in the former MSW disposal area outside the WMA as necessary to establish a nominal two-foot thick soil cover, including removal of surface debris, placement of geotextile on the prepared surface, placement of up to 24 inches of imported clean soil including six inches of topsoil, and revegetating to reduce potential soil erosion.
