PROJECT No.: 170364005	CLIENT: President Union LLC 505 Flushing Avenue, #1D Brooklyn, New York 11205	DATE: Fri., January 06, 2023
PROJECT: President Street Properties		WEATHER: Overcast, 45 – 47 °F, Wind: E @ 0.7 – 2.4 mph
LOCATION: Brooklyn, New York		TIME: 6:45 am – 2:45 pm
BCP SITE ID: C224221		MONITOR: Jack Frey
EQUIPMENT: Fraste XL Max Sonic Drill Rig DustTrak II Aerosol Monitors MiniRAE 3000 Photoionization Detector		PRESENT AT SITE: Langan: Jack Frey Aquifer Drilling and Testing (ADT) (Drilling Contractor): Dave Moon, Patrick MaGill
OBSERVATIONS, DISCUSSIONS, TEST RESULTS, ETC.: Langan was present to implement the New York State Department of Environmental Conservation (NYSDEC)-approved December 20, 2022 Supplemental Remedial Investigation Work Plan (SRIWP) for Brownfield Cleanup Program (BCP) Site No. C224221).		
Site Activities <ul style="list-style-type: none">• ADT used a Fraste XL Max sonic drill rig with dedicated plastic liners to advance soil borings SSB-06S1 and SSB-06SW for delineation of grossly contaminated material and/or non-aqueous phase liquid (NAPL) in the northeastern part of the site. Langan documented the work and screened the soil for environmental impac

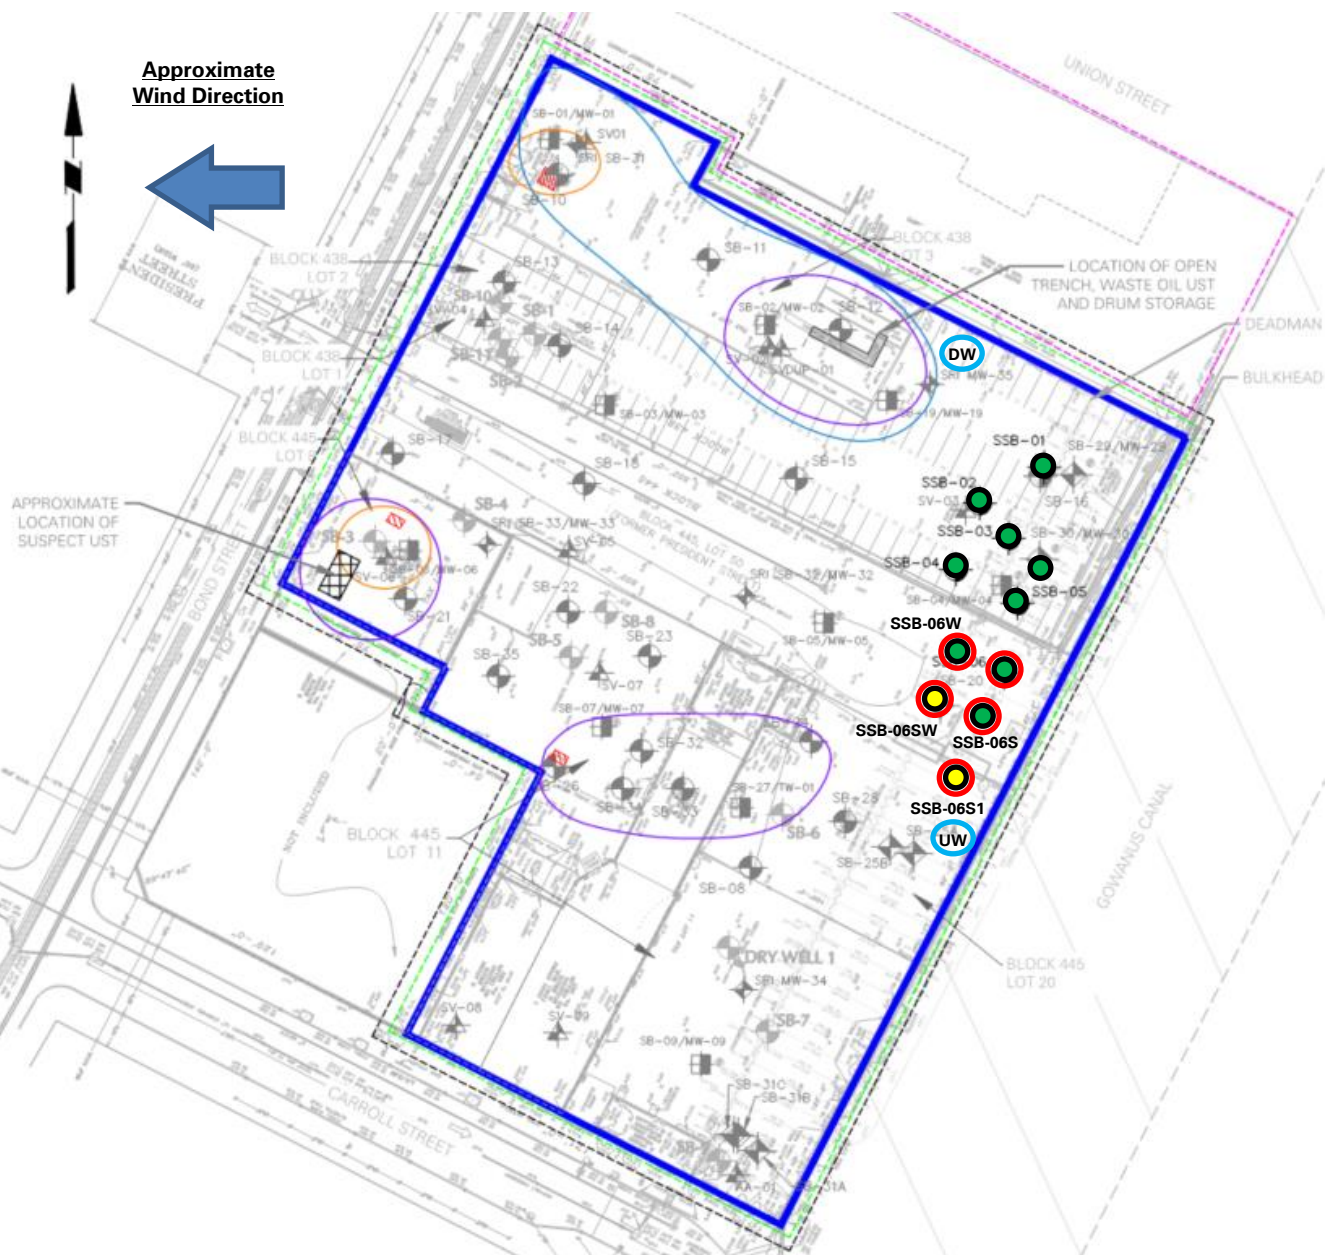
Site Map

| | Approximate Location of Soil Boring Completed Today |
| | Approximate Location of Soil Boring Completed Previously |
| | Approximate Location of Upwind CAMP Station |
| | Approximate Location of Downwind CAMP Station |

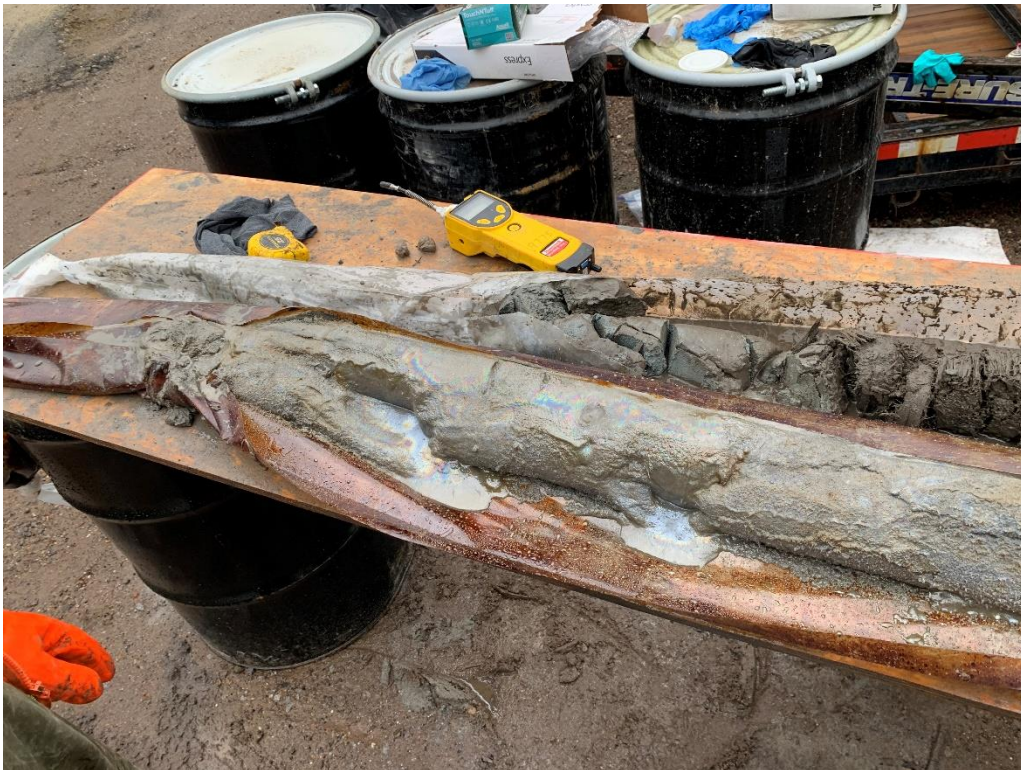
Photo 1: View of recovered soil from 20 to 30 feet bgs at soil boring SSB-06S1 (facing northeast)

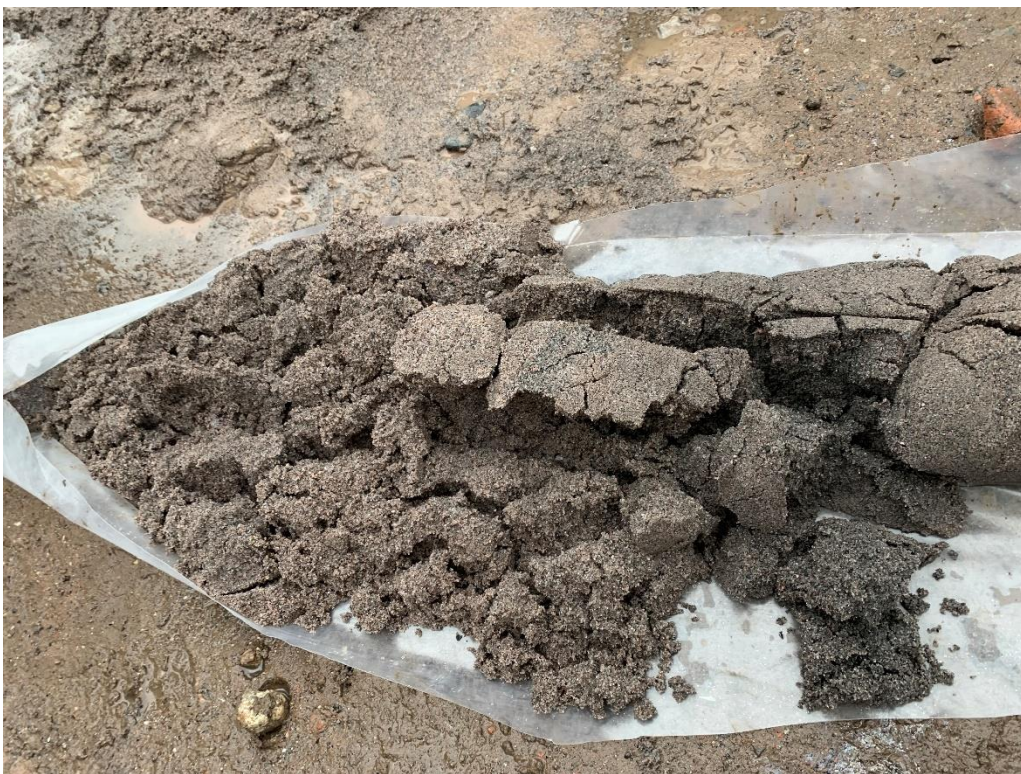
Photo 2: View of recovered soil from 40 to 50 feet bgs at soil boring SSB-06S1 (facing north)
