Daily Activity Report

Former United Hospital
Port Chester, NY
BCP No. C360202

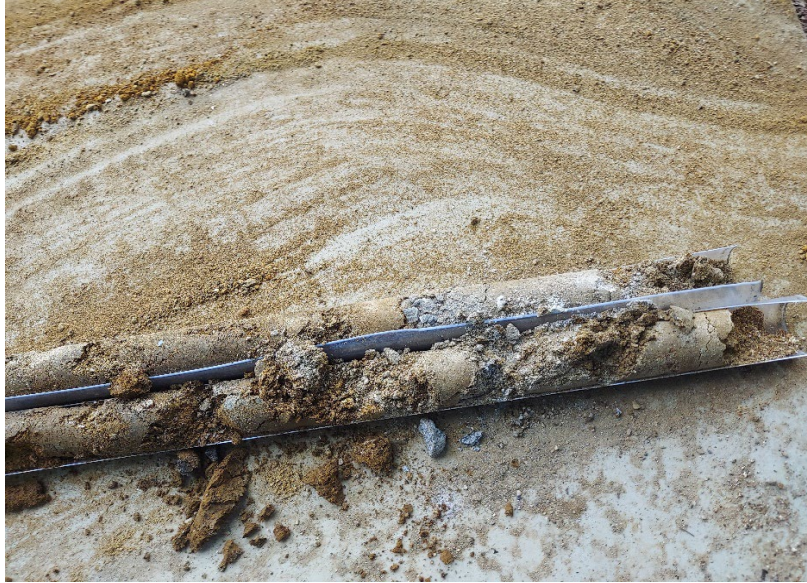
Photograph 1 -
Soil cores staged for field screening and sample collection.

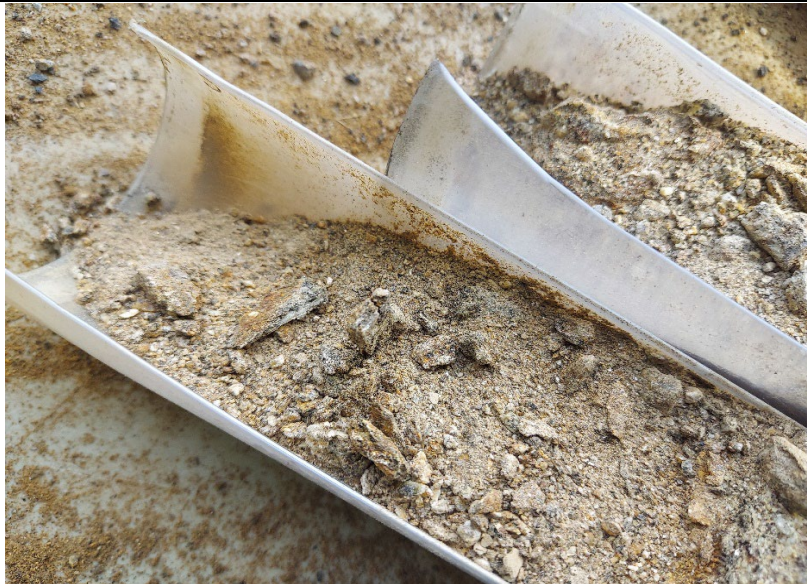
Photograph 2 -
Weathered bedrock observed at the terminal end of a soil core, consistent with findings at each soil boring advanced during Phase I of the Remedial Investigation.

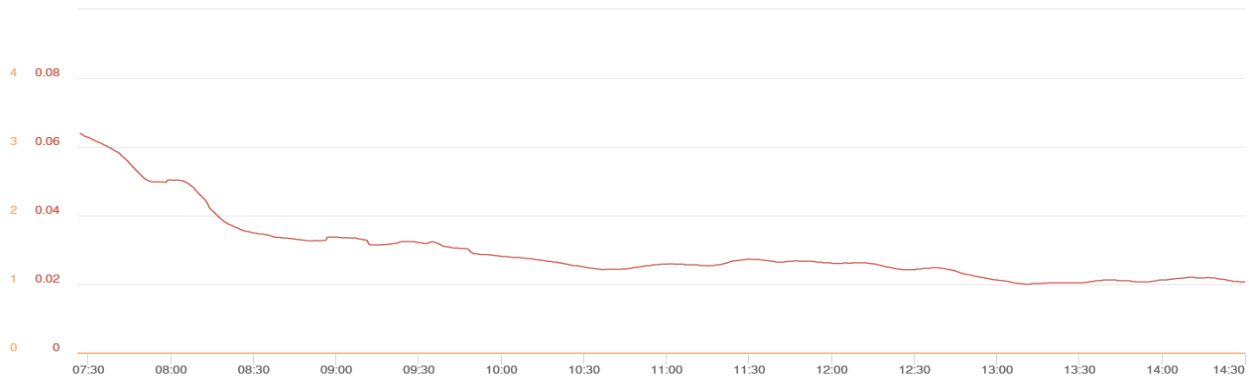
Downwind CAMP

08/29/2022 0:00:34 – 08/30/2022 0:00:00
(GMT-05:00) Eastern Time (US & Canada)

MIN	AVG	MAX
0.0201	0.0296	0.064

MIN	AVG	MAX
0	0	0
