June 5, 2020

RE: Surface Water System Maintenance Work Plan  
Riverview Innovation & Technology Campus, Inc.  
Brownfield Cleanup Program Site No. C915353  
Town of Tonawanda, New York

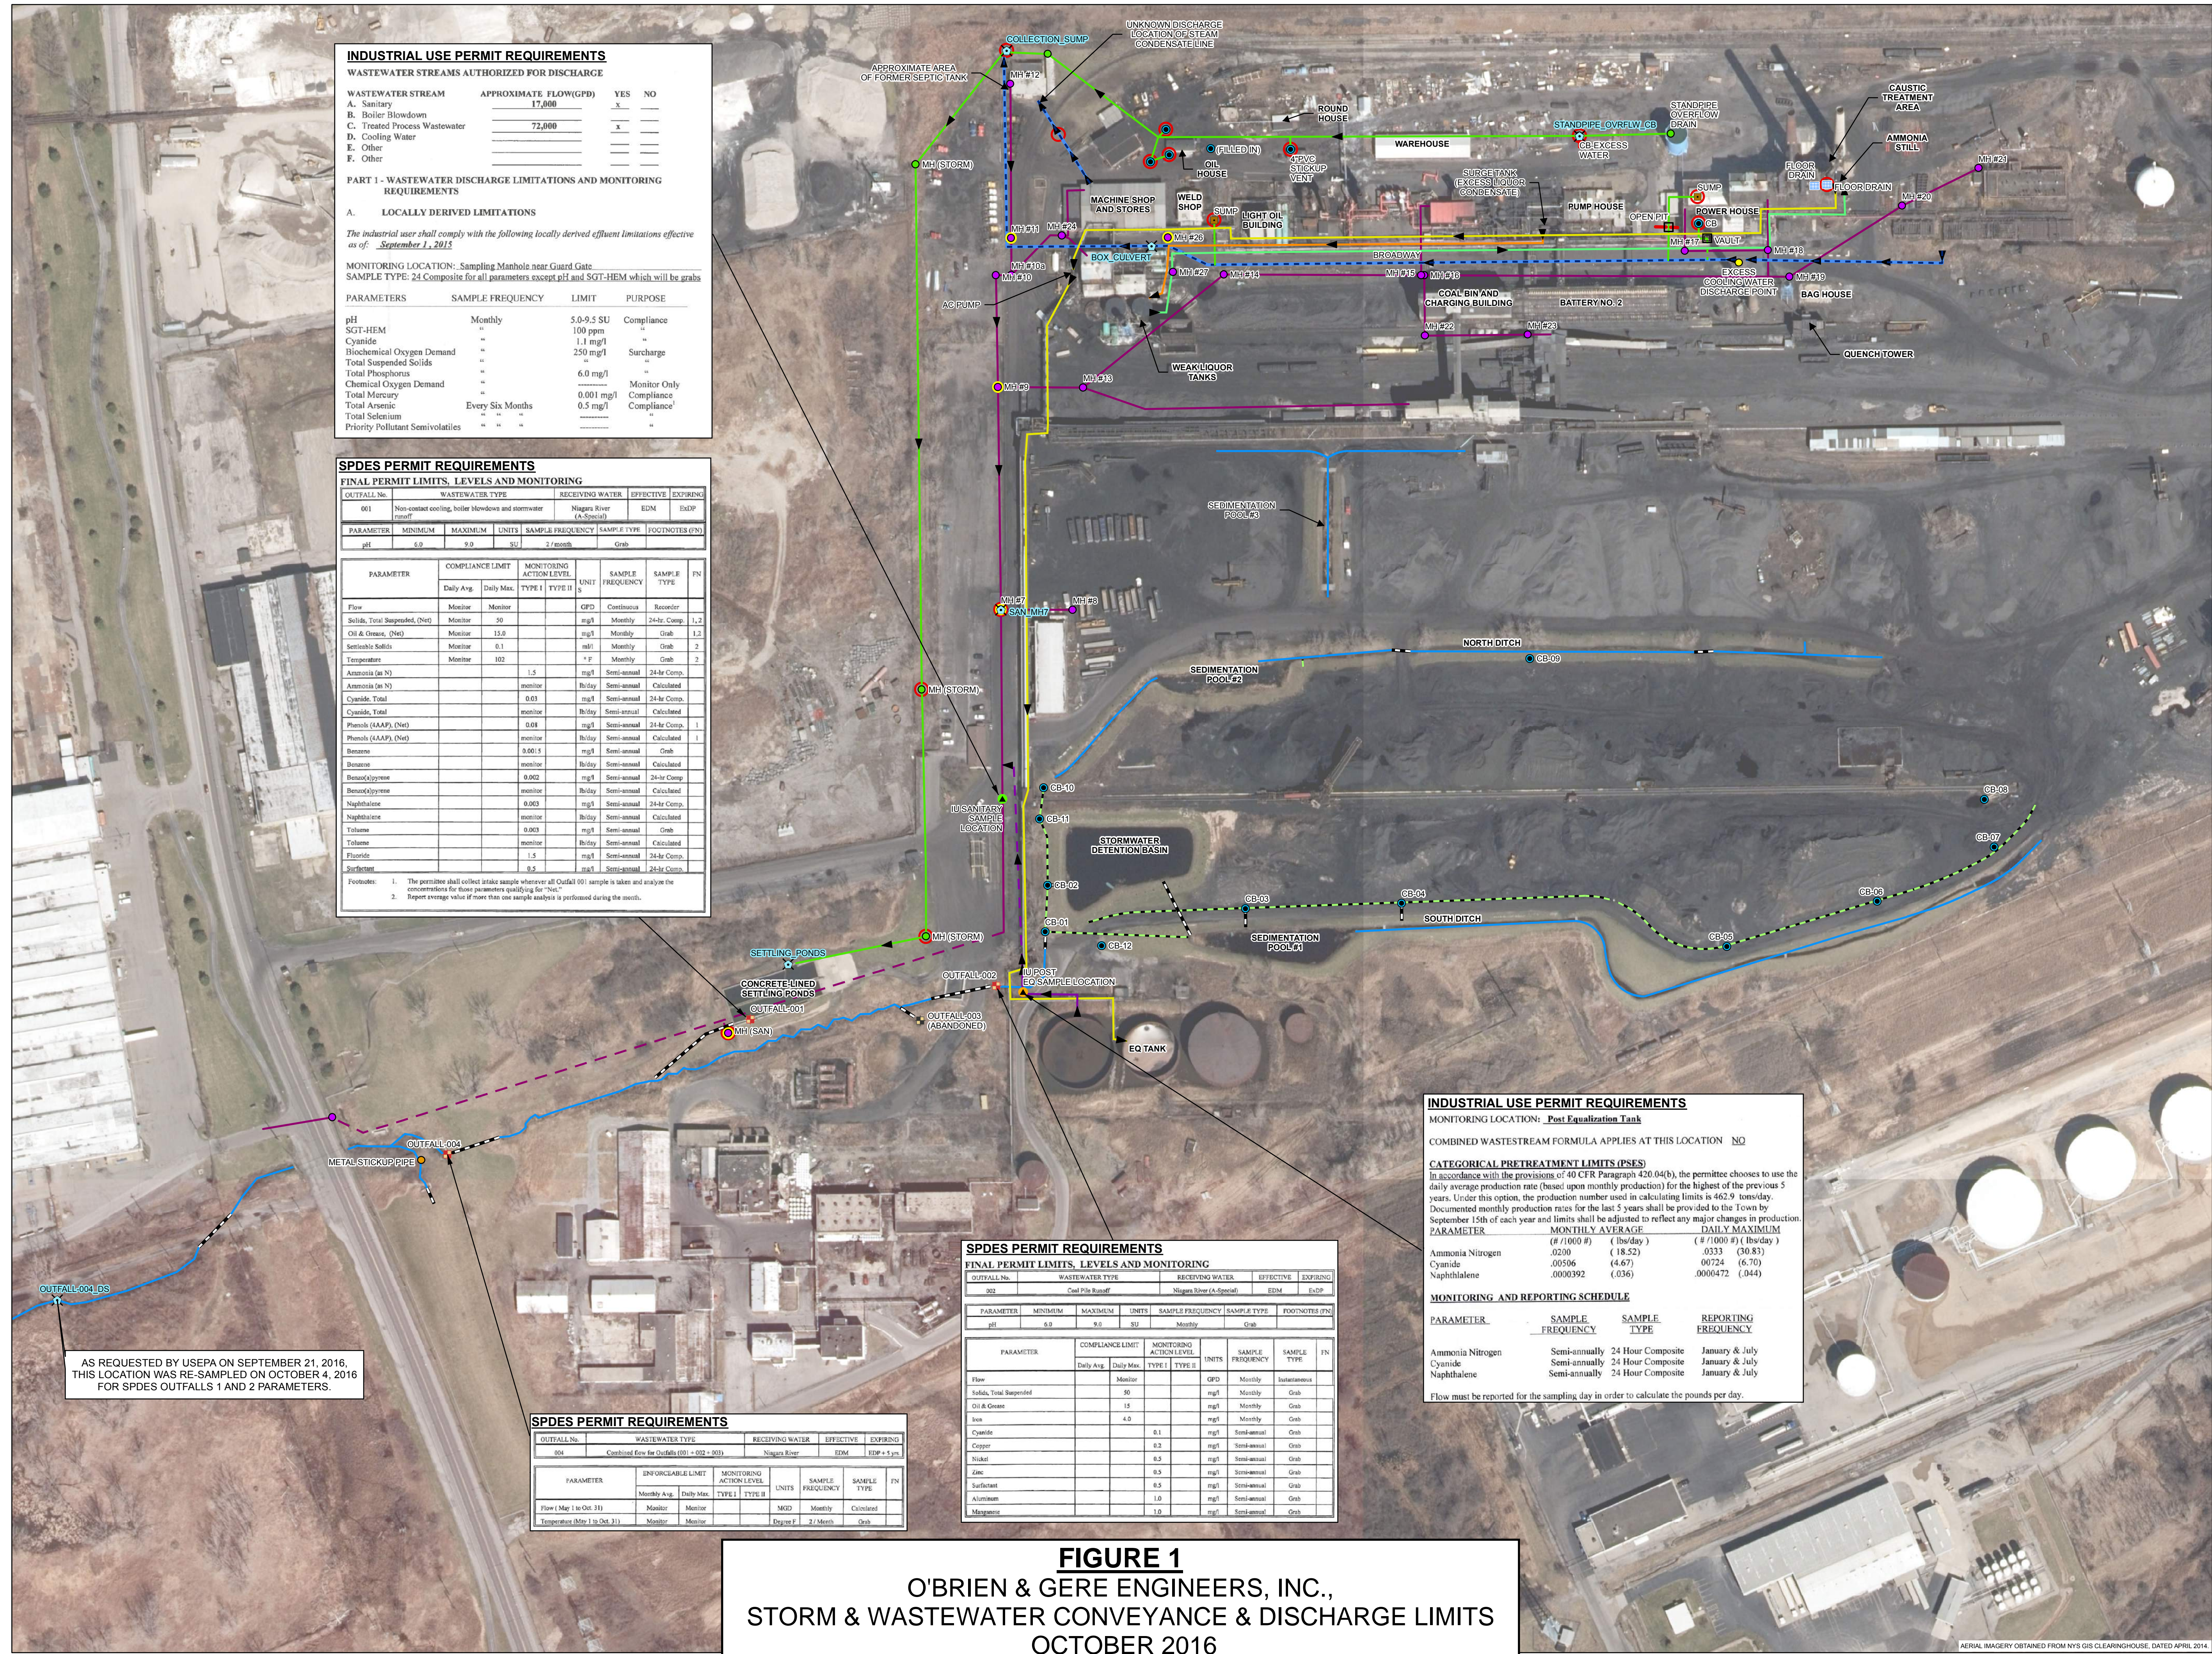
**FIGURE 1**  
O'BRIEN & GERE ENGINEERS, INC.,  
STORM & WASTEWATER CONVEYANCE & DISCHARGE LIMITS  
OCTOBER 2016  
FOR REFERENCE ONLY

The flow that discharges from Outfall #001 originates from the former process area, is conveyed through a series of storm sewers, and ultimately to a series of two concrete lined settling ponds (Figure 1 and Figure 1a) on Site 109. The enclosed Figure 1 is the October 2016 O'Brien & Gere Engineers, Inc., Figure 1 titled Storm and Wastewater Conveyance and Discharge Limits and Figure 1a, and Figure 2 are excerpt from this Figure.

**STORM & WASTEWATER CONVEYANCE & DISCHARGE LIMITS**

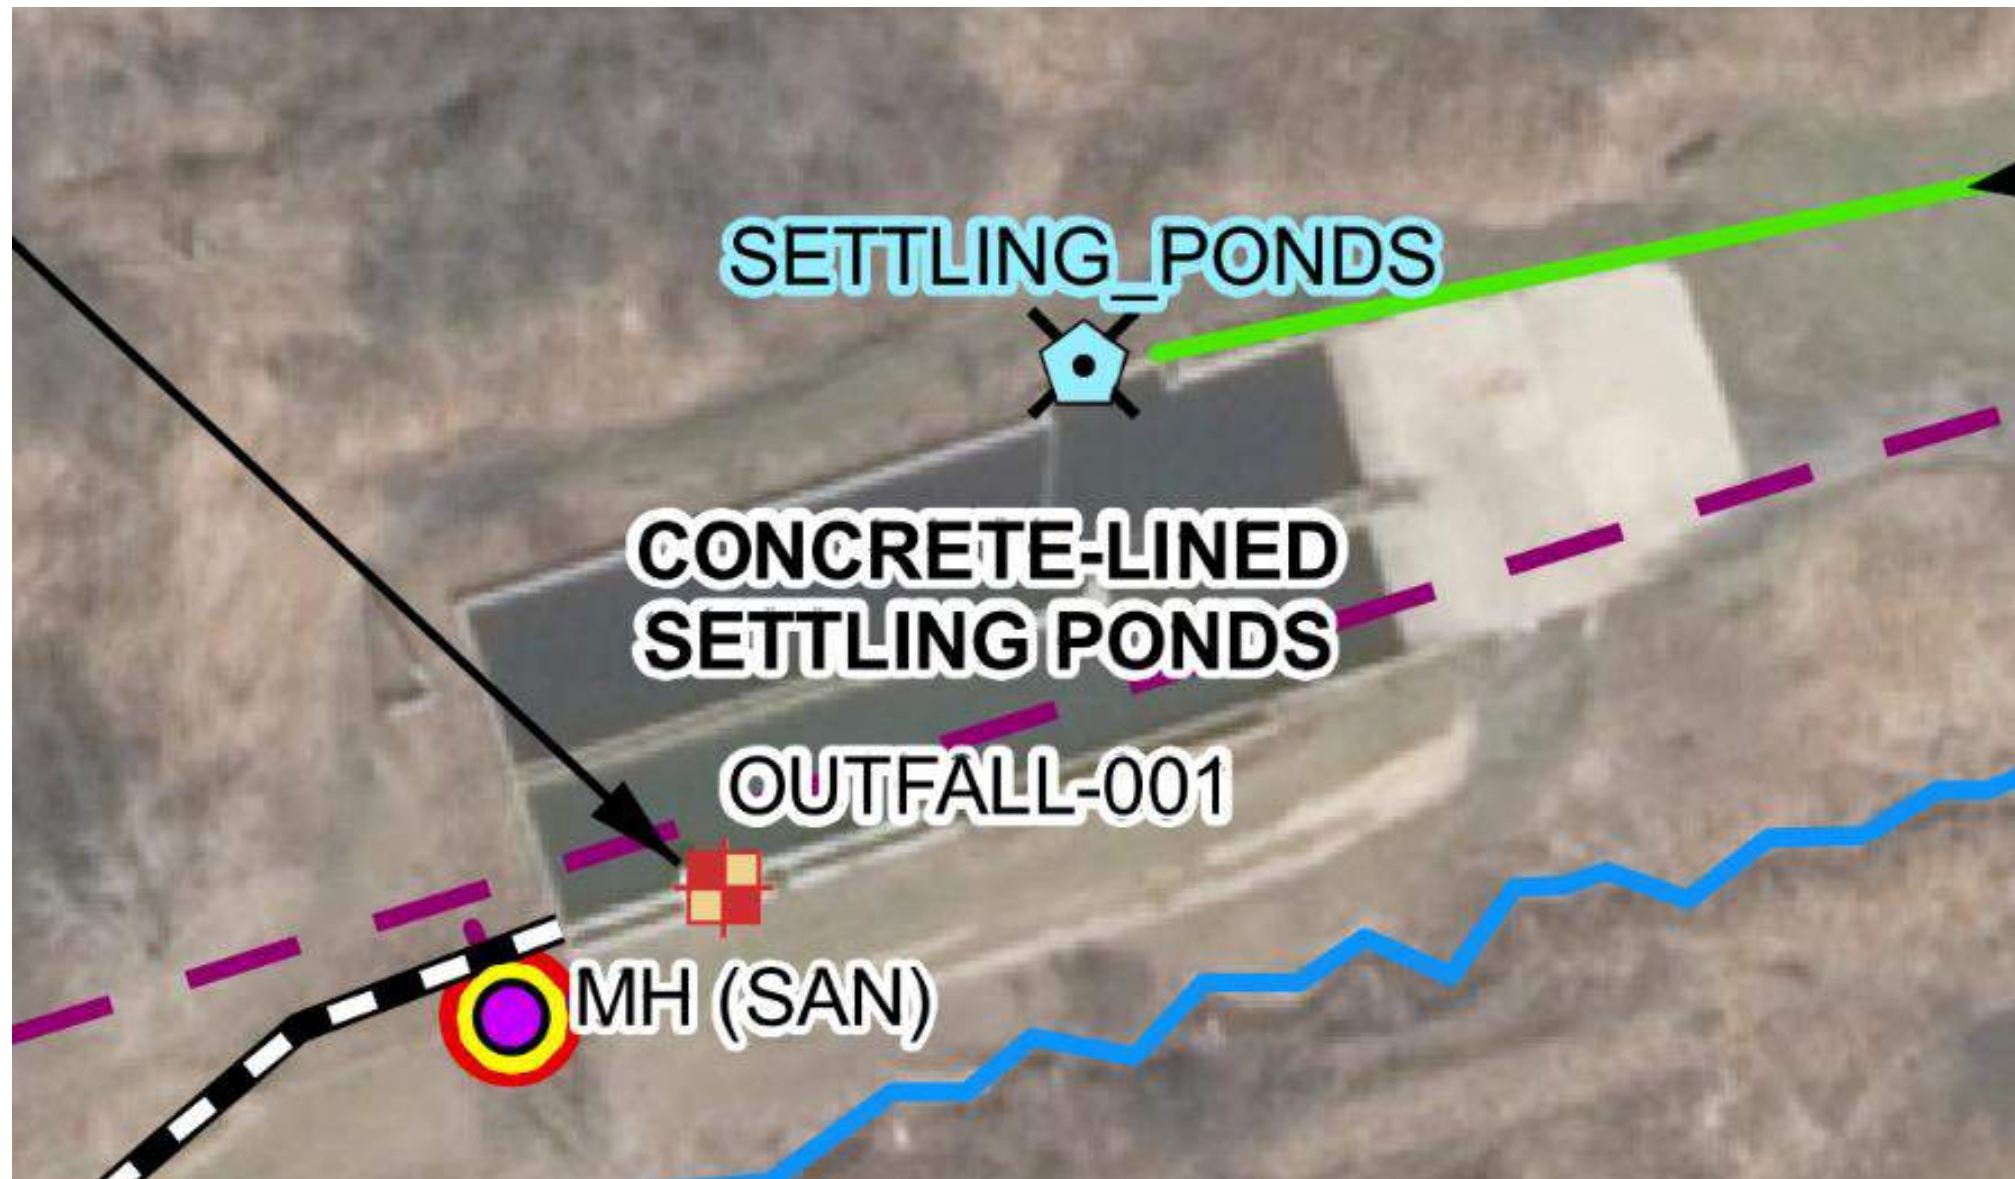
Figure 1a  
Concrete Lined Settling Ponds  
Source: O'Brien & Gere (2016)

The concrete pad to the right in Figure 1a (East) is a ramp to allow access for cleaning. The chase and flume are within the narrow channel along the south wall of structure in Figure 1a.

The flow currently enters the north chamber and flows over a weir into the south chamber before flowing over a second weir into the chase and flume that directs flow to the Outfall. The flow into the north chamber comes from a storm sewer that directs surface water flow from a collection sump behind the "Mansion" (former office building in the northwest corner of the BCP Site). The collection sump is often referred to as the "Mansion Sump". . Underground, east of the ponds is an influent manifold. No as-built drawing of the manifold has been found, but the design drawing and the valves that are visible suggest a 3-leg manifold into the settling ponds leading to the north pond, south pond, and directly to

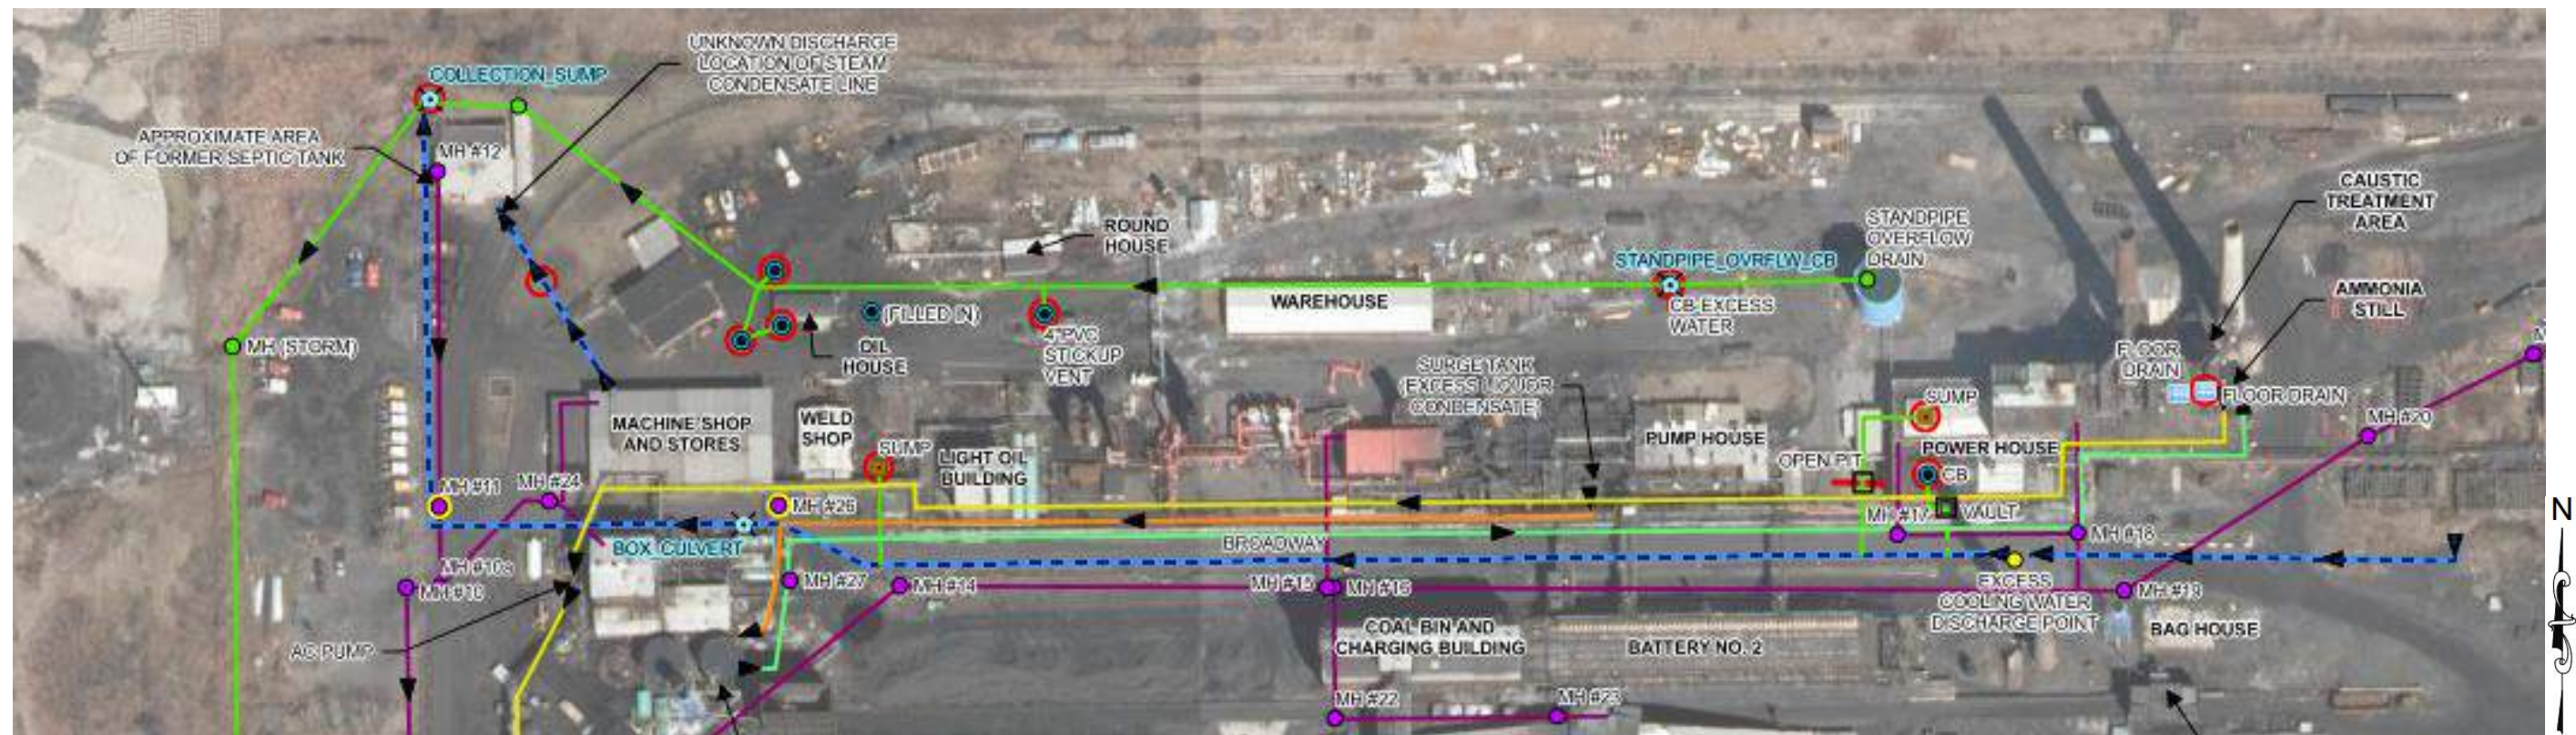
**Figure 2**

The flow into the collection sump (referred to as the “Mansion Sump”) comes from two surface water collection systems (Figure 2); the north storm sewer system (green) and the box culvert (black- blue dashed line). The north sewer collects surface water from the area of the property starting at an inlet near the fire water standpipe to the east wall of the Mansion Sump. The box culvert collects surface water along “Broadway” (the road between the battery and the by-products and boiler house areas) starting at an inlet southeast of the boiler house. The box culvert directs flow to the west where it discharges to another box culvert that conveys flow north along the former parking lot to the south side of the Mansion Sump.

Stormwater System – Process Areas

Note: The black-blue dashed line is the Box Culvert, the green line to the north and west are underground storm sewers, the yellow and purple lines are process utilities, not storm sewer lines.

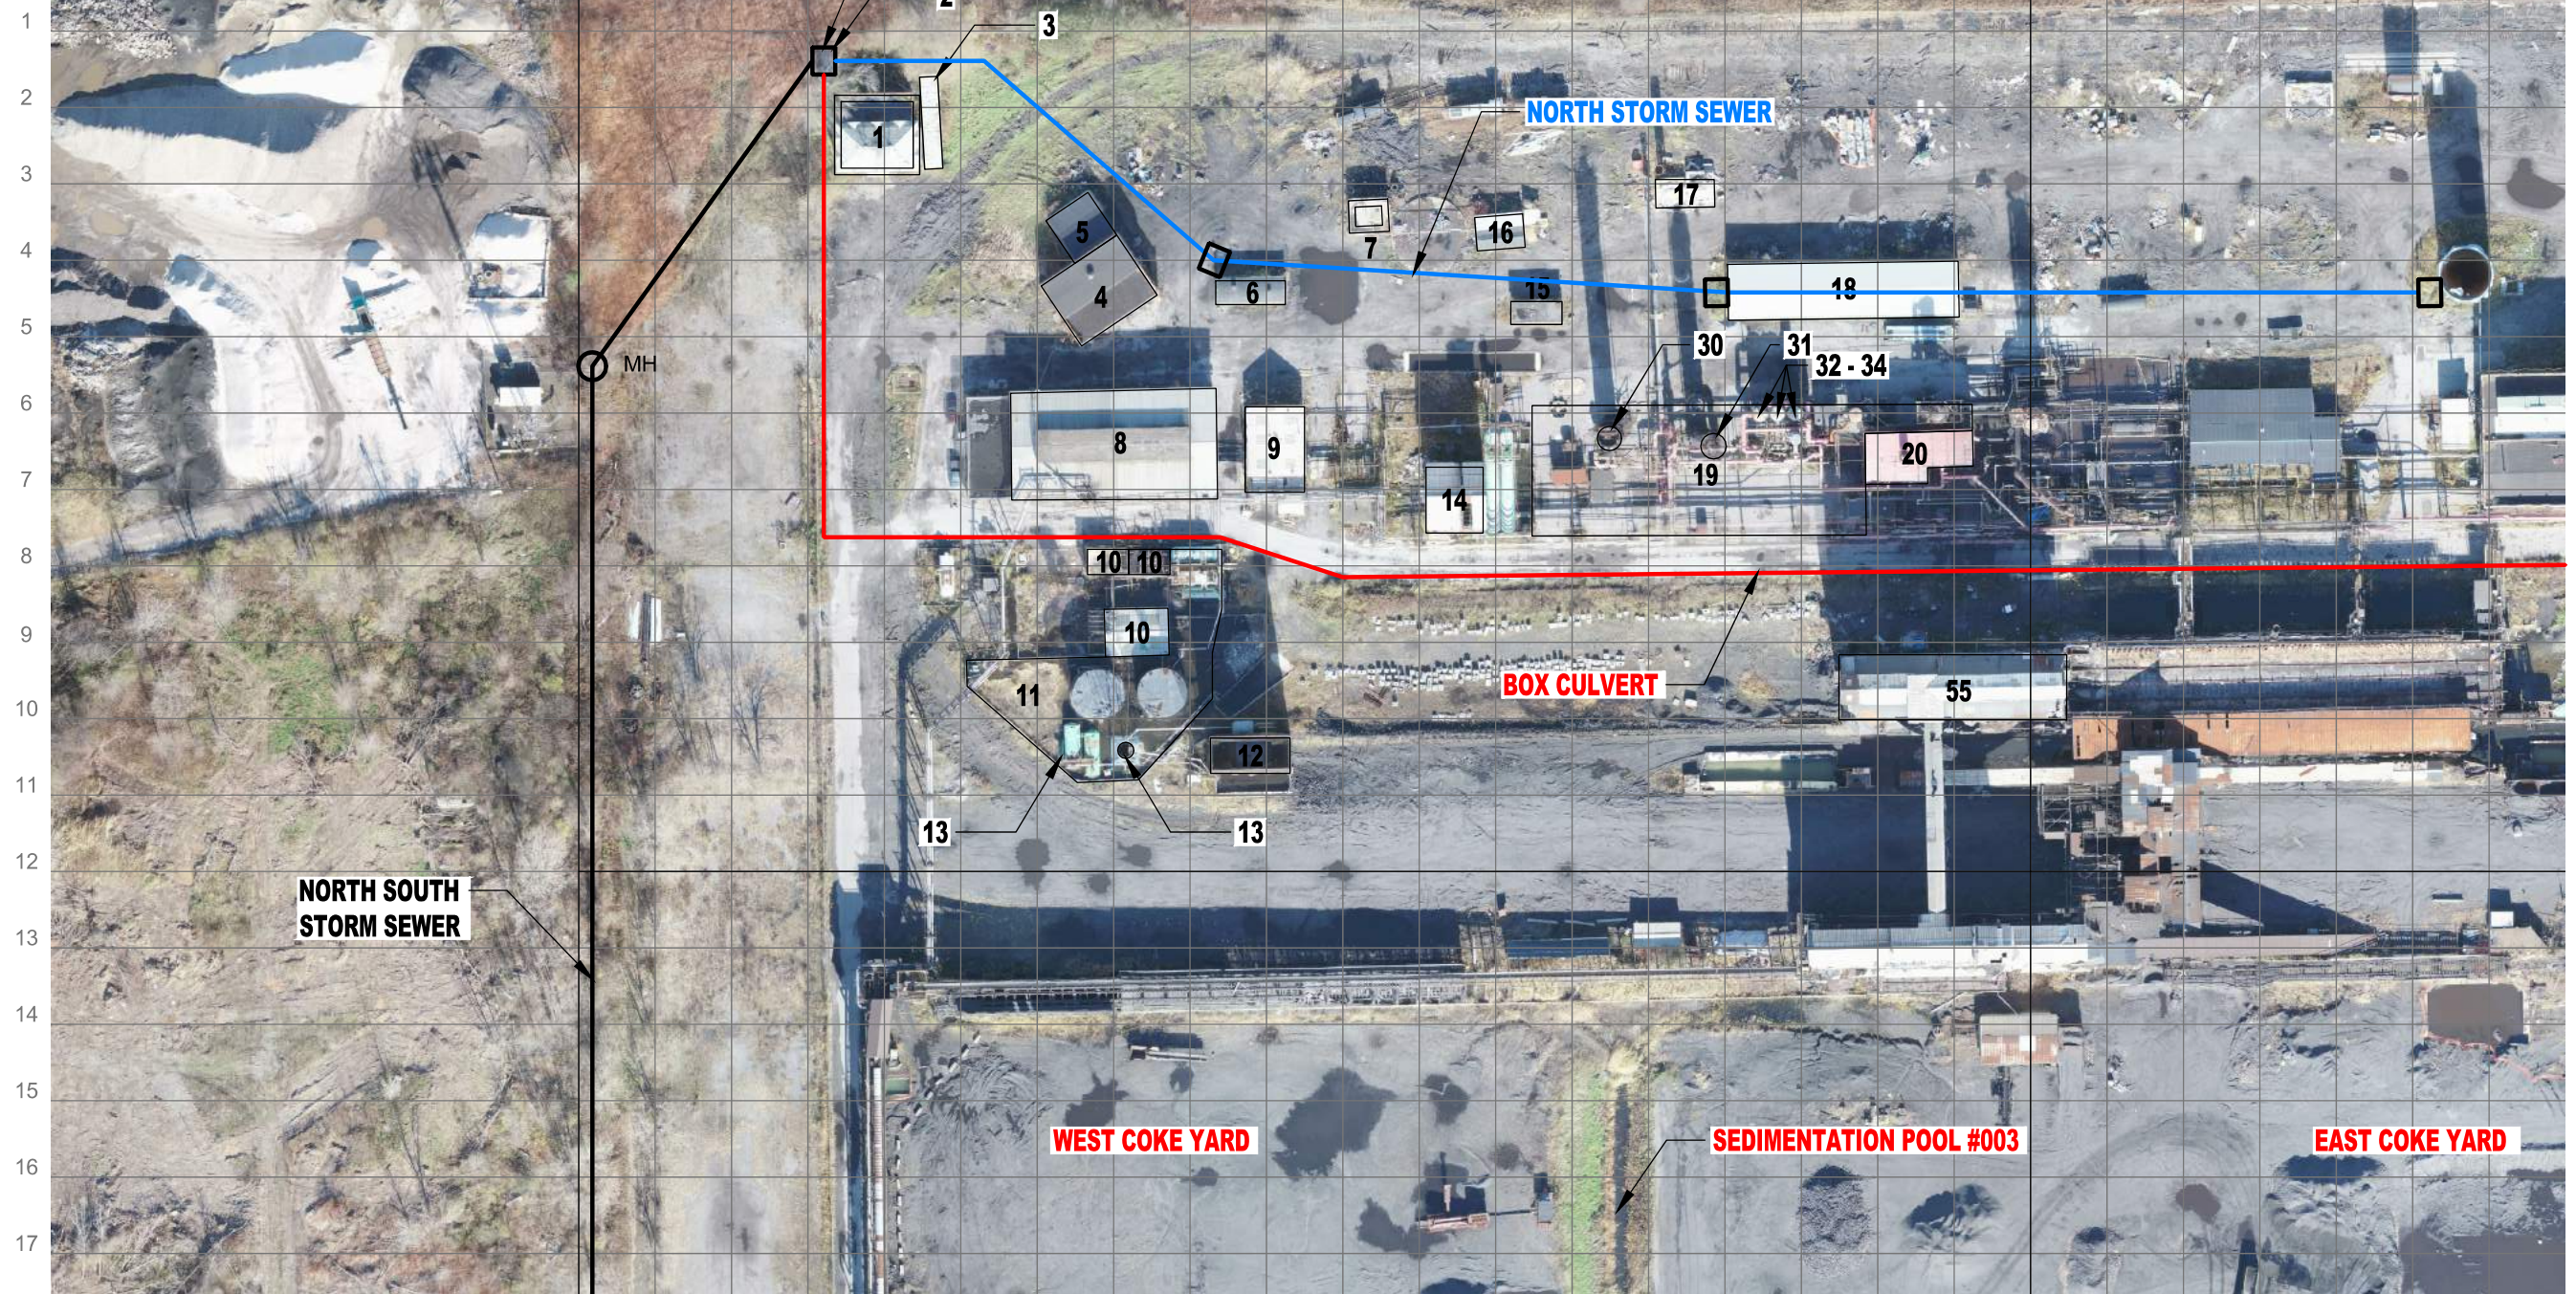
**FIGURE 3**  
DRAWING NUMBER  
**WCW SET**

NOTE: SEWER LOCATIONS ARE APPROXIMATE.

**NORTH WEST SECTION OF PROPERTY  
SURFACE WATER MANAGEMENT**

4. Northern Storm Sewer – The alignment from the Oil House (building number 6, Figure 3) to the Mansion (building number 1, Figure 3) sump is unknown. The drop inlets that can be accessed will be opened and the pipes in the inlets will be mapped and it will be attempted to confirm the flow configuration of the manifold at the Mansion sump (structure number 2, Figure 3). If required, a vacuum truck will be used to clean the inlet structures; and

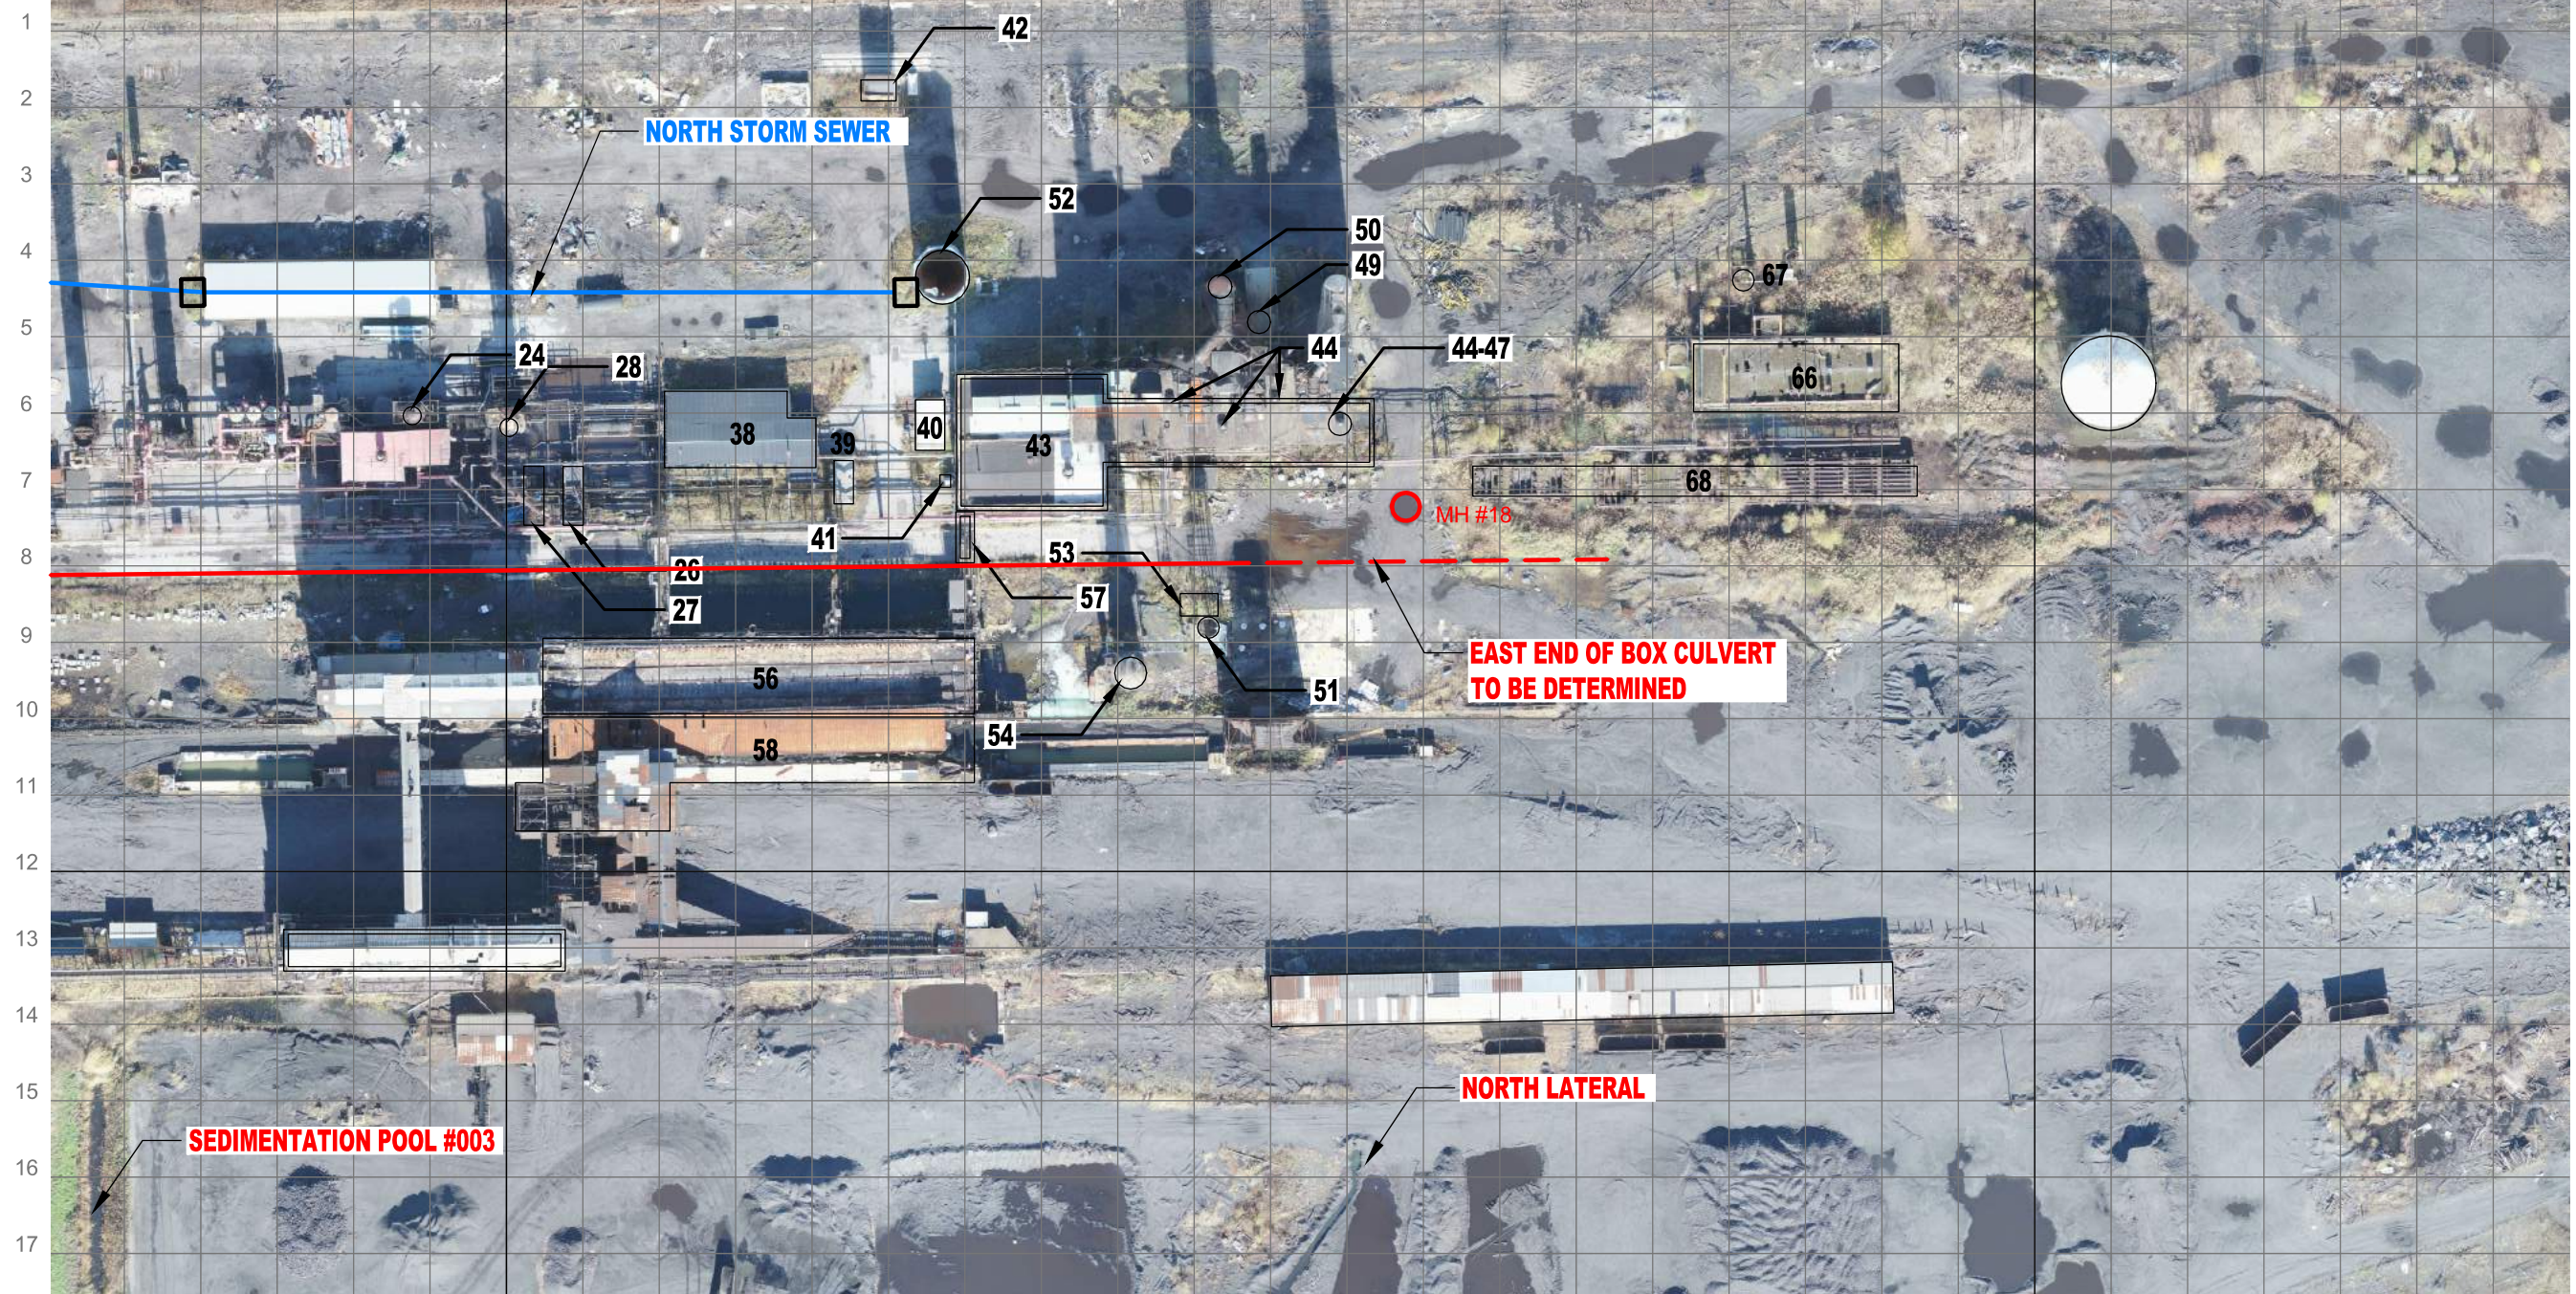
**FIGURE 4**  
 DRAWING NUMBER  
**107A**

NOTE: SEWER LOCATIONS ARE APPROXIMATE.

**NORTH CENTRAL SECTION OF PROPERTY  
 SURFACE WATER MANAGEMENT**

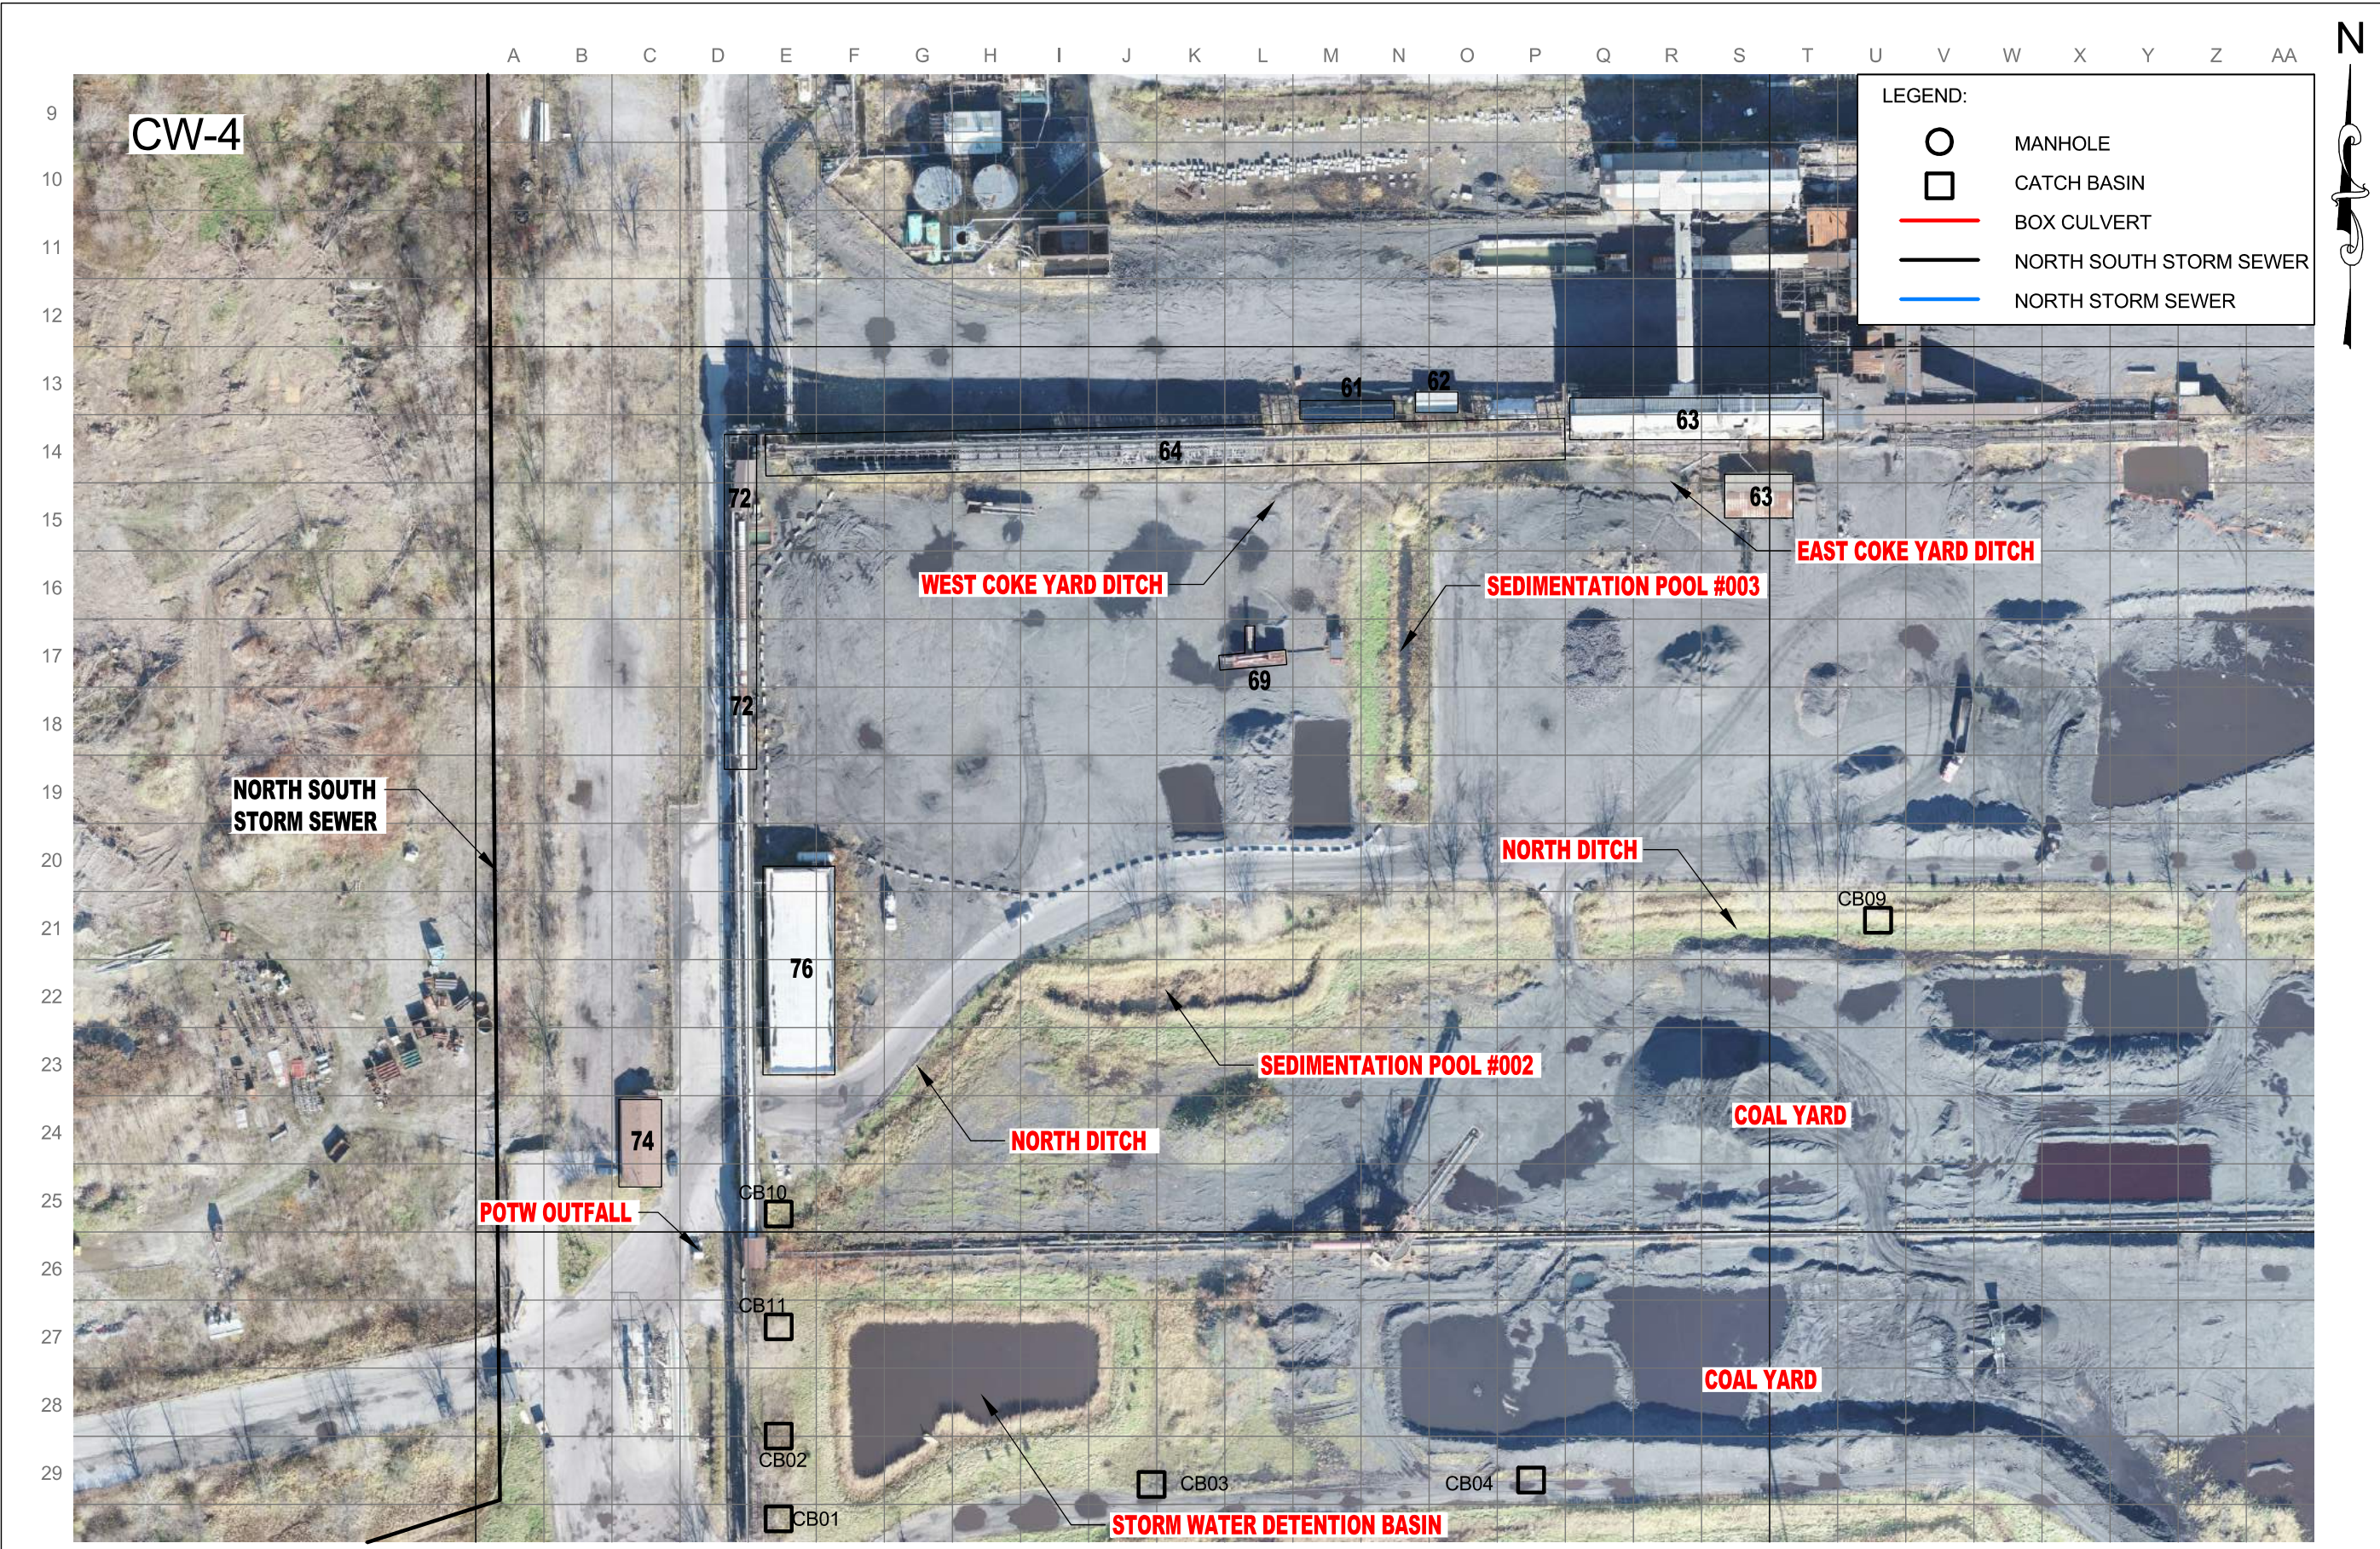
**FIGURE 5**  
 DRAWING NUMBER  
**107A**

NOTE: SEWER LOCATIONS ARE APPROXIMATE.

**CENTRAL WEST SECTION OF PROPERTY  
SURFACE WATER MANAGEMENT**

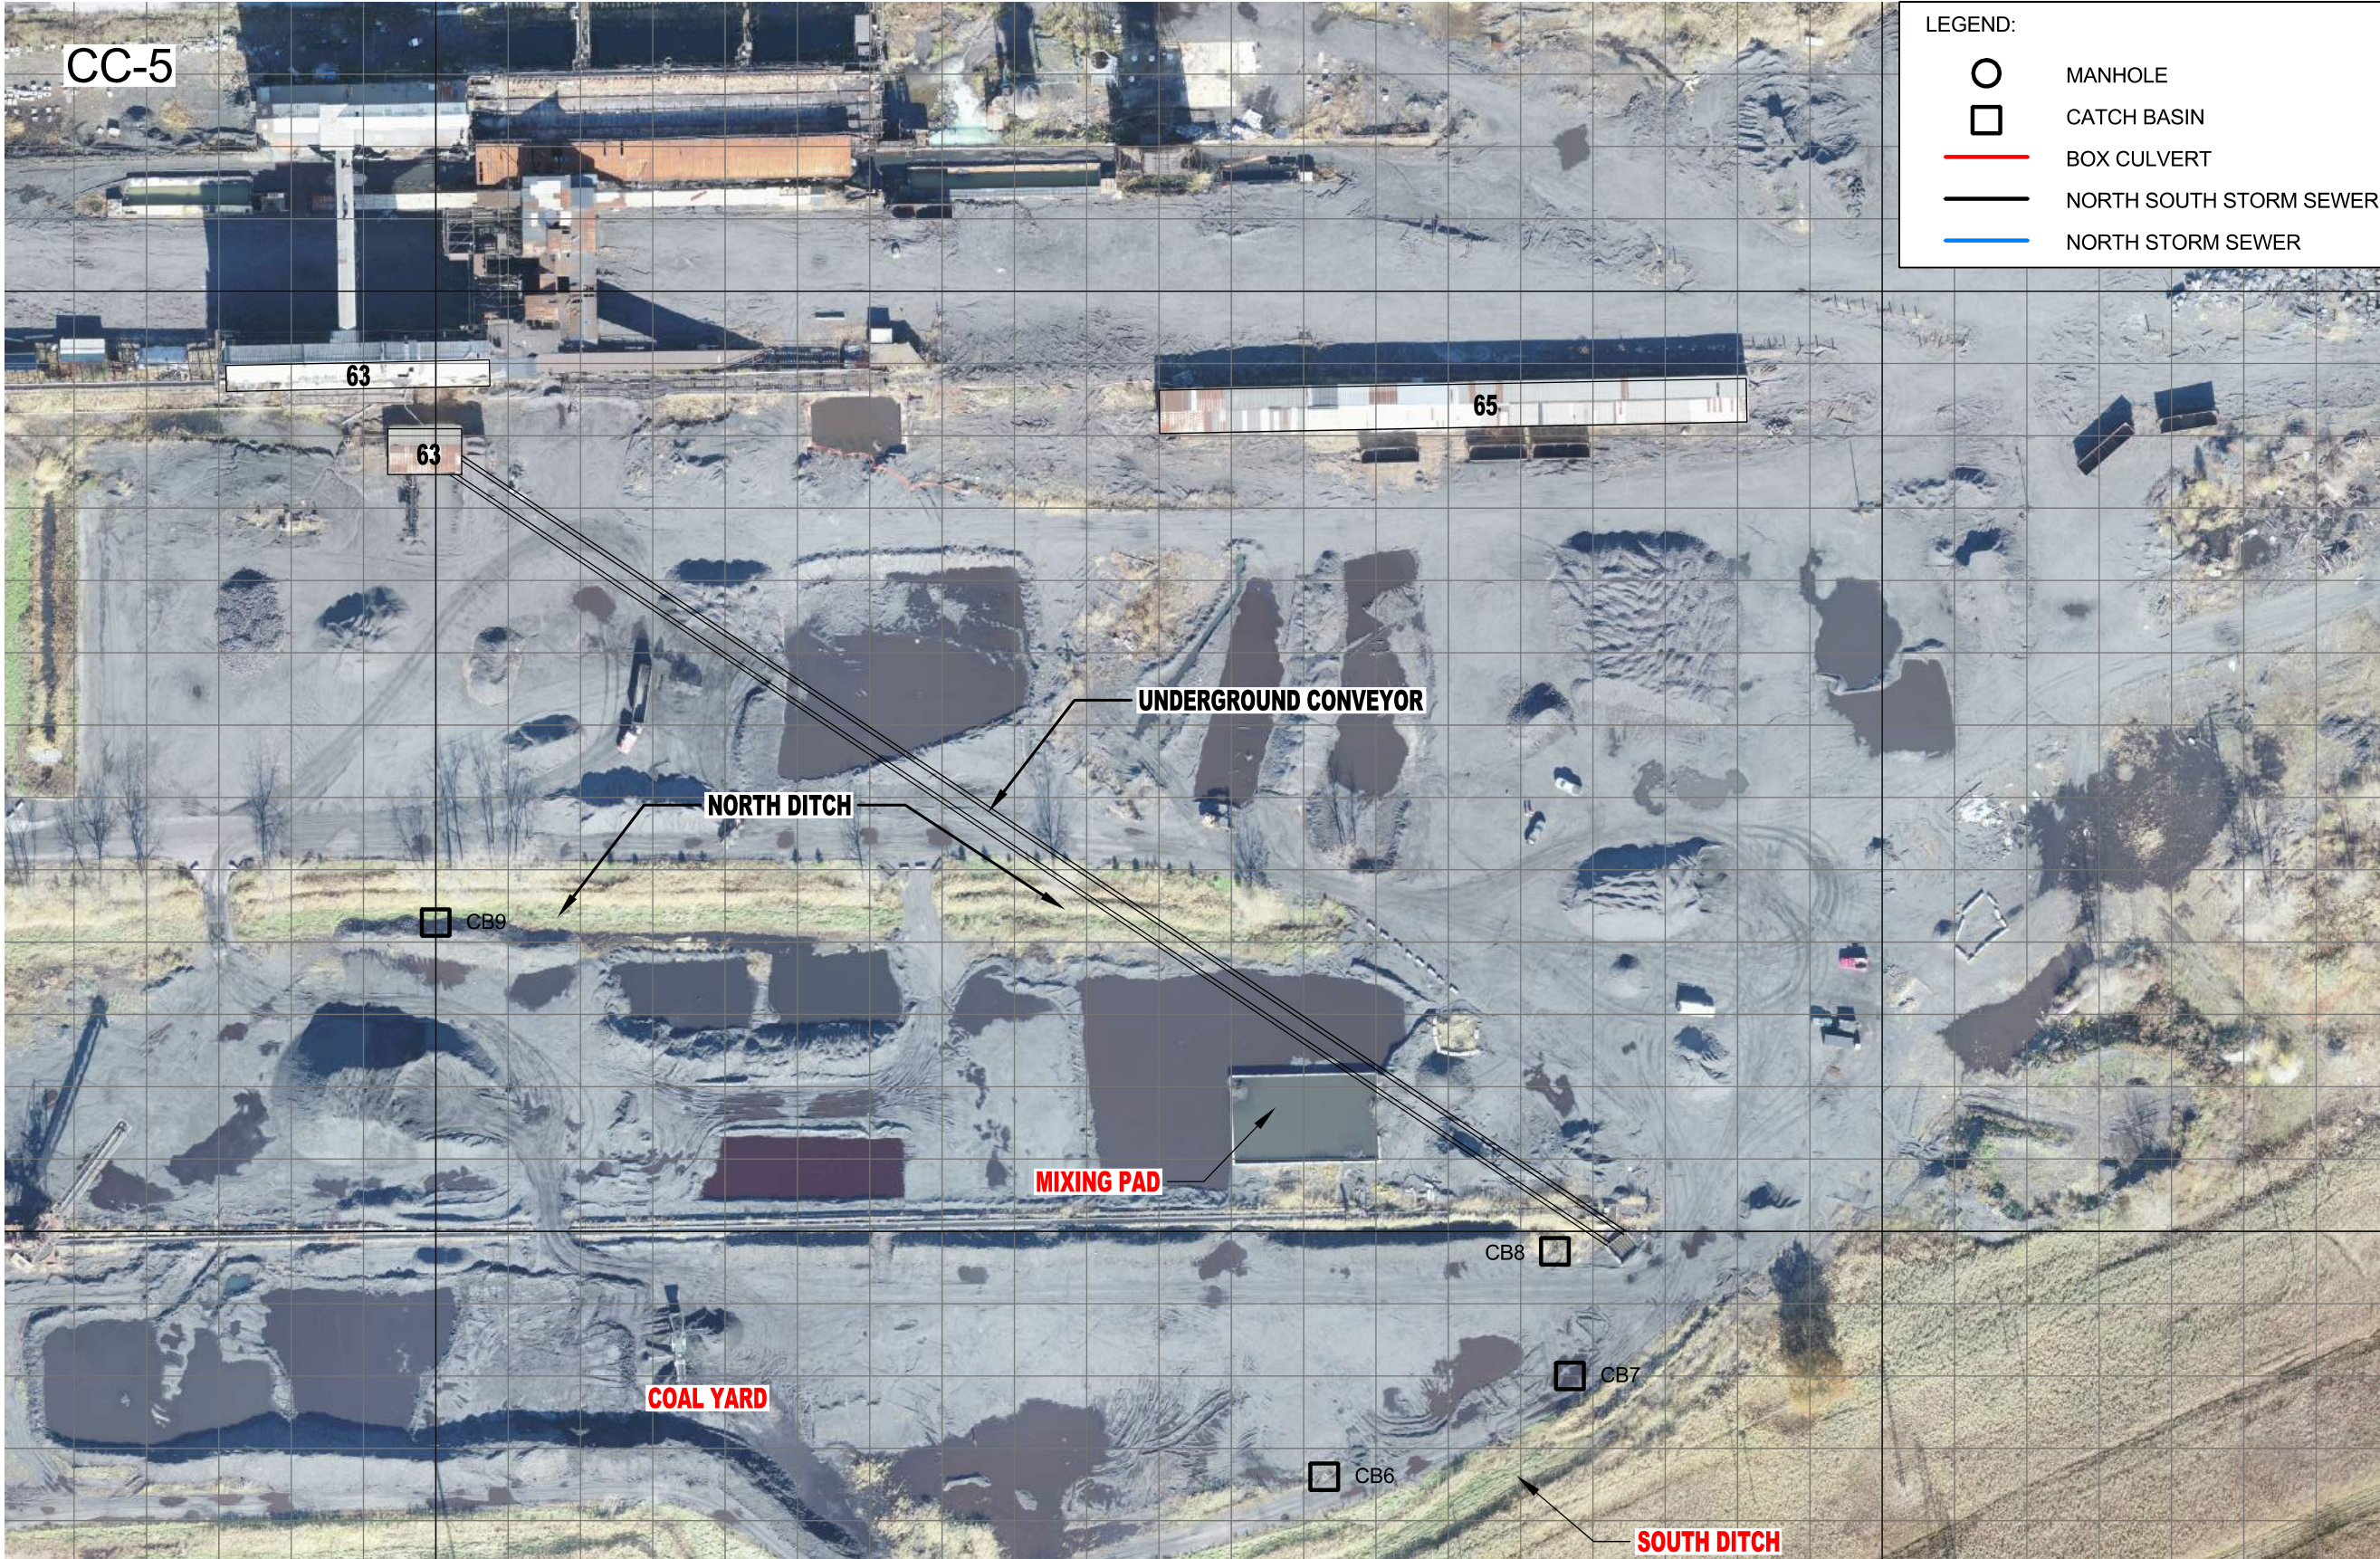
**FIGURE 6**  
 DRAWING NUMBER  
**107A**

**CENTRAL CENTRAL SECTION OF PROPERTY  
 SURFACE WATER MANAGEMENT**

NOTE: SEWER LOCATIONS ARE APPROXIMATE.
