Subject: 2019 Periodic Review Report
Former Champion Products Facility
200 North Main Street
Perry, New York 14530
NYSDEC Site No. V00189

1.0 EXECUTIVE SUMMARY

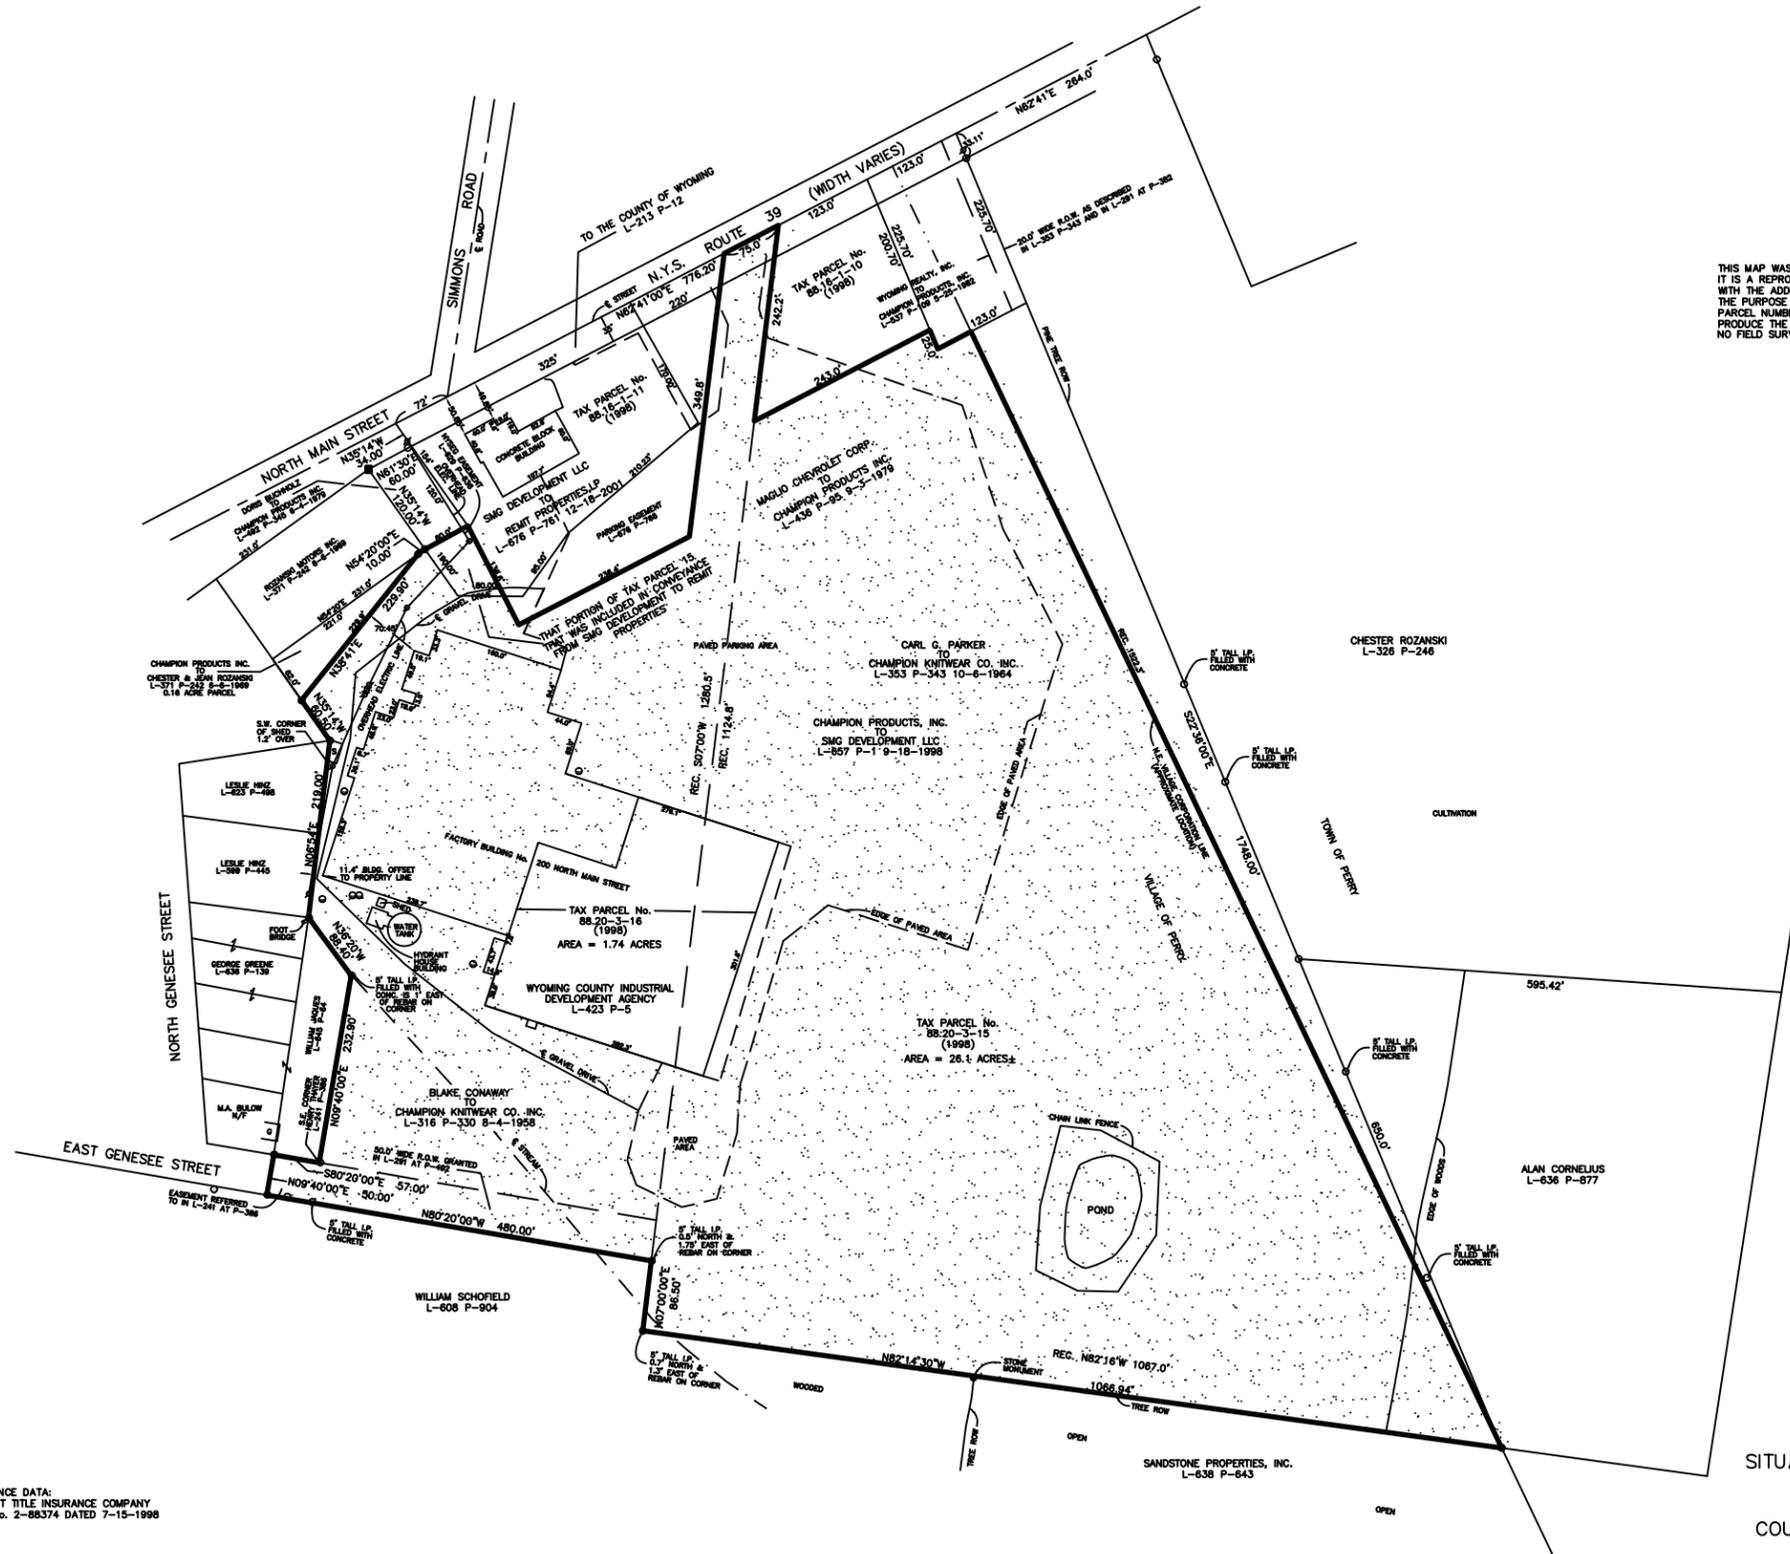
FIGURE 2-SITE SURVEY MAP
FORMER CHAMPION PRODUCTS FACILITY
200 N. MAIN STREET
PERRY, NY

The site is located at 200 North Main Street in the Village of Perry, County of Wyoming, New York and is approximately 26-acres in size (**Figures 1** and **2**). The site is bounded by North Main St., commercial properties and residential properties to the north, vacant wooded land to the south, farmland and residential properties to the east, and residential properties and North Genesee St. to the west. The main onsite building is approximately 150,000 s.f. in size with a section that is approximately 75,000 s.f., which is not part of the site (**Figure 3**). In 2014, a 9,600 s.f., three bay, steel frame construction, bus garage was constructed in the northeast corner of the site and is now utilized for parking of busses (**Figure 1**). The bus garage is located approximately 600 feet north-northeast of the main building in a paved parking area.

THIS MAP WAS DRAWN 4-10-2012
IT IS A REPRODUCTION OF GILLEN MAP 98-171-S
WITH THE ADDITION OF TAX PARCEL I.D. NUMBERS.
THE PURPOSE OF THIS MAP WAS TO IDENTIFY TAX
PARCEL NUMBERS THAT EXISTED IN 1998 AND TO
PRODUCE THE MAP IN DIGITAL/ELECTRONIC FORMAT.
NO FIELD SURVEYING WAS DONE ON 4-10-2012.

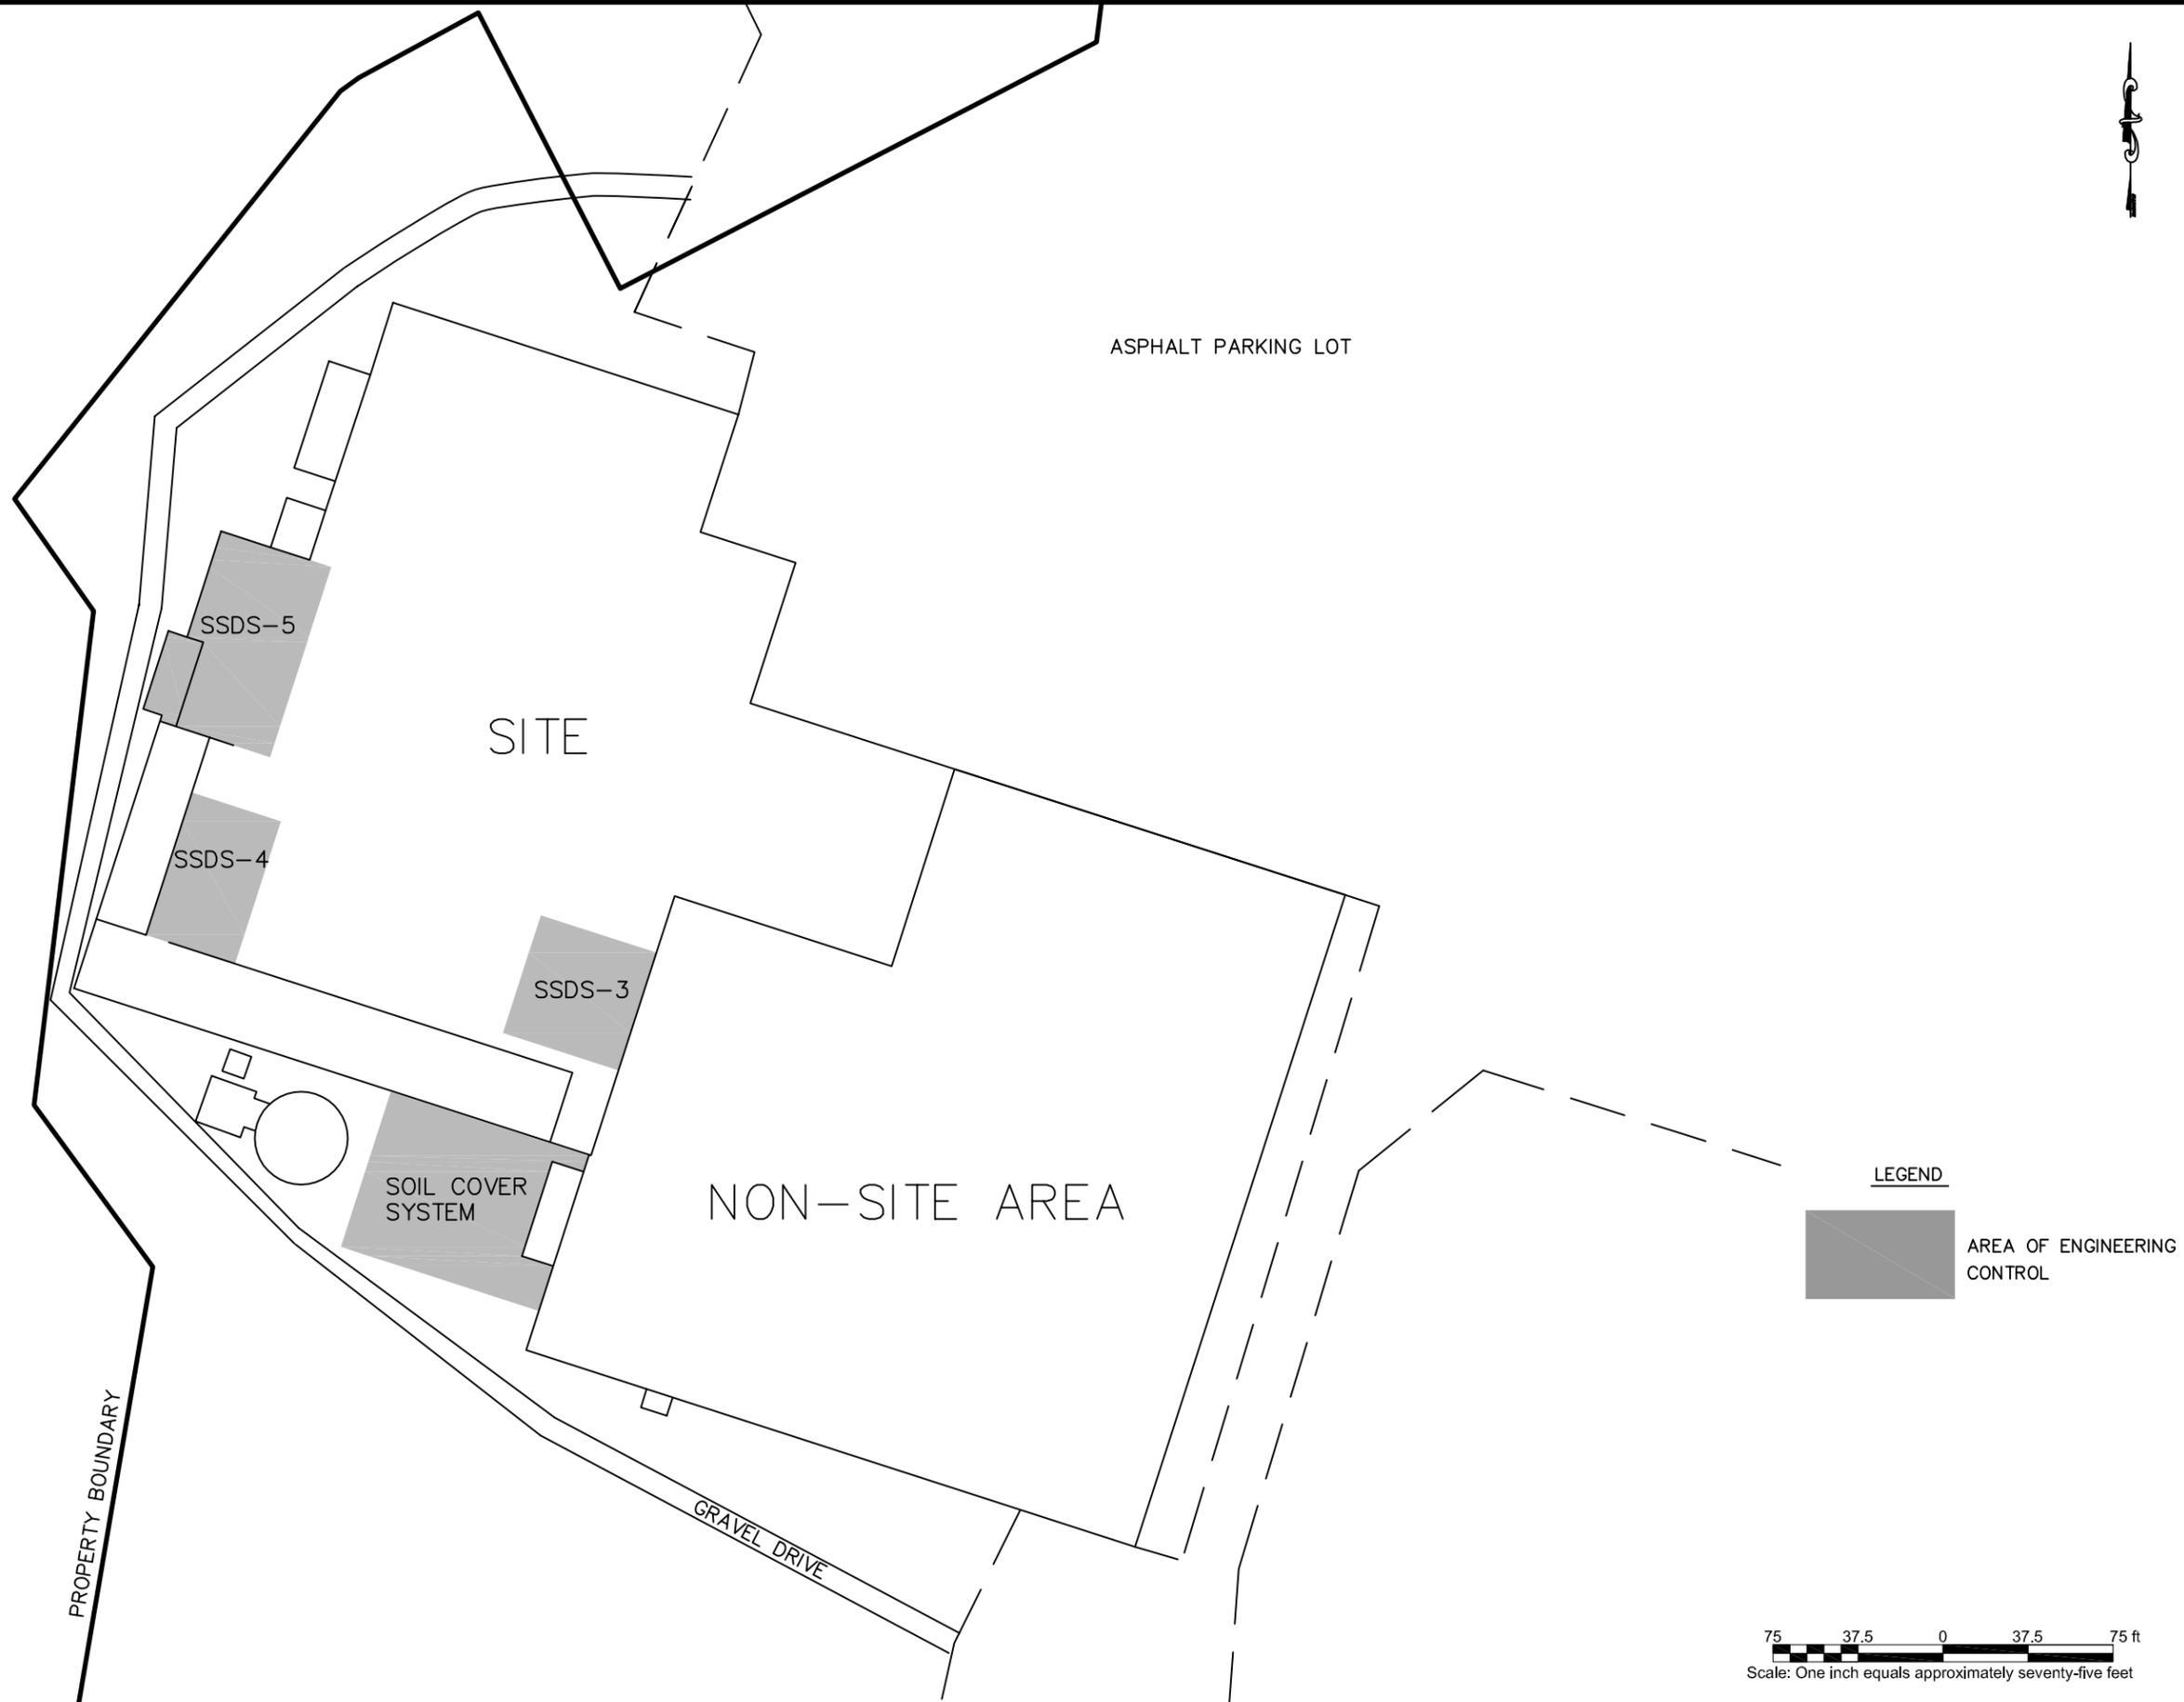
FIGURE 3- ENGINEERING CONTROL LOCATIONS
 FORMER CHAMPION PRODUCTS FACILITY
 200 N. MAIN STREET
 PERRY, NY

Exposure to remaining VOC impacts in soil/fill at the site is prevented by the use of two types of cover systems. In the former empty drum storage area, which is located outside of the south central area of the building, the cover system is comprised of a minimum of 6 feet of soil backfill (**Figure 3**). In the interior of the building, the cover system is comprised of the building's existing 4 -inch to 6-inch thick concrete floor slabs (**Figure 3**). The cover systems are permanent controls and the quality and integrity of these systems is verified by quarterly and

SSDSs were installed in three areas (SSDS-3, SSDS-4 and SSDS-5) at the site to address sub-slab soil vapor in areas of the site where previous indoor air and sub-slab vapor sampling indicated the presence of VOCs at concentrations in excess of the New York State Department of Health (NYSDOH) decision matrix recommended action levels for monitoring and/or mitigation (**Figure 3**). The SSDS at each area consists of a series of 2 to 3 sub-slab suction points (installed in high permeability material), which are connected by 3-inch PVC piping to exterior mounted low volume blower units. Each unit vents sub-slab vapor to the outdoor air. Vacuum at each suction point is measured by liquid filled U-tube manometers, which are installed on riser piping. The objective of the SSDS in each area is to create a vacuum field of at least 0.004" water column under the slab across each area to mitigate vapor intrusion. Each SSDS is designed to operate independently and continuously. Operation of the systems are verified by quarterly and annual inspections, which monitor the vacuum field and blower operations. These systems were fully in place and completely effective during the reporting period. Corrective measures are not required.
