RE: Final Focused Feasibility Study Report
Greif, Inc. Facility
Town of Tonawanda, Erie County, New York
NYSDEC VCP Number V00334-9

Sonoco Products Company

Final Focused Feasibility Study Report

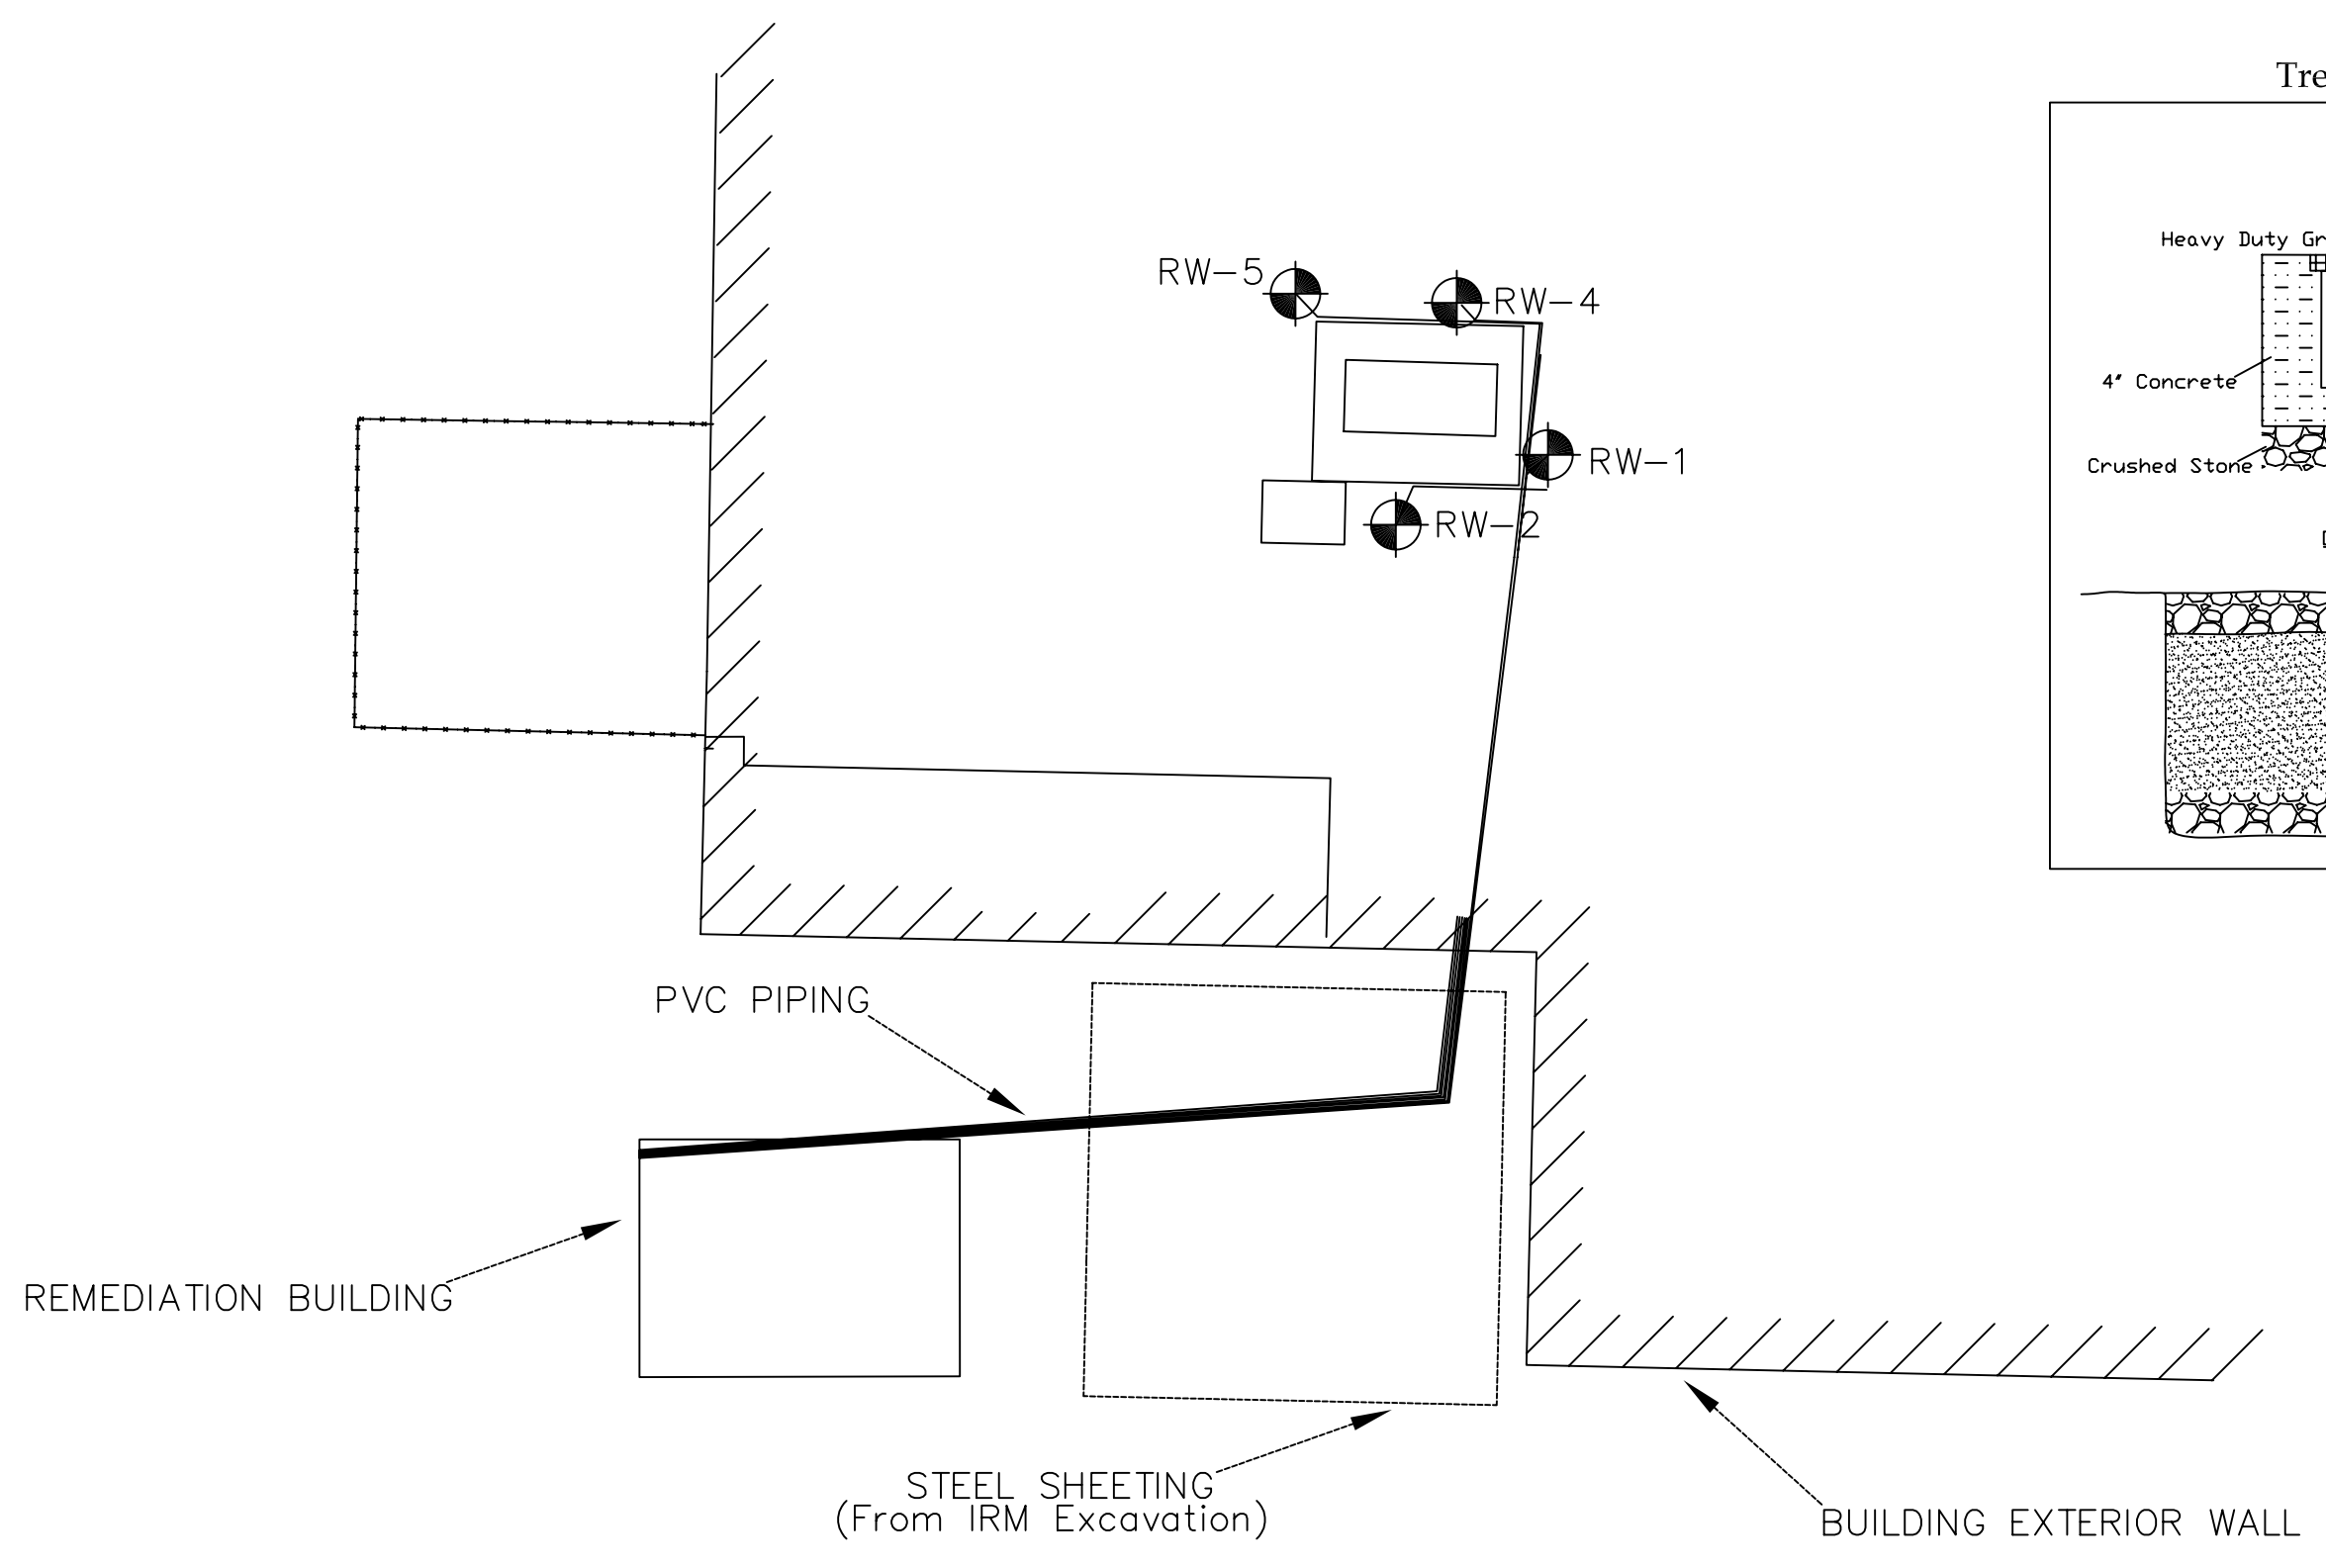
SCALE 1"=20'	FIGURE 1-14
DATE 4/07

Trench Cross-Sections

ERM initiated construction for the implementation of low vacuum enhancement of the DNAPL recovery system in December 2006. A sub-slab trench was installed from the Varnish Pit Area to the southern wall of the facility. The trench utilizes a steel form with steel grates covers to house the associated piping. This allowed easy access to the piping for repairs or to change the configuration of the piping, if deemed necessary. Pipe from the facility to the treatment building, which houses the SVE system and off-gas treatment equipment was insulated and directly

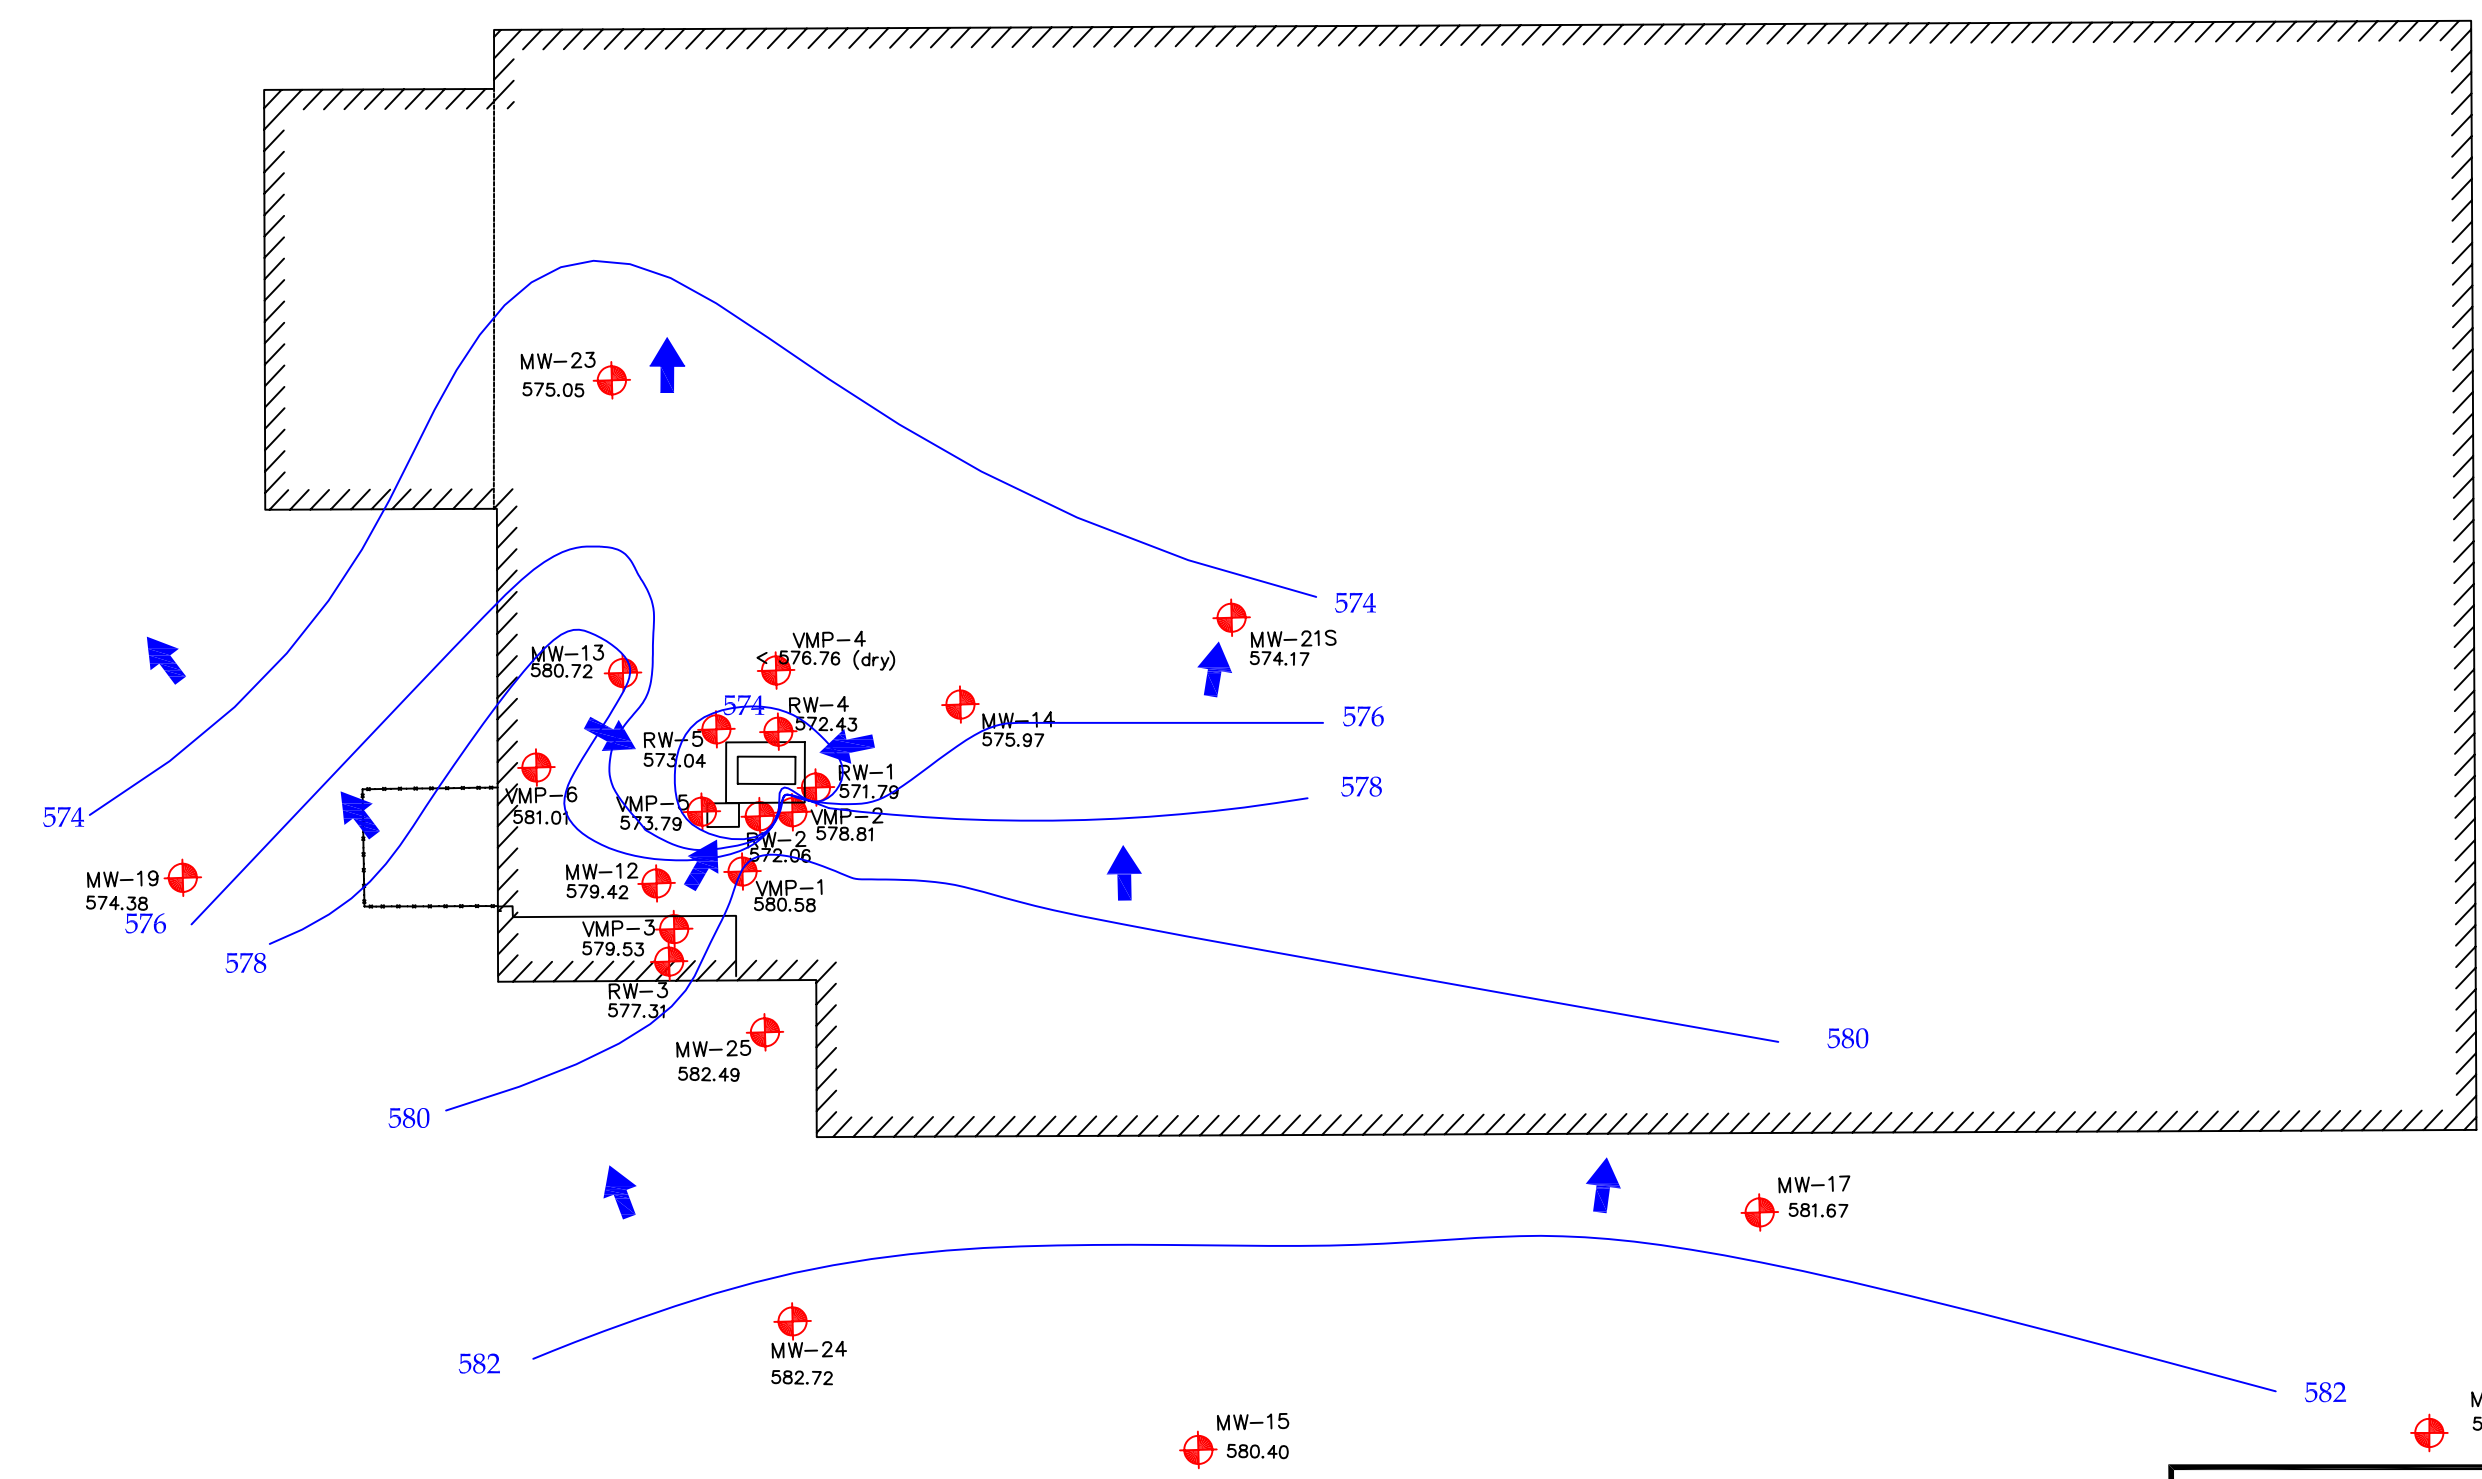
SHALLOW GROUND WATER CONTOUR PLOT - 8 October 2007 GRIEF FACILITY- TONAWANDA NEW YORK	
PREPARED FOR SONOCO PRODUCTS COMPANY	
ERM 5788 WIDEWATERS PARKWAY DEWITT, NEW YORK 13214	SCALE 1" = 50.5' DATE 11/07
FIGURE 1	PROJECT #070121

Notes:
 Ground water elevation data collected during operation of DNAPL recovery system.
 Base map obtained from WM. Schutt & Associates, P.C. survey drawings updated on 12 January 2006

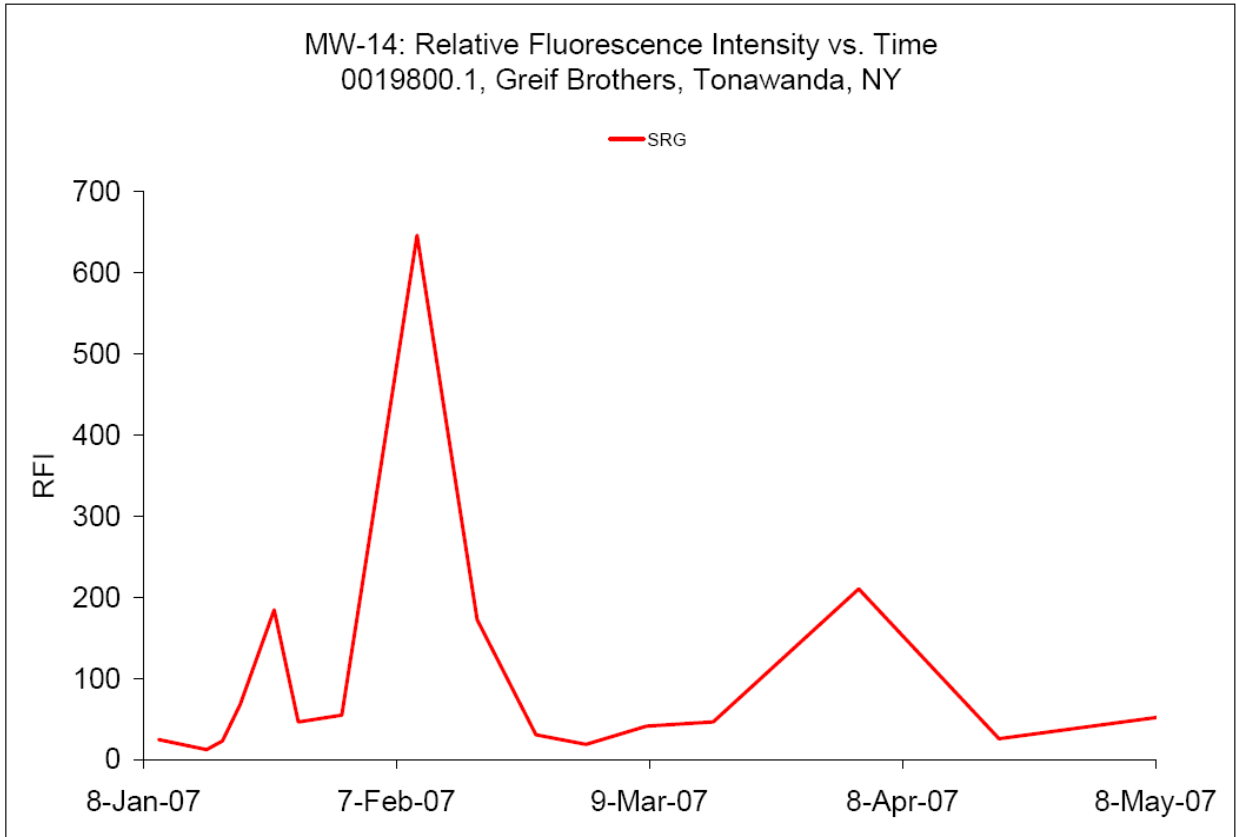
Figure C3: The dye breakthrough curve shows that the maximum dye concentration reached this well 29 days after dye injection.
