**New York State Department of Environmental Conservation  
Waste Tire Stockpile Assessment Summary Sheet - Site 4-02**

**Stan's Auto  
Town of Guilderland**

**Region 4, Albany County**

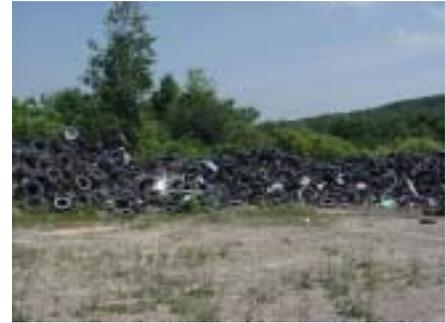
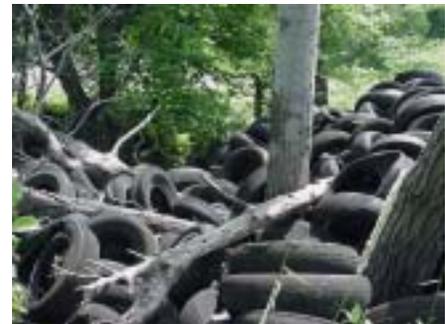
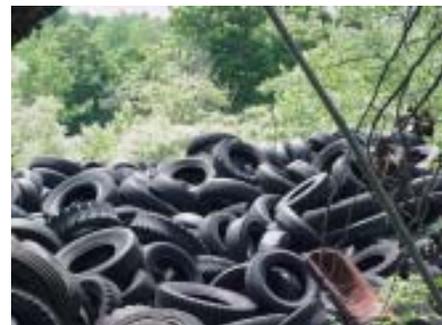
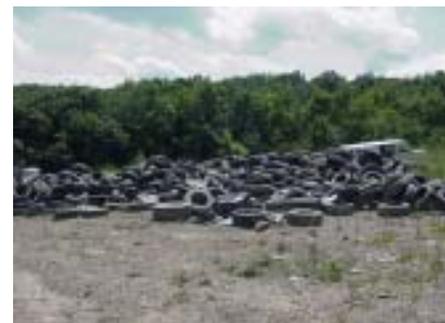
**Site Setup: sloped dirt road to tires,  
one pile along road, road ends at field,  
rest of tires in a line along field and  
into wooded ravine**

**Condition of Tires:  
Many are hard to see, overgrown  
Most are passenger tires without rims  
Difficult to estimate number that is down  
into a ravine  
Tires are blocked by trees, ravine, and  
junk automobiles**
