Poestenkill Assessment Area Bedrock Groundwater PFAS Radar Plots

Poestenkill Assessment Area
 Averill Park, NY
 Figure 4-4A

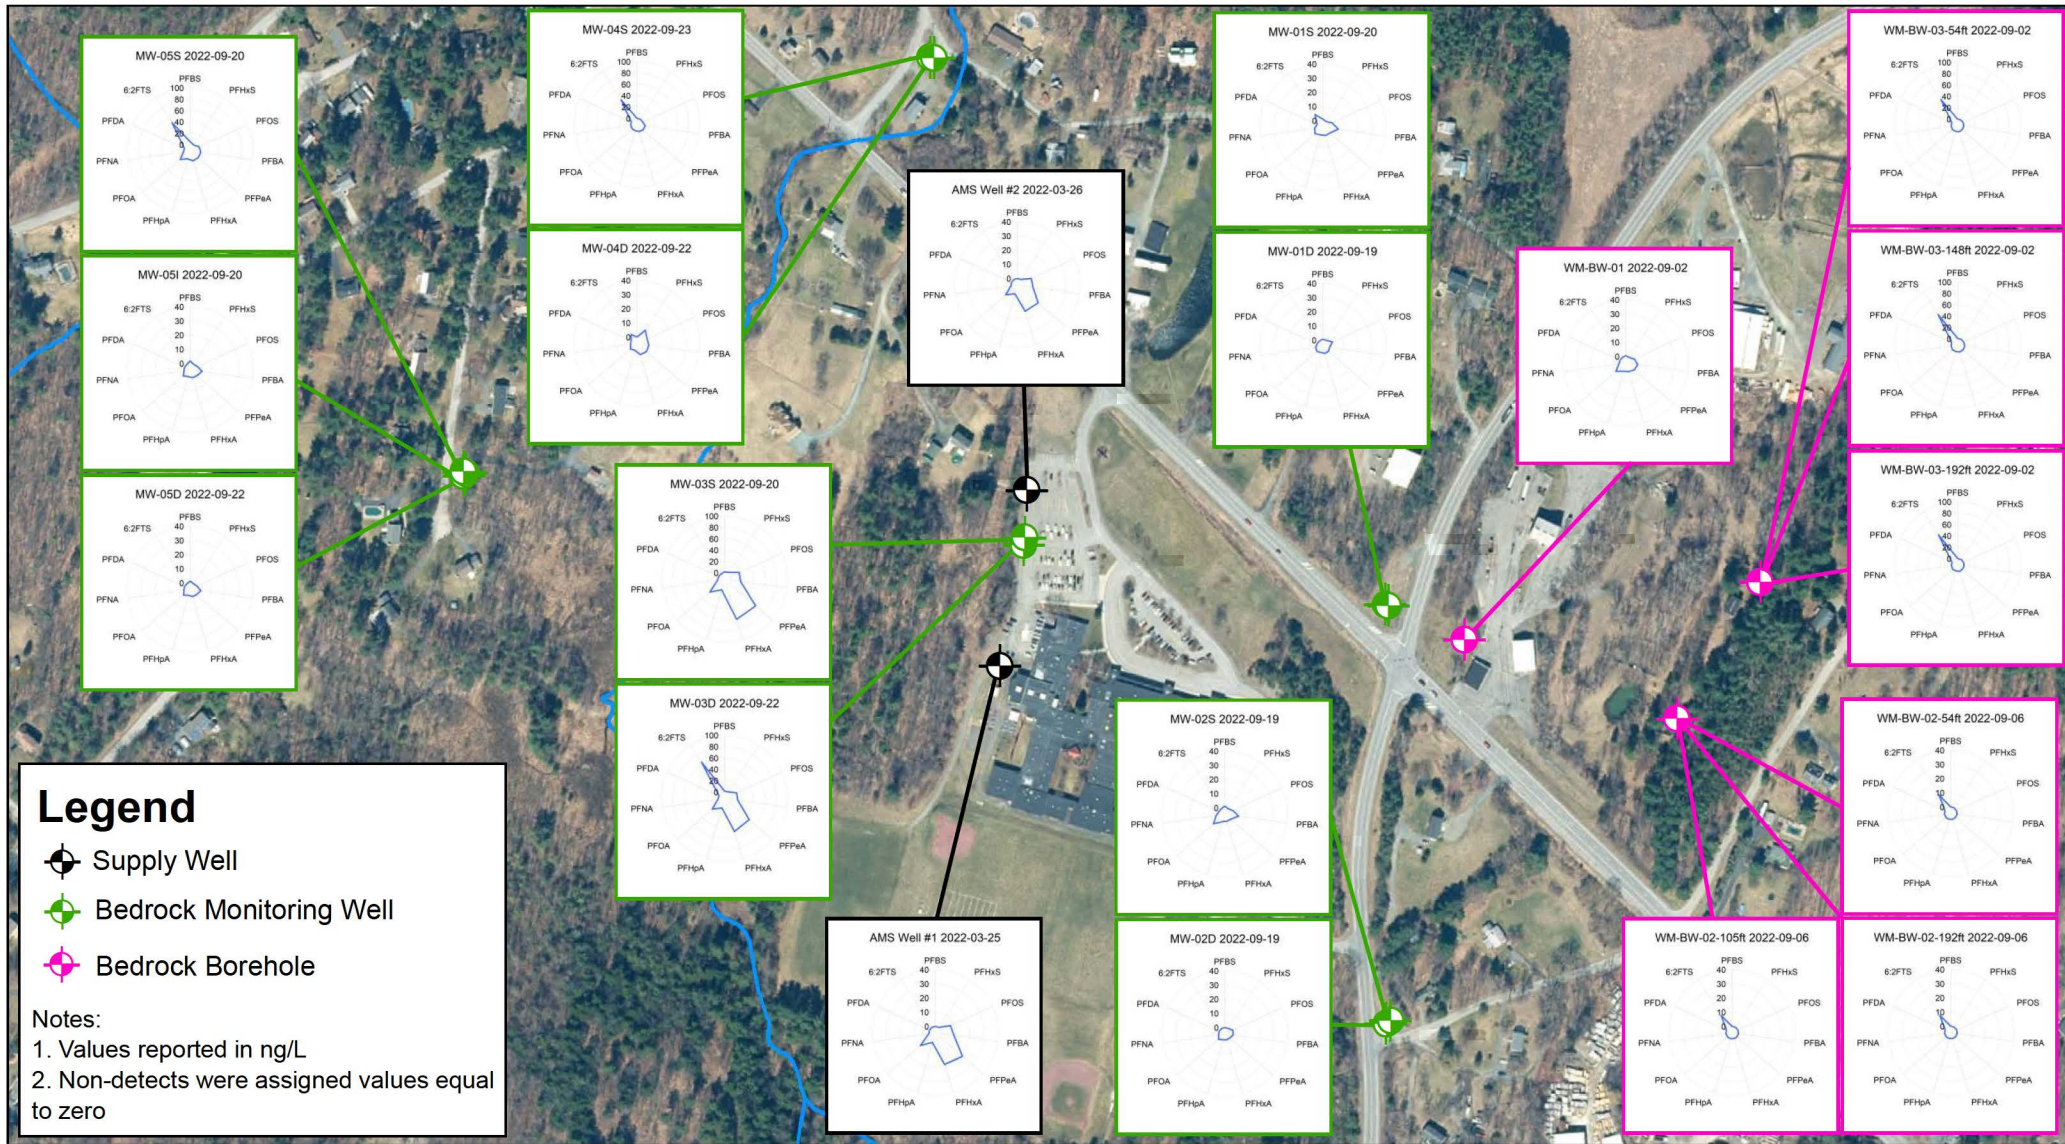
Notes:
 1. Values reported in ng/L
 2. Non-detects were assigned values equal to zero

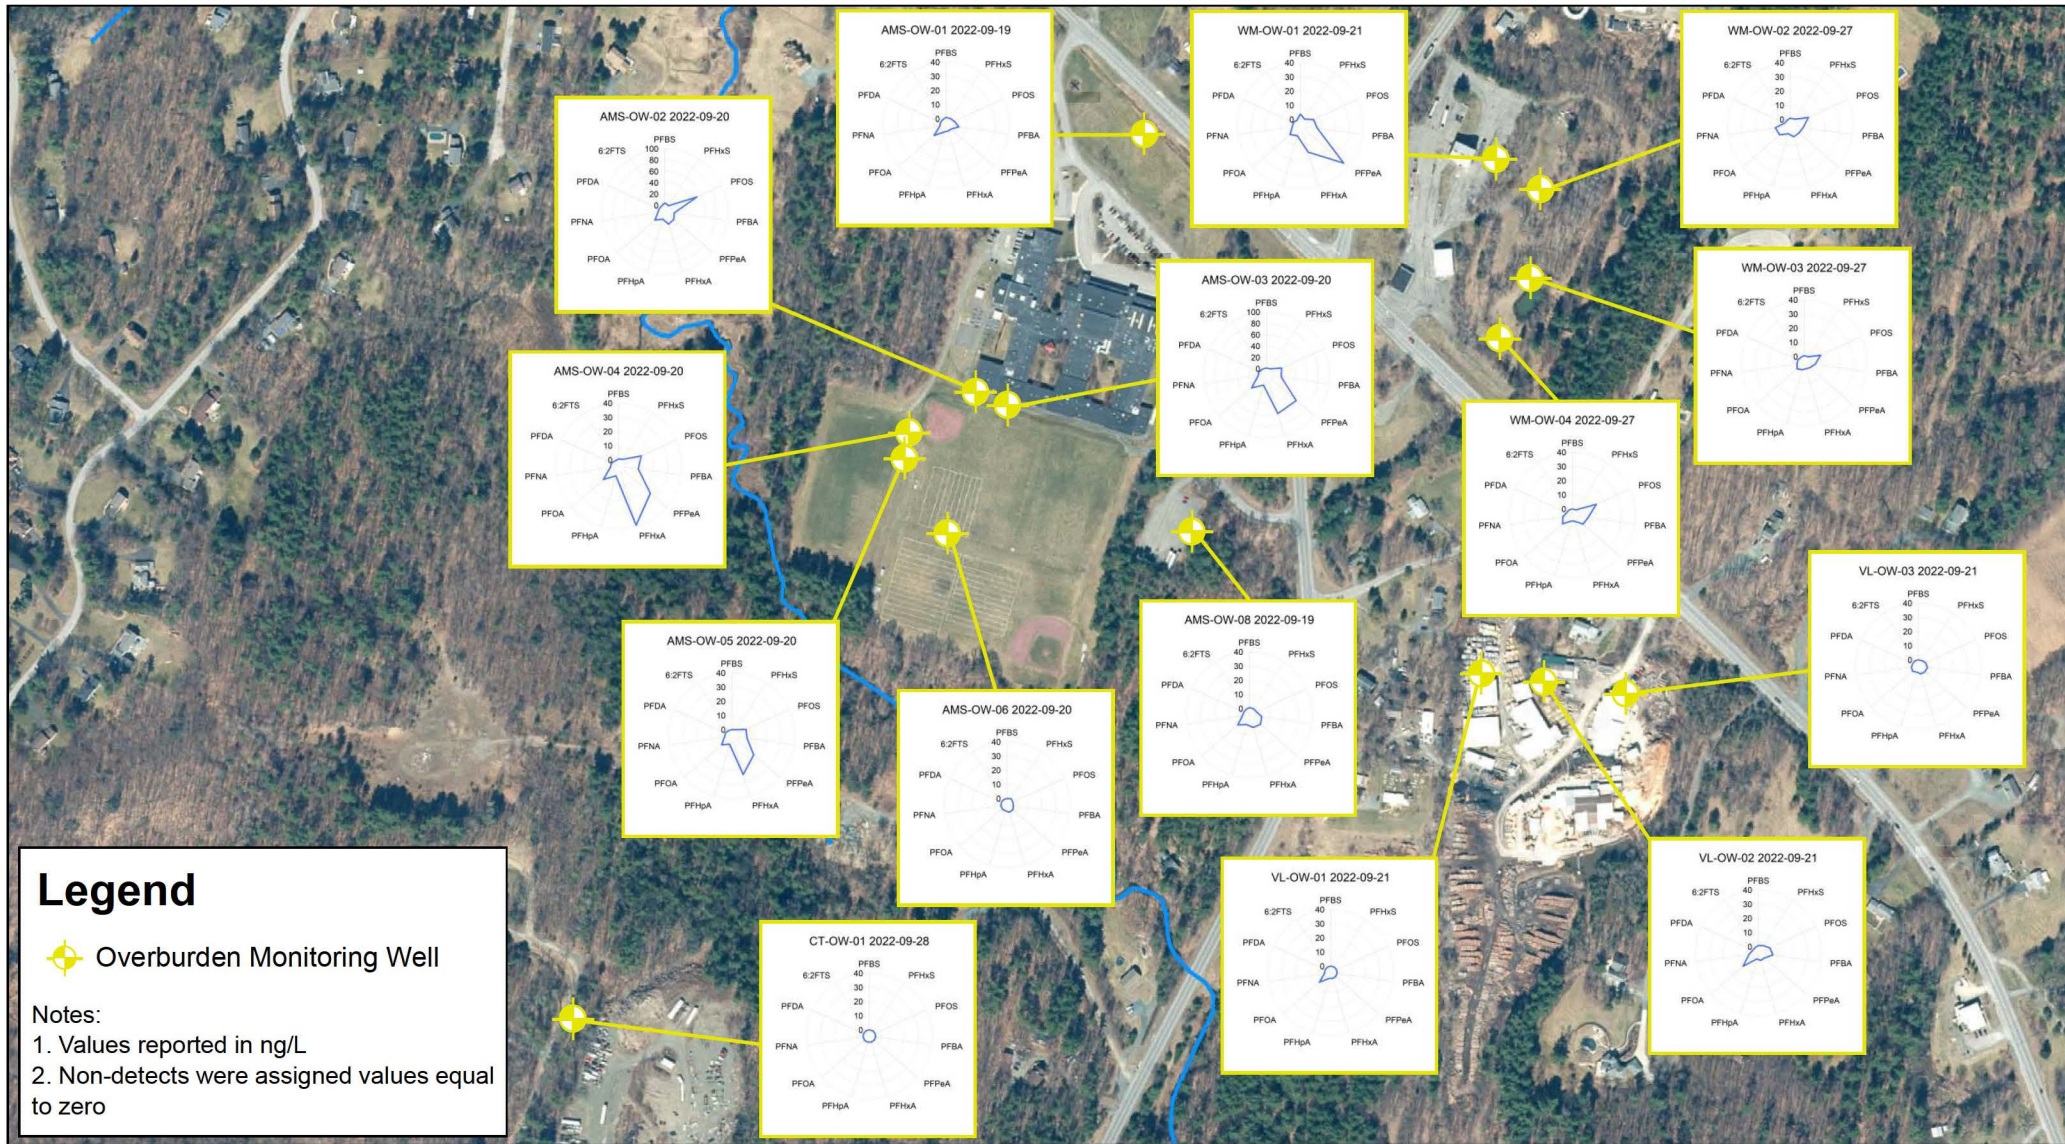
Poestenkill Assessment Area
Averill Park, NY
Figure 4-4B

Poestenkill Assessment Area Overburden Groundwater PFAS Radar Plots

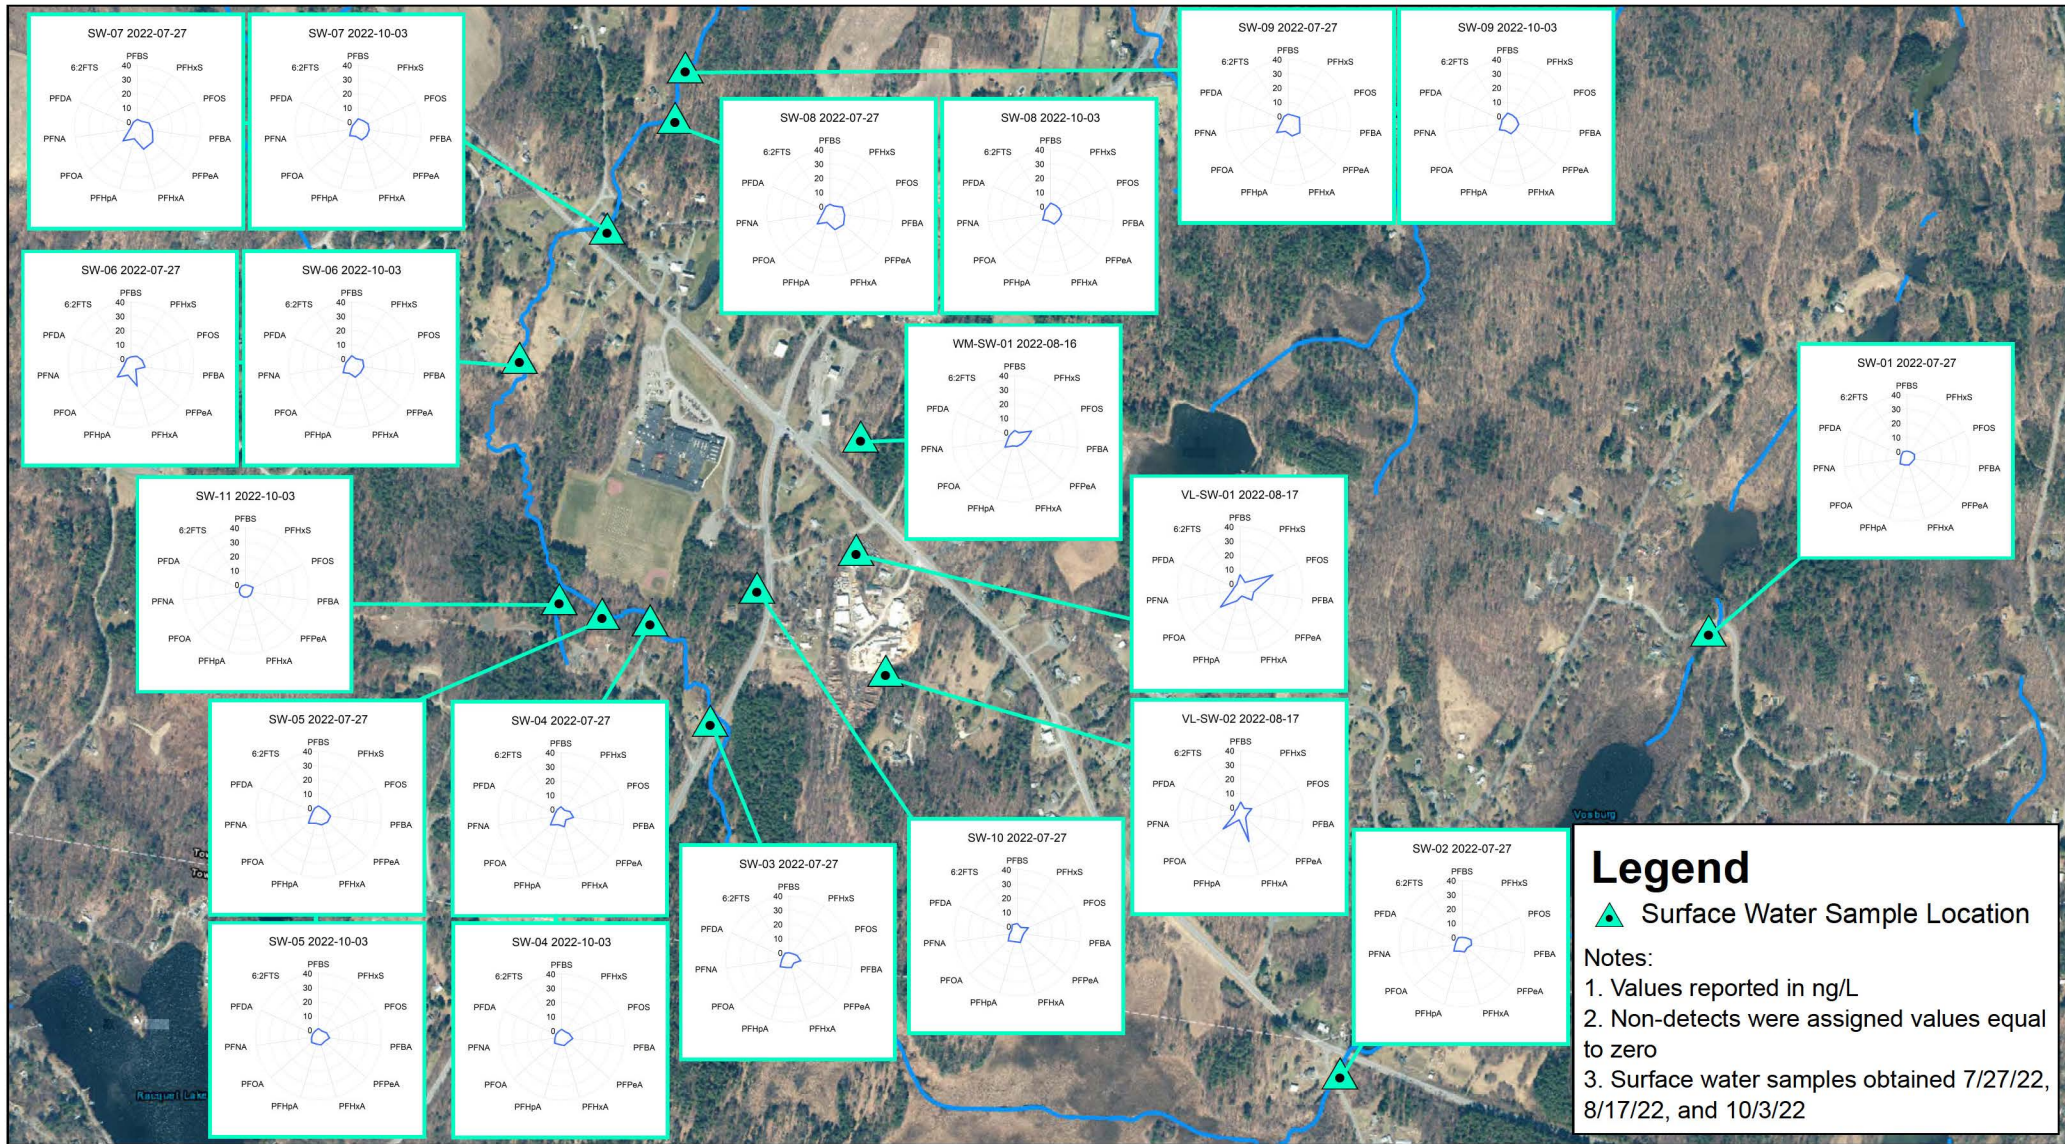
Poestenkill Assessment Area
Averill Park, NY
Figure 4-4C

1. Values reported in ng/L
2. Non-detects were assigned values equal to zero
3. Surface water samples obtained 7/27/22, 8/17/22, and 10/3/22

Poestenkill Assessment Area Surface Water PFAS Radar Plots
