Poestenkill Assessment Area Overburden Well Artificial Sweetener Results

Poestenkill Assessment Area
Averill Park, NY
Figure 4-5A

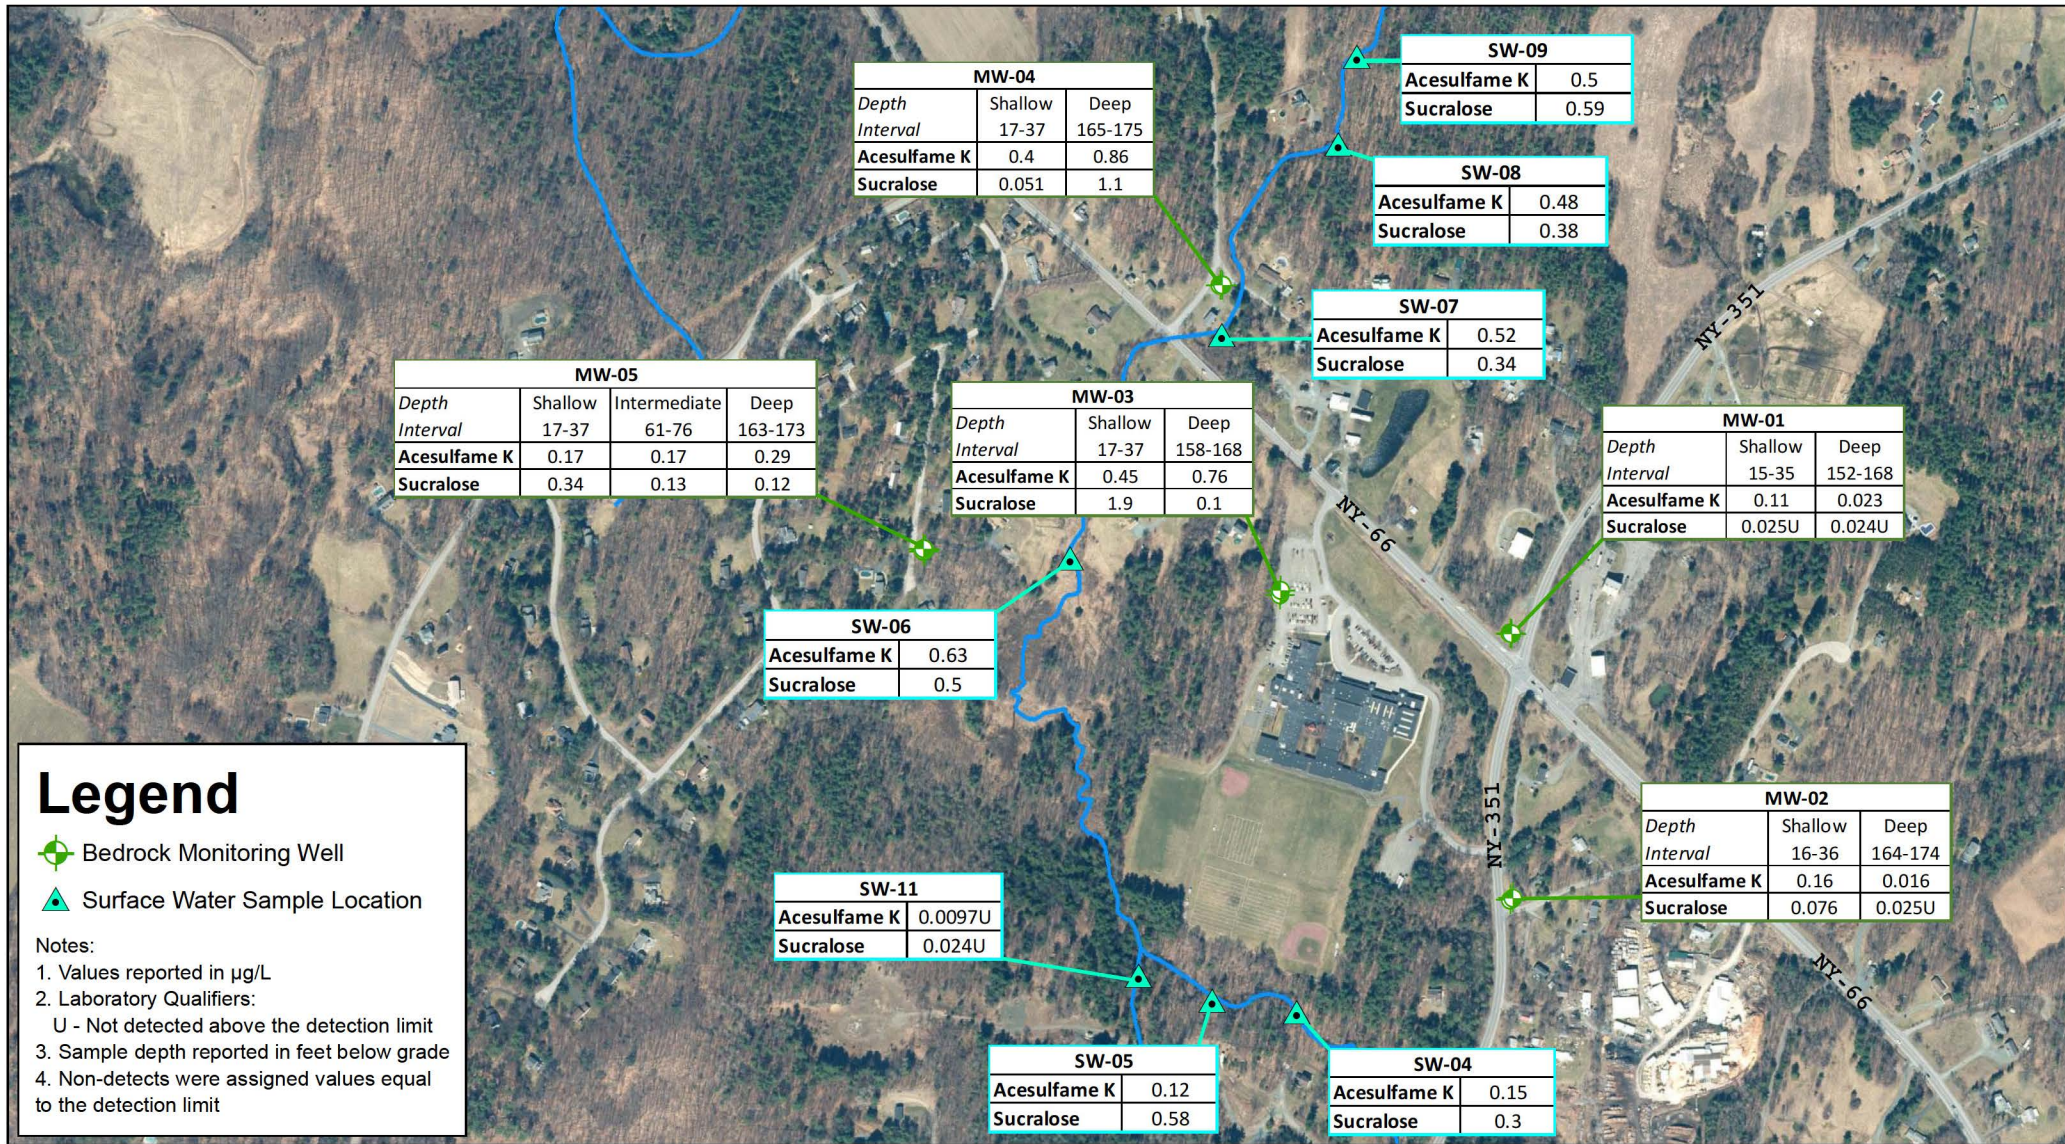
Poestenkill Assessment Area
Averill Park, NY
Figure 4-5B

Poestenkill Assessment Area Surface Water and Bedrock Well Artificial Sweetener Results

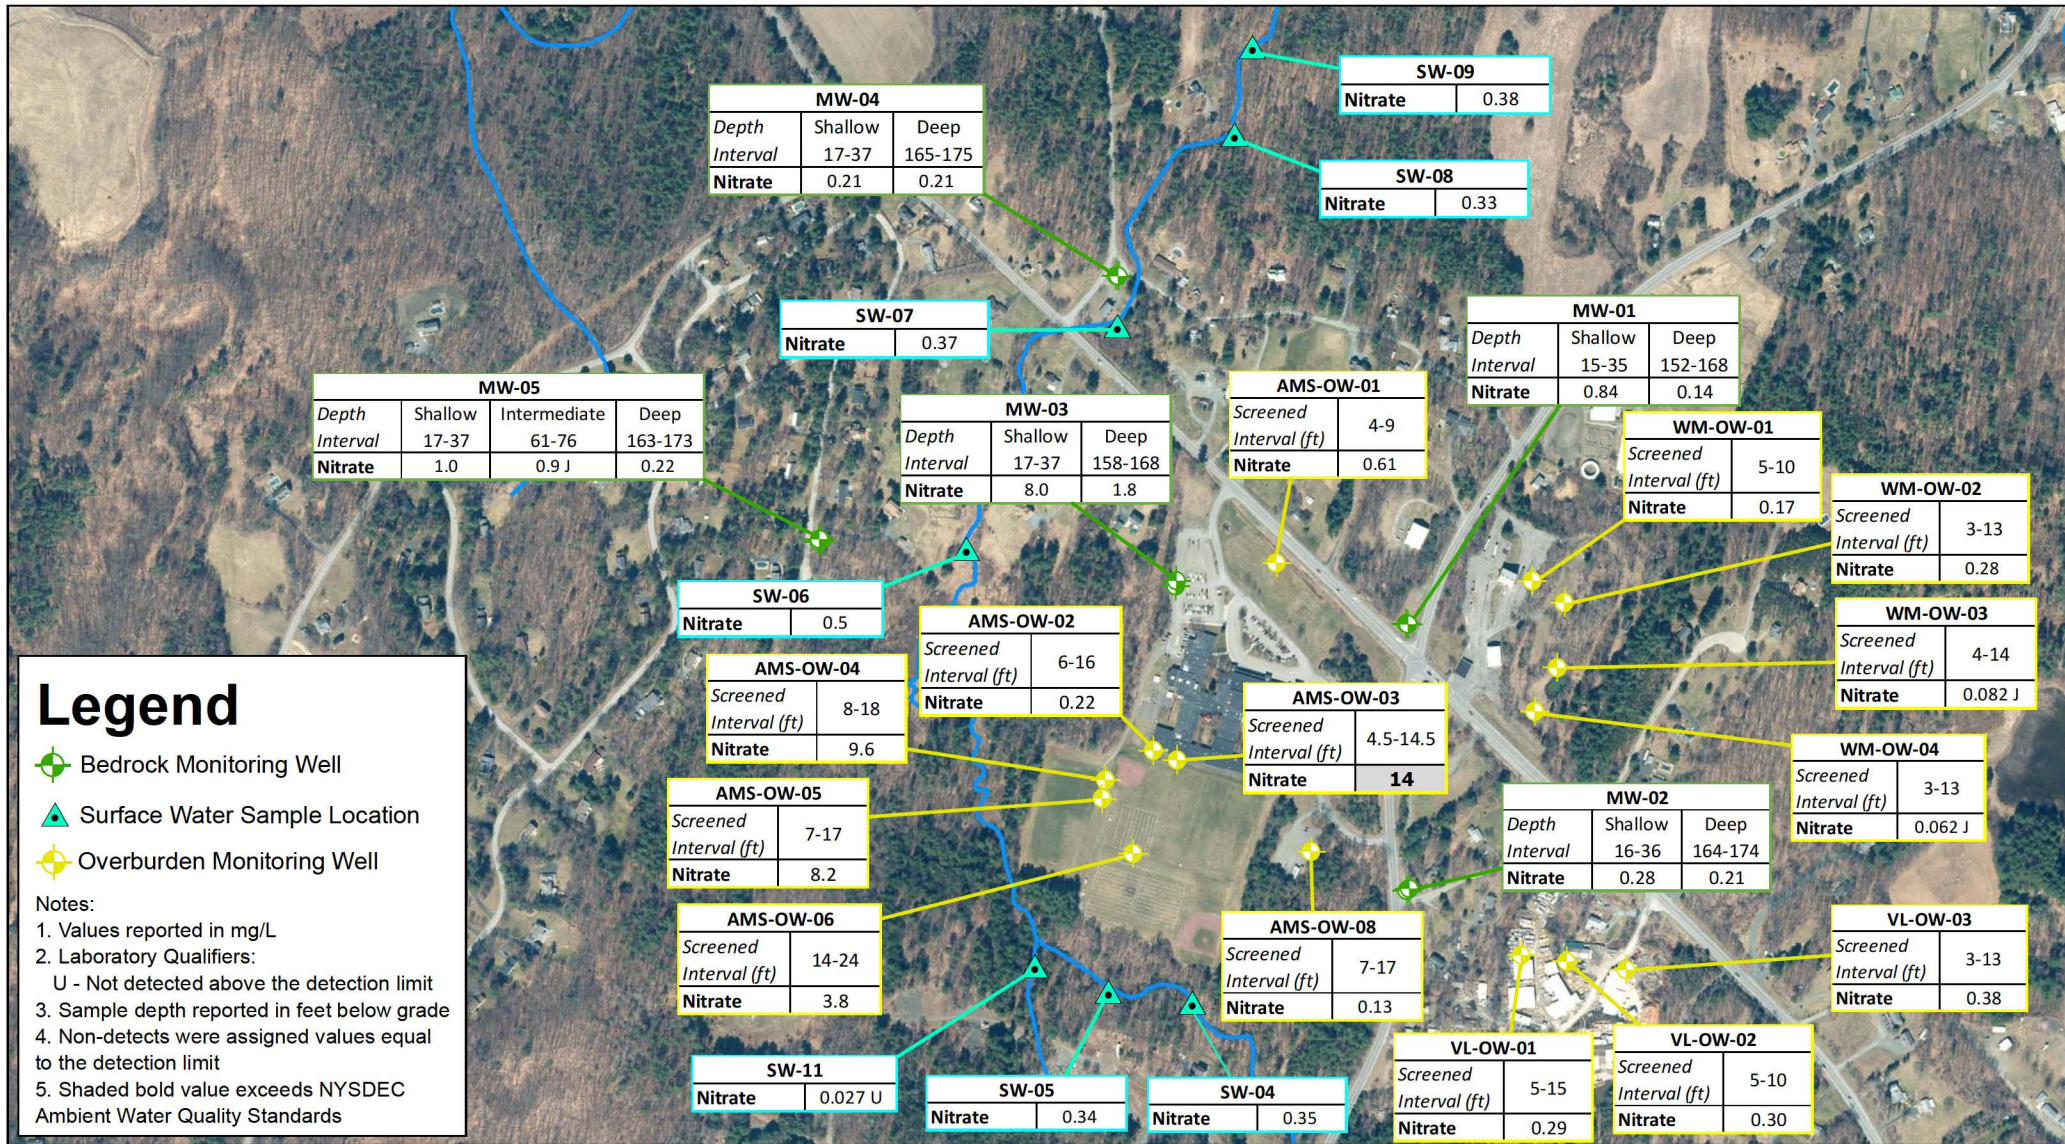
Poestenkill Assessment Area
Averill Park, NY
Figure 4-6

Poestenkill Assessment Area Nitrate Results
