Spring Mills Creek Fish Passage Enhancement Survey

Scott Cornett, Region 9 Fisheries

3/25/2024

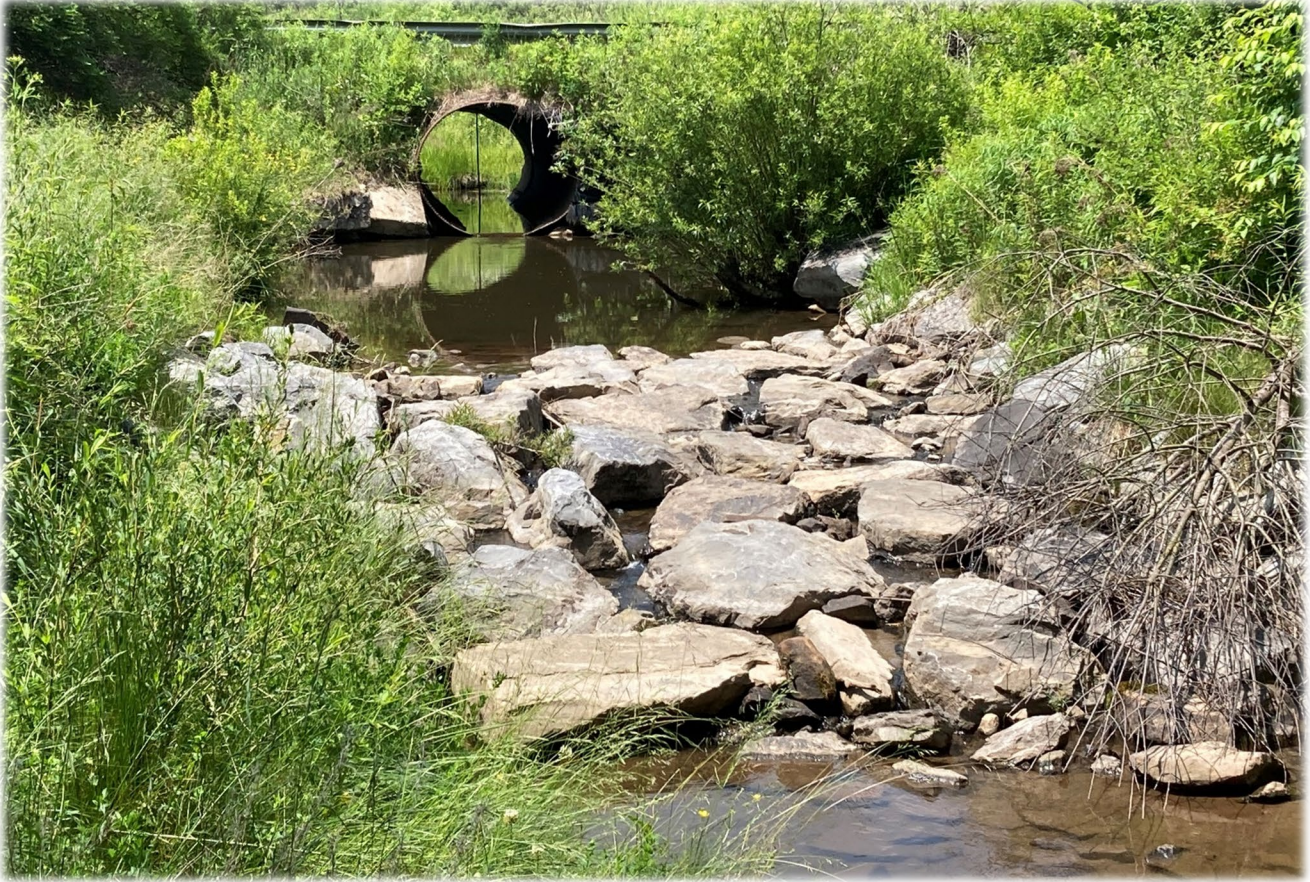
Figure 1. Engineered rock riffle below Pleasant Valley Rd on Spring Mills Creek, June 29, 2023.

In the fall of 2020, two impassable culverts on Town and County roads were improved by installing engineered rock riffles downstream to back water up into the culverts (Figure 1). Sampling in 2022 by USFWS staff had not been able to determine if wild brook trout were moving upstream through the improved culverts. At the upper improved culvert on Pleasant Valley Road, 200 feet of sampling below the culvert produced four adult wild brook trout, ranging from 4-9 inches (Figure 2). An additional 100-foot done immediately above the culvert captured no trout. Several non-trout fish species were captured both below and above the culvert. The area sampled above the culvert was heavily impacted by beaver and very thick with willows, making sampling efficiency low.
