Phase I Environmental Site Assessment

750 East Ferry Street
Buffalo, New York

LaBella Project No. 2160590

March 16, 2016

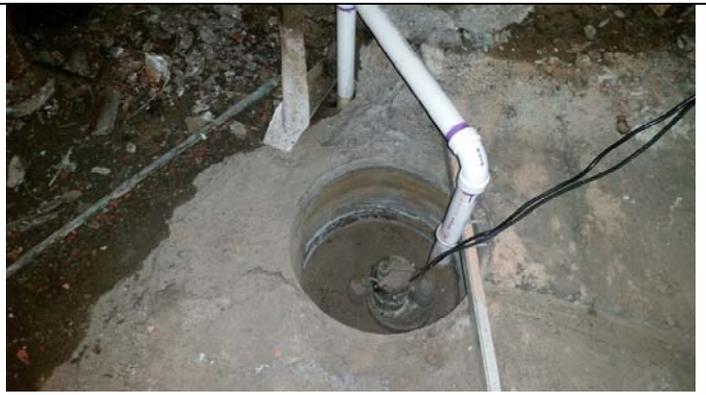
Sump in basement of Site Building 1

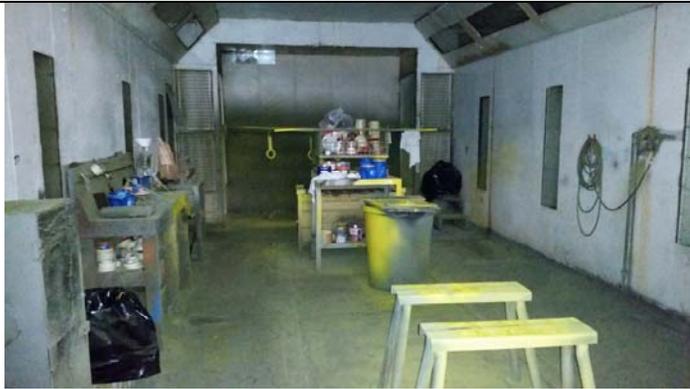
Spray booth in Site Building 2

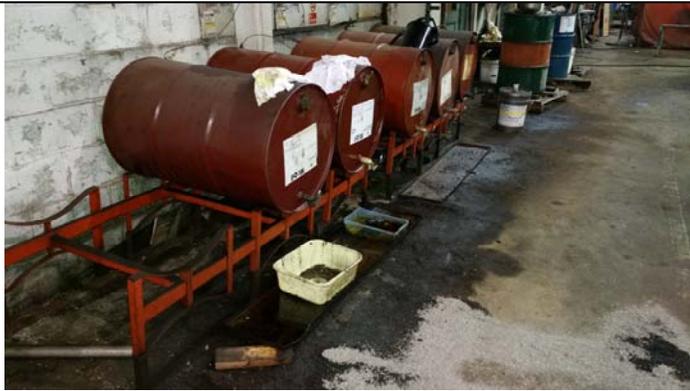
Drum storage/dispensing area in Machine Shop Main Floor portion of Site Building 2

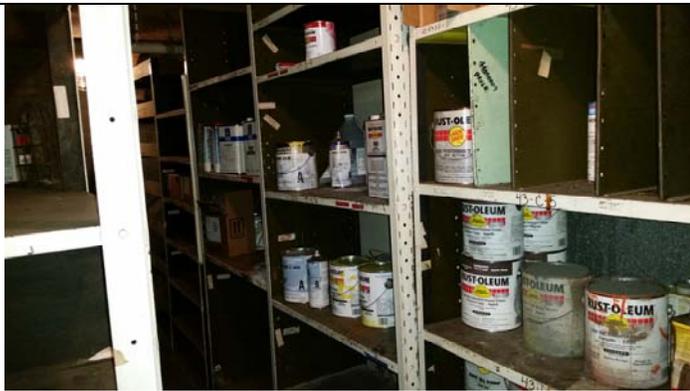
Paint storage room between Machine Shop portion and Fabrication Department portion of Site Building 2

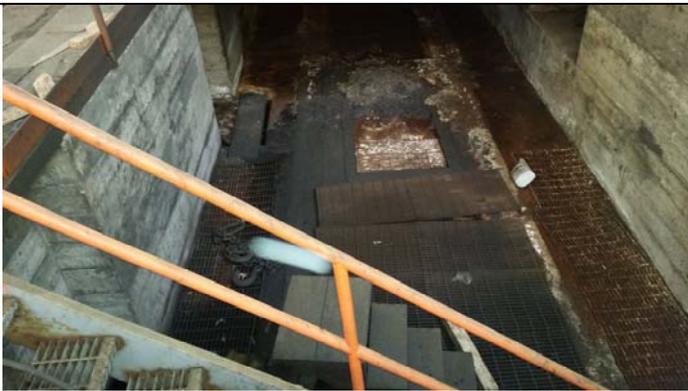
- The four reported pits located in the Fabricating Department portion of Site Building 2.
- The material observed at the bottom of the open pit in the Fabricating Department portion of Site Building 2 may contain hazardous material and petroleum products.

Open pit in Fabricating Department portion of Site Building 2 used as storage

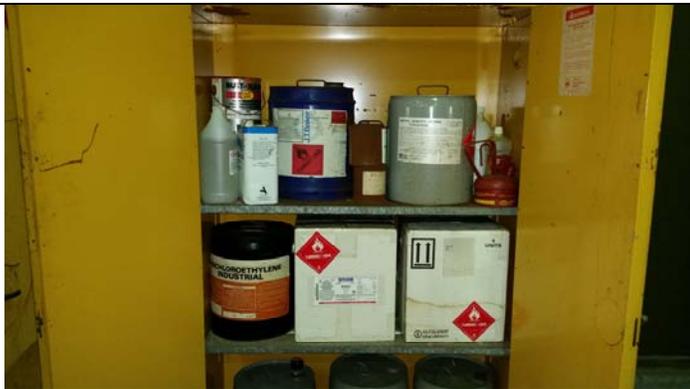
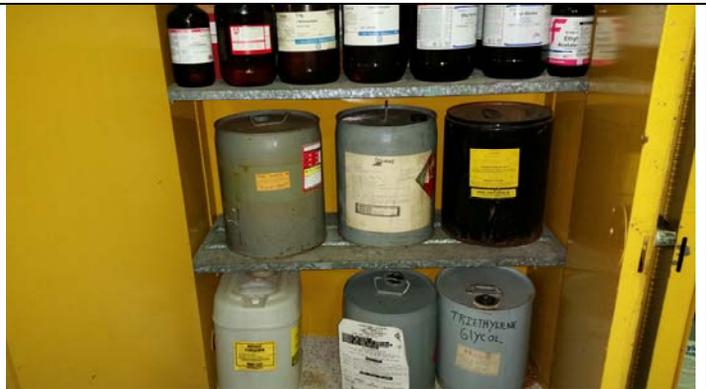
Flammable Cabinet chemical storage in Site Building 3

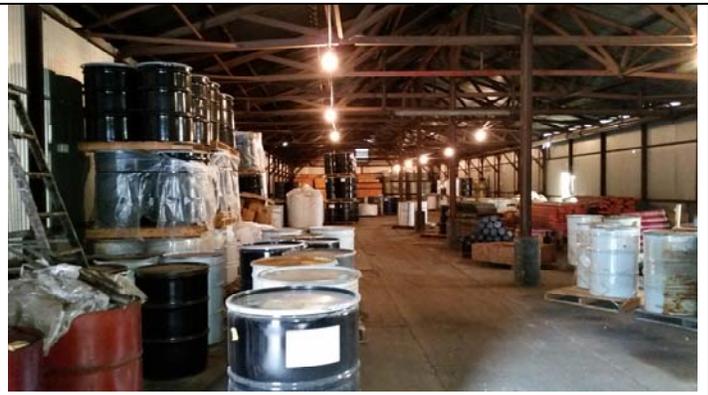
Site Building 4 interior

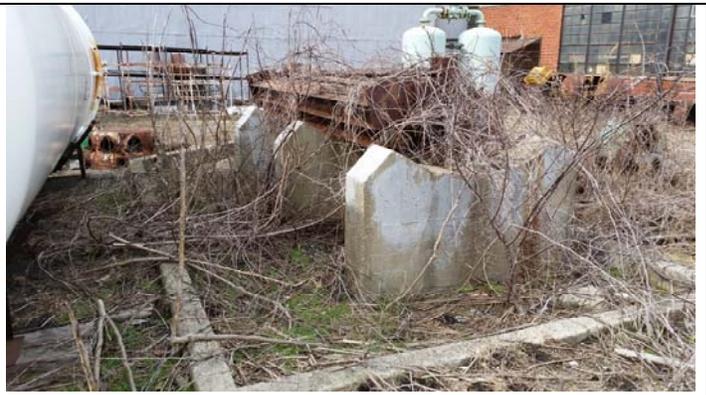
Concrete cradles and containment for AST east of Storage Building & Receiving portion of Site Building 2

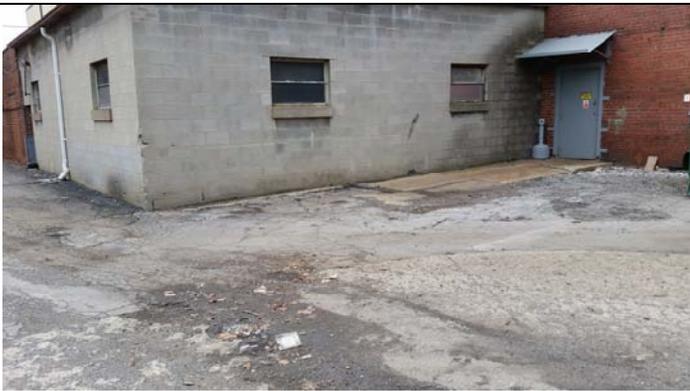
Area at north end of 10,000-gallon UST closed in place

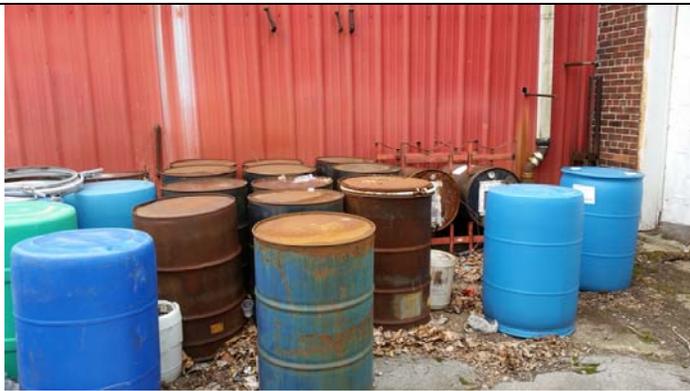
Drum storage north of Site Building 3

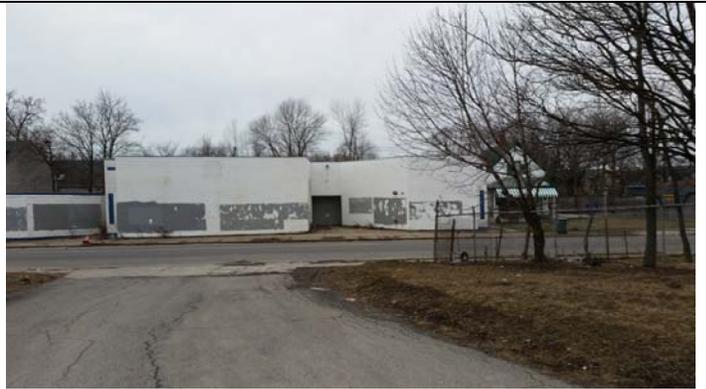
West adjoining property

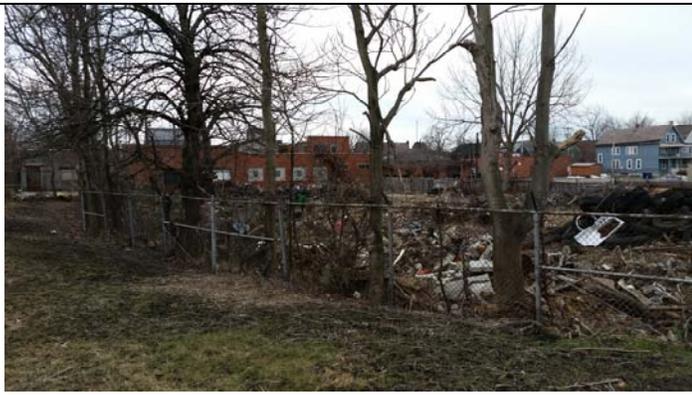
West adjacent property

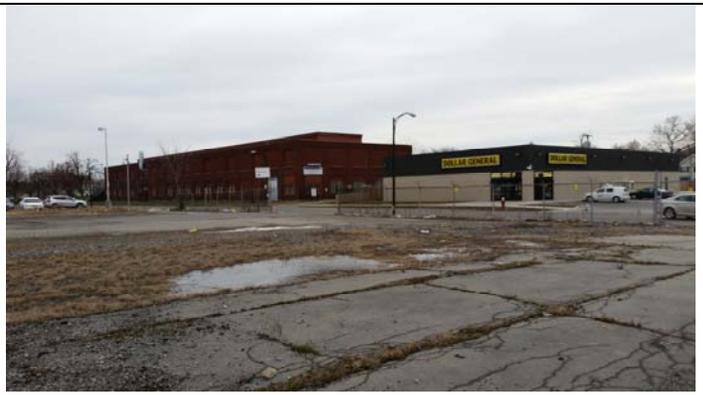
West adjoining property

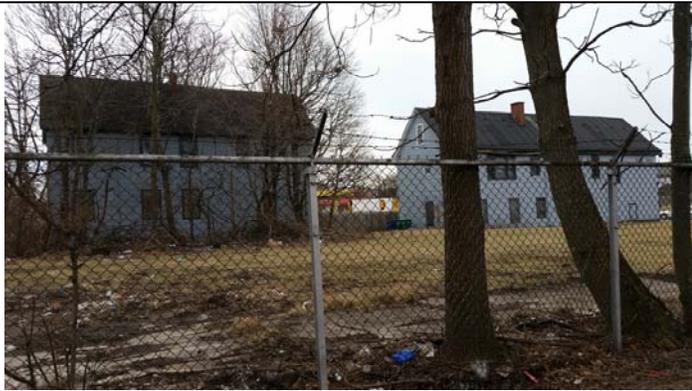
South adjacent properties
